Technical Paper

A Case Study on Condition Assessment of Fire-Damaged RC Members of Turbo-Generator

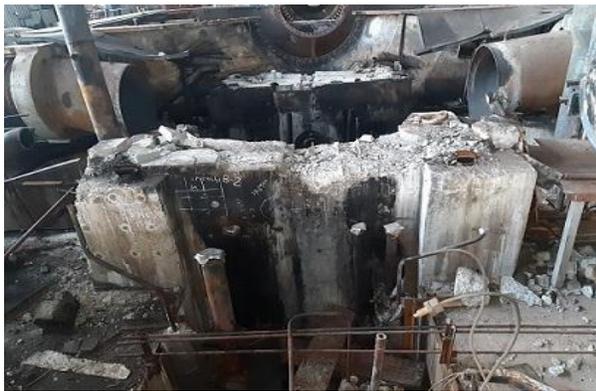
Fig. 2 – Spalling and crushing of top chemical grout along with underneath concrete and black stains of the fire-damaged face of Pedestal B2

The visual inspection indicated the crushing and spalling of top grout and underneath concrete was observed at concrete bearing pedestals of B2 and B4 (as shown in Figure 2 and Figure 3). The crack width and depth were measured by using a crackoscope and UPV equipment, respectively. In addition to soot, inclined cracks initiated from the top and extended to downward direction were also observed on concrete bearing pedestal B2 (width varies from 0.25 to 0.4 mm, depth varies from 73 to 112 mm, and length of approx. 350 mm). No such cracks were observed on concrete bearing pedestal B4. Deposition of soot on a small portion of the deck slab soffit was also observed. However, no deposition of soot and change in colour were observed at supporting columns. Side and top reinforcement were exposed at a few locations on a pedestal bearing B2. Change in colour from grey to black was observed on cores extracted from concrete bearing pedestal B2 as shown in Figure 4 and Figure 5. Based on the visual inspection it was observed that concrete bearing pedestal B2 was moderately distressed while pedestal B4 and deck slab were in the minor distress category and no apparent distress was observed on supporting columns.

Further, the repair was proposed for a distressed concrete bearing pedestal using micro concreting at crushed portion followed by FRP wrapping. For inclined cracks, epoxy grouting was proposed. The protective coatings were also suggested for all repaired and non-repaired portions for improving the performance of RC members of the TG unit. This

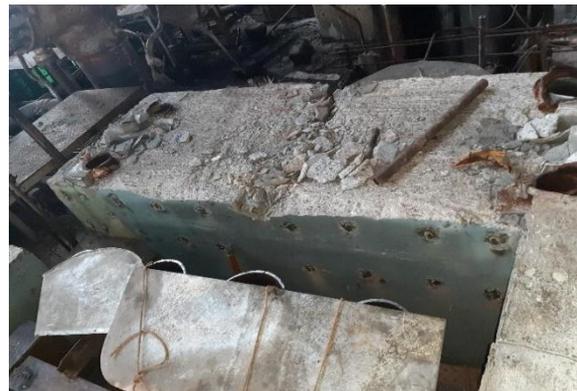
Fig.3 – Spalling and crushing of top chemical grout of Pedestal B4

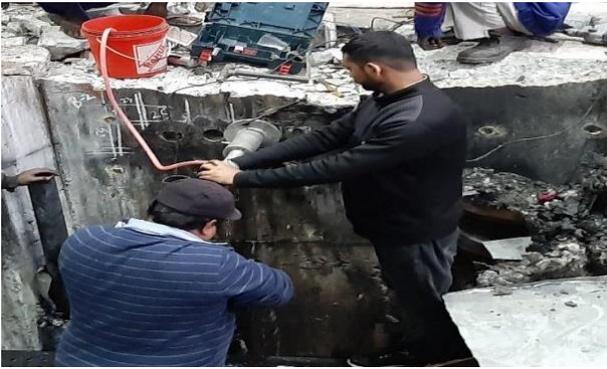
Fig. 4 – Extraction of cores from the concrete bearing pedestal B-2

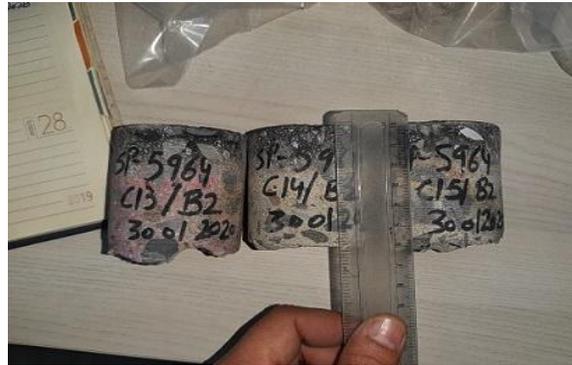
Fig. 5 – Colour change to a blackish grey colour in the cover region of concrete bearing pedestal B2.

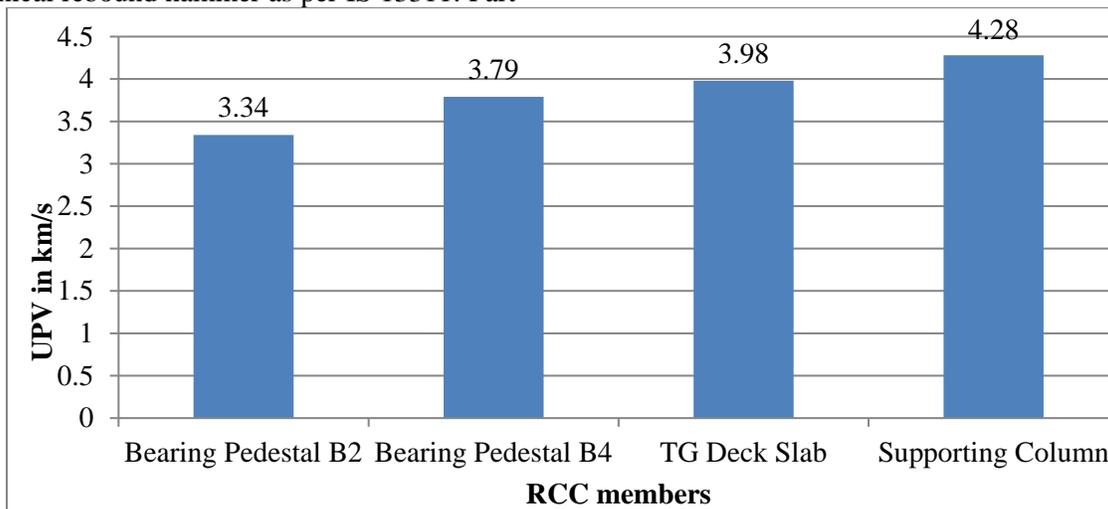
Ultrasonic Pulse Velocity measurements were carried out by the cross-probing method at different locations as per IS 516: Part 5: Sec 1: 2018 [12] to assess the quality of concrete in RCC members of the TG unit. The average results of the UPV test on pedestal B2 and B4 were found to be 3.34 km/s and 3.79 km/s, respectively, which indicates that the overall quality of concrete was found to be doubtful in bearing pedestal B2 and good in bearing pedestal B4. The same was supported by Kore et al [13] that there was a decrease in UPV results of fire exposed members. For deck slab and supporting columns, the results were found to be 3.98 km/sec and 4.28 km/sec, respectively, which indicates the overall quality of concrete was good.

Fig. 6 – UPV (by cross probing method) of various RCC members of the TG unit

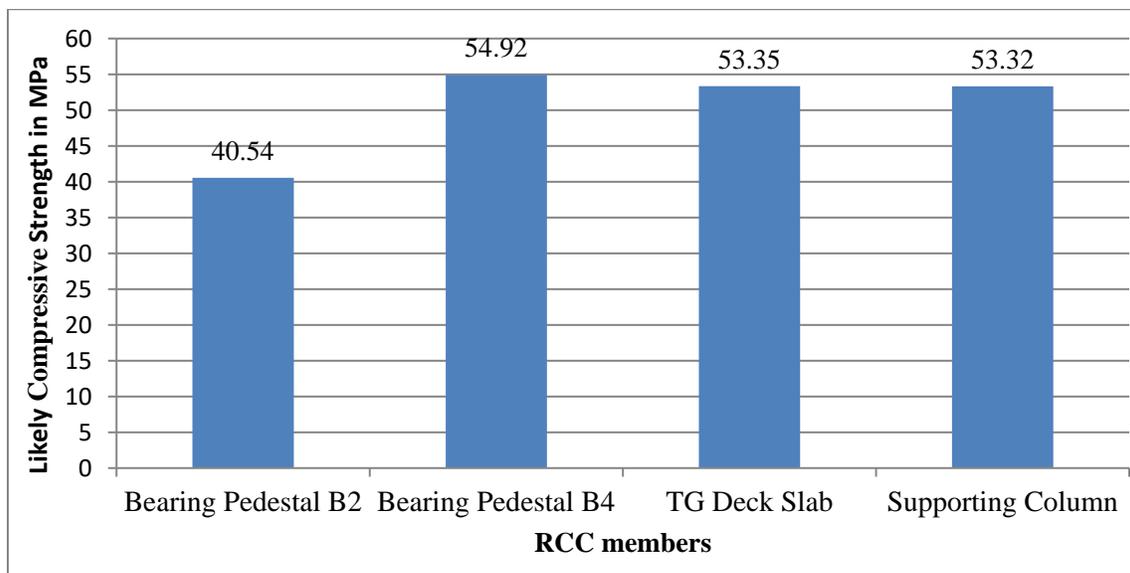
2: 1992 [14] to predict the likely compressive strength of the fire and non-fire damaged members of the TG unit. The results obtained by Rebound Hammer testing on fire damage concrete bearing pedestal B2 (as shown in Figure 7) indicate the average likely compressive strength of 40.54 MPa, and for non-fire damaged concrete bearing pedestal, i.e., B4 likely compressive strength is 54.92 MPa. The rebound hammer test on other non-fire damage RCC members (TG deck slab and supporting columns) indicates 53.35 MPa and 53.32 MPa, respectively. These results show that the rebound test gives less likely compressive strength on the fire-damaged portion than non-fire damaged, and the variation is approximately 26%. Similar results were also observed by Wróblewska J. et al. [15].

Fig. 7 – Likely Surface Compressive Strength of RCC members of TG unit

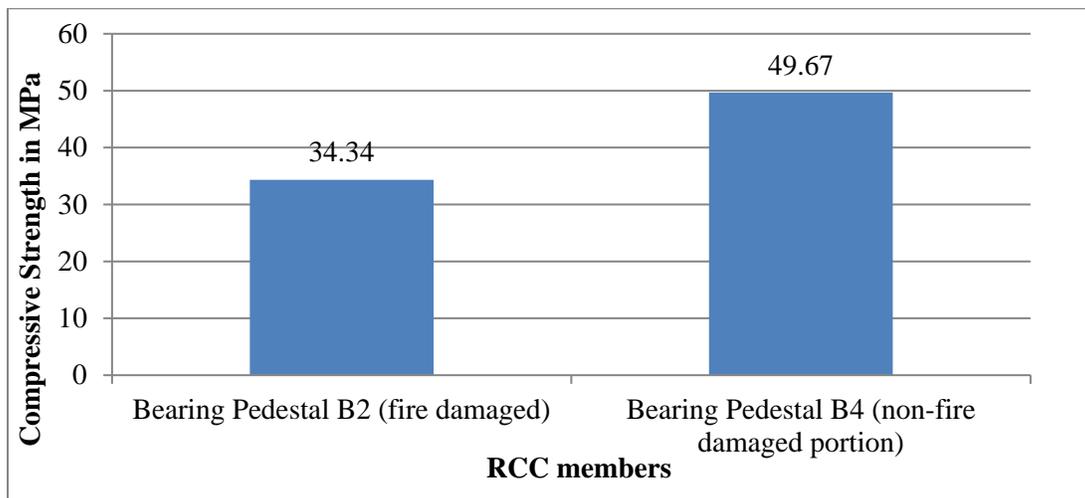
The cores of 60 mm diameter were extracted from fire-damaged and non-fire damaged locations through a core drilling machine for estimating the compressive strength of in-situ concrete. Its equivalent cube compressive strength was assessed duly by applying the correction factors, i.e., diameter, length/diameter ratio, etc., as per clause 8.4.2 of IS 516: Part 4: 2018 [16]. The average compressive strength of cores extracted from the fire-damaged portion of pedestal B2 and non-fire damaged portion of pedestal B4 were 38.51MPa and 49.67MPa (as shown in Figure 8), respectively. The results are satisfying the requirement of the M 35 grade of concrete. The member exposed to high temperature resulted in a reduction in compressive strength approximately by 22%. Similar trend was observed by Xiao et al [17] for the reduction in residual compressive strength with the increase in temperature. Heating up to 400°C generated relatively small cracks, which did not cause any immediate loss of carrying capacity in compression.

Fig. 8 - Equivalent Cube Compressive Strength of RCC members of TG unit

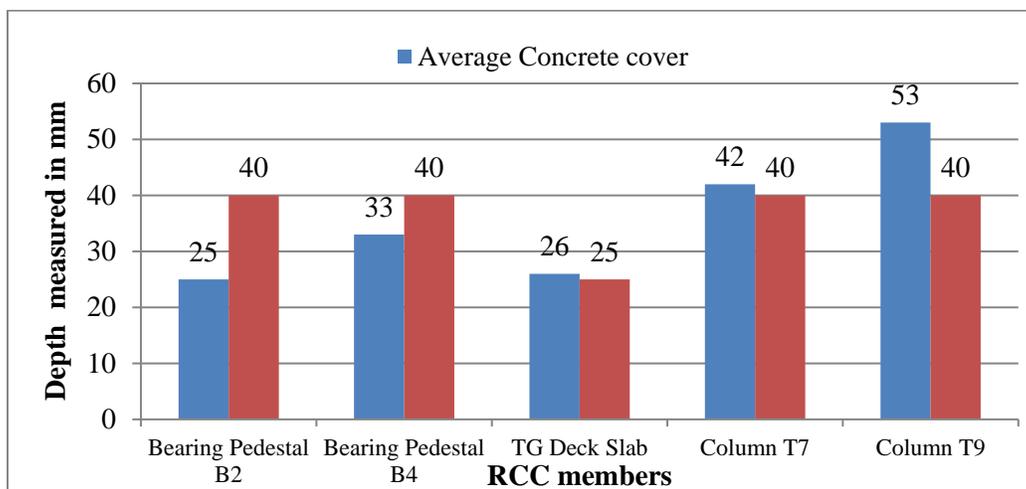
Profoscope instrument was used at identified locations on pedestals B2 and B4 for measuring the concrete cover thickness. The depth of concrete cover to reinforcement steel in the concrete bearing pedestals of B2 and B4 were 25 mm and 33 mm, respectively (shown in Figure 9). The existing concrete cover provided in these concrete bearing pedestals were satisfying the requirement of mild environmental

exposure conditions but not meeting the requirement of fire resistance period of 120 minutes as per provisions of table 16 and 16A of IS 456: 2000 [18]. However, at non-fire damaged portions i.e. TG deck slab and columns, both the requirements were satisfied.

Fig. 9 – Showing Nominal cover requirement as per table 16-A of IS 456: 2000 corresponding to the average concrete cover of RCC members of TG unit

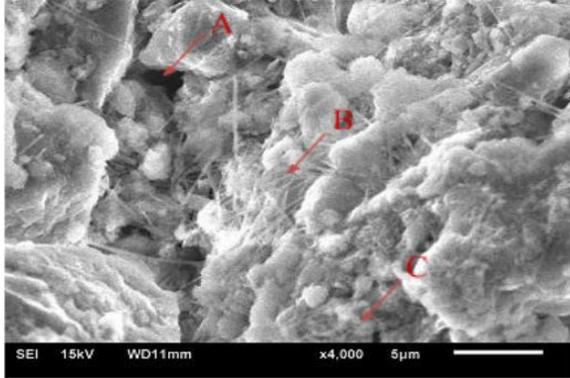
In this investigation, the S-400 Scanning Electron Microscope (magnification ranging from 20X to approx. 30,000X, the spatial resolution of 50 to 100 nm) was used to analyse the morphology. The fire-damaged pedestal B2 had shown disturbed or less densified microstructure. Micro-cracks gradually decreased from the depth of 35 mm to 50 mm from 50% to 20% respectively on fire-damaged specimens. The presence of hexagonal crystals was also observed at a depth of 10-15 mm for fire-damaged pedestal B2. The observations for SEM images of bearing pedestal B2 are made in figure 10, where A shows void and cavities due to release of moisture, B shows delayed Ettringite crystal with hair-like projections, C shows the presence of extending cracks [19], which indicates temperature may not cross beyond 350°C. The

Fig. 10 – SEM micrograph of a sample taken from Concrete bearing pedestal B2 at 30-35mm depth having a relatively loose microstructure

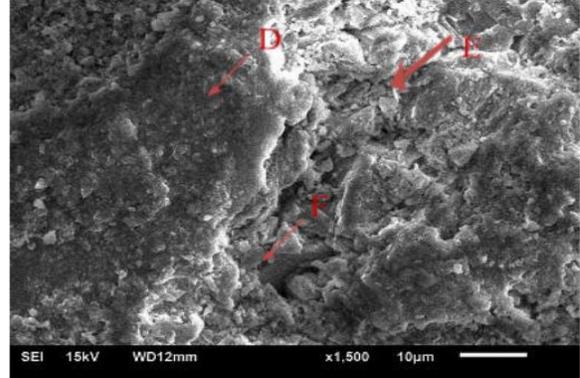
densified microstructure with Lath-shaped crystals is observed at a depth of 25-30 mm on a non-fire damaged bearing pedestal B4 sample. The observations for SEM images of pedestal B4 are made in figure 11, where D shows dense packing of concrete matrix, E shows grainy filling of cement hydrated

particles present in the concrete matrix of cement, F shows filled concrete matrix in void showing cement bound. The presence of Lath-shaped crystals suggests that the presence of ettringite or monosulphoaluminate minerals. These crystals are stable below 150°C of temperature.

Fig. 11 – SEM micrograph of a sample taken from Concrete bearing pedestal B4 at 25-30mm depth having relatively Densified microstructure

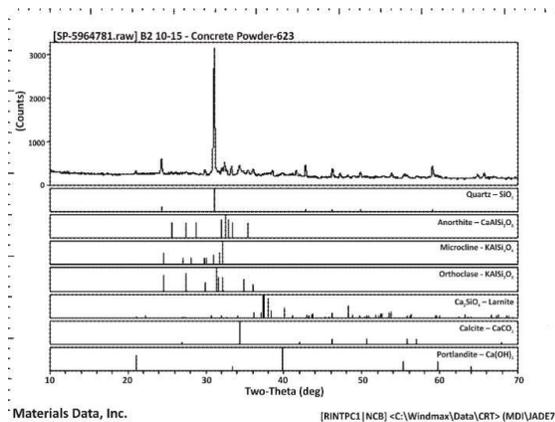
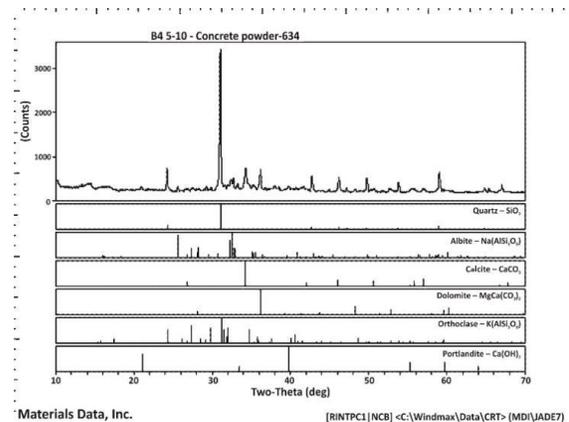
generated through powdered samples in the laboratory by using the X-Ray Diffraction technique (PANALYTICAL Expert Pro Powdered diffractometer with Copper Electrode and Ni Filter). In all samples of the bearing pedestal B2 and B4 across various depths, quartz was found to be in abundance along with other phases of feldspar, calcite and dolomite. In fire-damaged pedestal B2, portlandite was found at a depth of 10-15 mm, while in non-fire damaged pedestal B4, the same was found at 5-10 mm depth. This indicates the attended temperature may not have gone beyond 450 to 500°C from the above-mentioned depths in the pedestals.

Fig. 12 – XRD peak pattern for 10-15mm depth of Concrete bearing pedestal B2

Fig. 13 – XRD peak pattern for 5-10mm depth of Concrete bearing pedestal B4

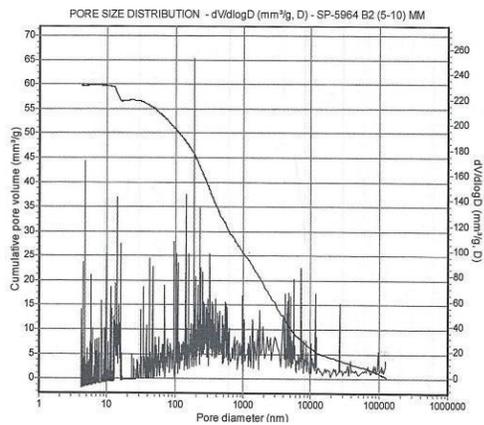
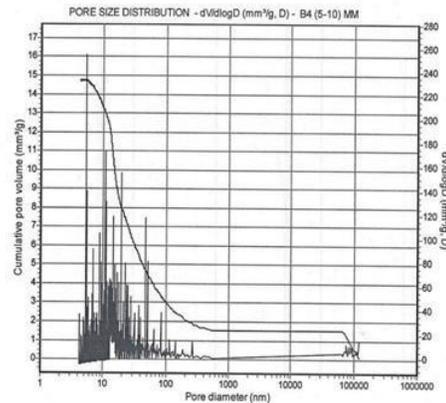
It is evident from the results that all the MIP parameters i.e. relative porosity, pore-volume, and the average pore size is higher for fire-damaged concrete sample when compared to the non-fire damaged sample [21]. The possible reason was the disintegration of CSH gel in concrete near the surface in B2, which is also observed in the SEM images. Pore size distribution of both B2 and B4 concrete bearing

pedestal at 5-10 mm depth is shown in Figure 14 and Figure 15. However, at a depth of 0-5 mm, the pore volume of concrete bearing pedestal B2 (fire damaged), is found to be less than that of the non-fire damaged pedestal, this may be due to the incidence of burning off some lubricant and burnt particles got stuck on the outer face of the concrete bearing pedestal B2, resulting in a reduction of pore size and volume.

Fig. 14 – Pore size distribution at a depth of 5-10mm of concrete bearing pedestal B2 (fire damaged)

Fig. 15 – Pore size distribution at a depth of 5-10mm of concrete bearing pedestal B4 (non-fire damaged)

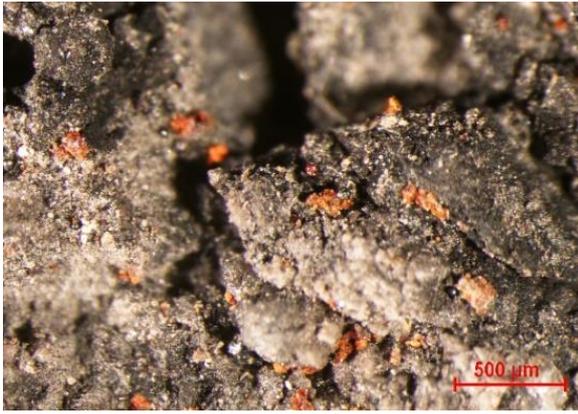
The stereo-zoom microscope (SMZ-1500) with Nikon Image system was used to observe the concrete samples extracted from different depths (shown as Figure 16 & Figure 17). The sample taken at a depth of 0-5 mm from fire-damaged bearing pedestal B2 shows that the concrete colour had changed to blackish-grey with a significant number of micro-cracks and partially oxidized fine aggregate. While in non-fire damaged concrete bearing pedestal B4 at a

depth of 0-5 mm, the presence of partially closed voids with relatively smooth margins were observed. Microscopic observations also showed significant parallel cracking toward the core axis in concrete bearing pedestal B2, indicating large-scale internal cracking, which may be due to internal shrinkage caused by overheating followed by rapid cooling due to fire-extinguishing.

Fig. 16 – B2-(0-5mm), Development of the cracked surface with partial oxidation of the fine aggregate

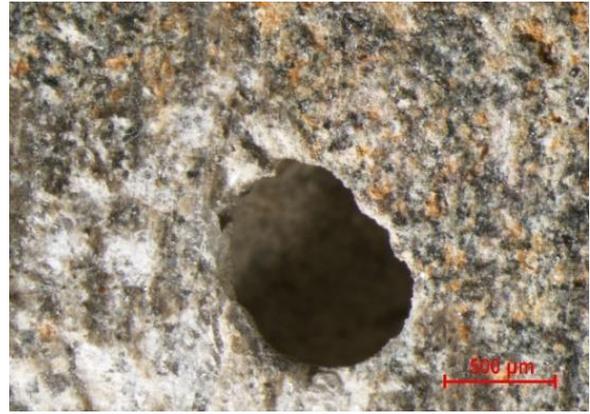
Fig. 17 – B4-(0-5mm), Development of an open void with smooth margins
