Assessment of a fire damaged reinforced concrete building

Abstract: A proper condition assessment of reinforced concrete structure after a fire event involves field and laboratory work to determine the extent of fire in order to design an appropriate and cost effective repair scheme. The present paper presents a case study where an attempt has been made to carry out a condition assessment of a fire damaged building in a systematic manner. The approach adopted broadly consisted of questioning of on-site personnel, a detailed visual survey, on-site non-destructive / partially-destructive tests, collection of in-situ samples from site along with some laboratory based investigations on samples collected from site. Differential Thermal Analysis (DTA), X-Ray Diffraction (XRD) Analysis and Scanning Electron Microscopy (SEM) Imaging were conducted for microstructural characterization and analysis of concrete to correlate, corroborate and validate the results obtained through on-site assessment. Since the building was an old structure, carbonation depth in structural members was also evaluated. Finally, based on the visual inspections indicating the condition of surface and structural elem

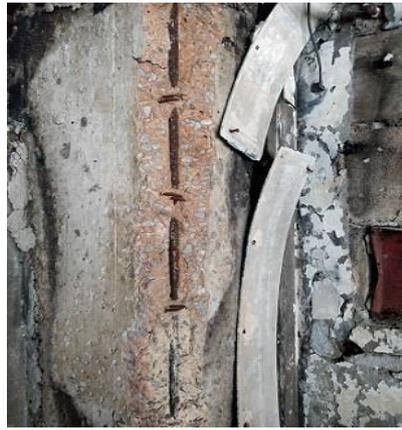
was found in some of the beams and columns close to the room where fire was first detected (Fig. 11). The depth up to which change in colour of concrete had occurred was also noted on the extracted concrete cores. At locations close to the room where fire was first detected and duration to exposure to fire was more, the maximum depth up to which change in colour of concrete had occurred was found to be about 30-40 mm (Fig. 12). At other locations the colour change was visible only up to about 20 mm depth.

Fig.11 – Change in colour of concrete to pink
