Assessment of a fire damaged reinforced concrete building

Abstract: A proper condition assessment of reinforced concrete structure after a fire event involves field and laboratory work to determine the extent of fire in order to design an appropriate and cost effective repair scheme. The present paper presents a case study where an attempt has been made to carry out a condition assessment of a fire damaged building in a systematic manner. The approach adopted broadly consisted of questioning of on-site personnel, a detailed visual survey, on-site non-destructive / partially-destructive tests, collection of in-situ samples from site along with some laboratory based investigations on samples collected from site. Differential Thermal Analysis (DTA), X-Ray Diffraction (XRD) Analysis and Scanning Electron Microscopy (SEM) Imaging were conducted for microstructural characterization and analysis of concrete to correlate, corroborate and validate the results obtained through on-site assessment. Since the building was an old structure, carbonation depth in structural members was also evaluated. Finally, based on the visual inspections indicating the condition of surface and structural elem

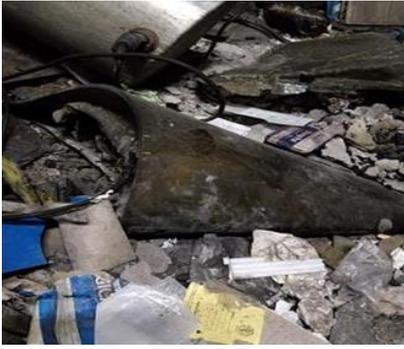
Fig. 1 – Deformation of glass in doors and windows

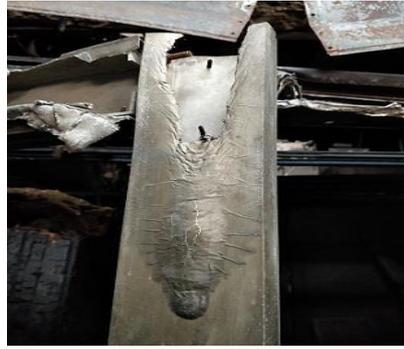
Fig. 2 – Localized softening and partial melting of Aluminum

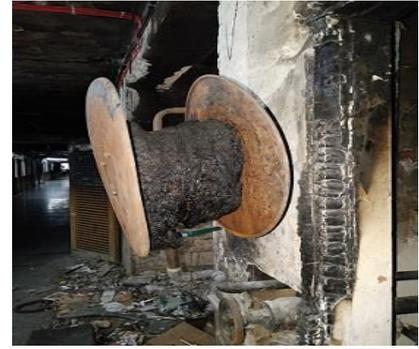
Fig. 3 – Melting of Rubber hose pipe of fire hydrant

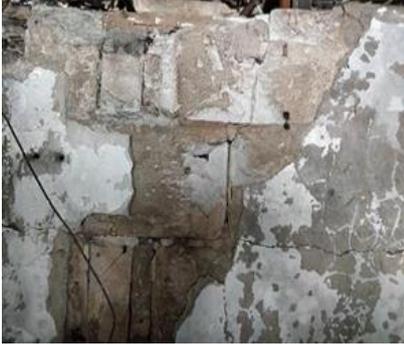
Fig. 4 – Excessive cracking and damage in foam concrete blocks

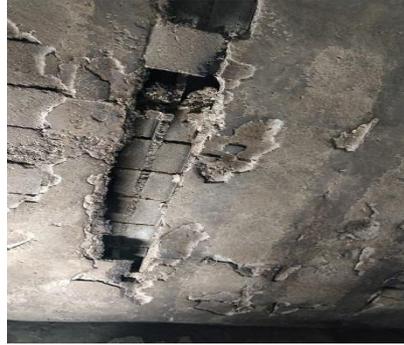
Fig. 5 – Spalling of ceiling plaster

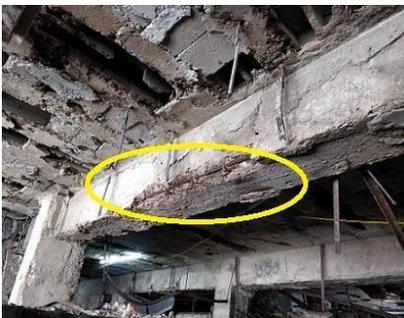
Spalling of concrete in the bottom edges of the main longitudinal ceiling beams was observed at some locations close to the room where fire was first spotted (Fig. 7). Delamination of cover concrete in the cross beams (where cover was less) was observed mostly in locations close to the room where fire was first detected (Fig. 8). Spalling of concrete due to corrosion (Fig. 9) was also observed in some of the cross beams of the ceiling near the expansion joints

Fig.7 – Spalling of concrete in bottom edges of the main longitudinal ceiling beams

- Strengthening of severe damaged RCC ceiling beams (both longitudinal and cross) was done with non-metallic composite fiber wrapping system comprising of uni-directional E-glass fiber (900 Grams per Square Meter (GSM)) wrap and compatible epoxy saturant, by wet lay-up system by applying compatible primer on prepared substrate. FRP wrapping of beams was done after carrying out all normal repair works as described above. Before execution of fiber wrapping, the edges of the rectangular beams should be rounded off (to a minimum of 25 mm radius) by chamfering.

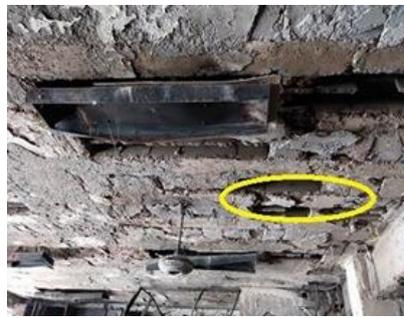
Fig.8 – Delamination of cover concrete in the cross beams

- Firstly, removal of plaster/paint on the surface of the members and chipping off and removal of all loose/delaminated concrete. Detection and removal of loose concrete was done by striking the

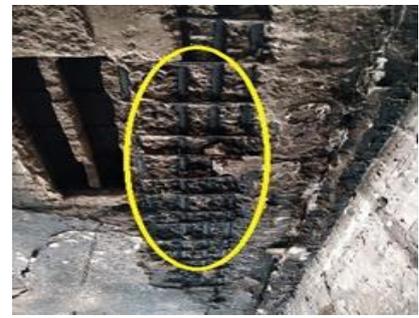
where cover to bottom steel was found to be very less i.e. in the range of 5 to 10 mm as observed visually. Reduction in diameter of the rebar due to corrosion in the range of about 40-50% along the length of the reinforcement bars was observed. Overall, the damage visible on concrete of the columns was found to be less than that observed on the ceiling beams. No noticeable residual deflections at the member level or deformations in the exposed reinforcement bars (other than reduction in diameter at few locations due to corrosion damage) of the RC members were observed anywhere.

Fig.9 – Spalling of concrete due to corrosion

- Where rebars are found to be corroded, cleaning of reinforcement of rust and loose scale using alkaline rust remover was done. This was followed by application of anticorrosive coating on reinforcement steel.

- Fixing of additional reinforcement wherever reduction in diameter of rebar due to corrosion is found to be more than 10% was done as part of repair system prior to building up the profile of the members by polymer modified mortar/prepacked micro concrete. Visible reduction in cross section of the reinforcement steel, particularly the stirrups, was observed in some of the cross beams of ceiling at 5th floor level and therefore, additional steel will was recommended at these locations.

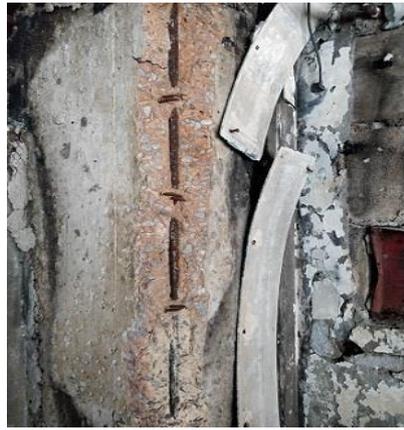
was found in some of the beams and columns close to the room where fire was first detected (Fig. 11). The depth up to which change in colour of concrete had occurred was also noted on the extracted concrete cores. At locations close to the room where fire was first detected and duration to exposure to fire was more, the maximum depth up to which change in colour of concrete had occurred was found to be about 30-40 mm (Fig. 12). At other locations the colour change was visible only up to about 20 mm depth.

Fig.11 – Change in colour of concrete to pink

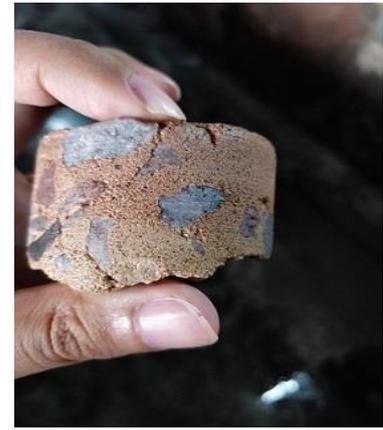
Fig.12 – Change in colour of concrete at locations close to the room where fire was first detected

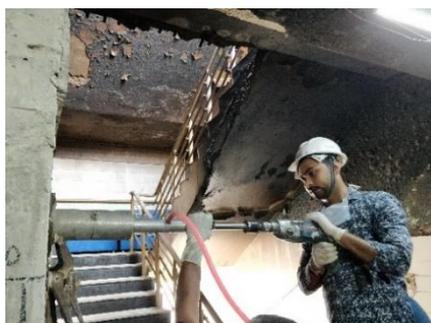
Fig.13 – Extraction of concrete core from column of fire damaged floor

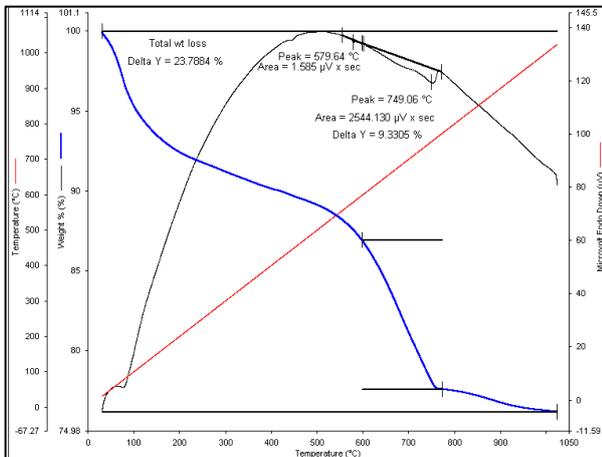
curves up to 19 mm depth whereas the peaks were present in the DTA curves at greater depths (Fig. 17 & 18). This indicates that the absence of $\text{Ca}(\text{OH})_2$ dissociation peak up to 19 mm depth is due to exposure to elevated temperature due to fire whereas at greater depths the peaks are present as the exposure temperature was at a much lower level. Same was also seen from the depth of the colour change to pink as observed on the extracted concrete cores. For

Fig.17 – DTA curve for 2nd floor column outside room where fire was first spotted at 14-19 mm depth

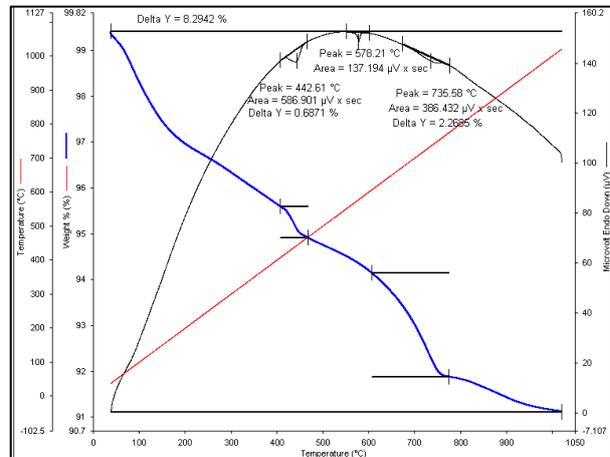
Fig.18 – DTA curve for 2nd floor column outside room where fire was first spotted at 21-26 mm depth

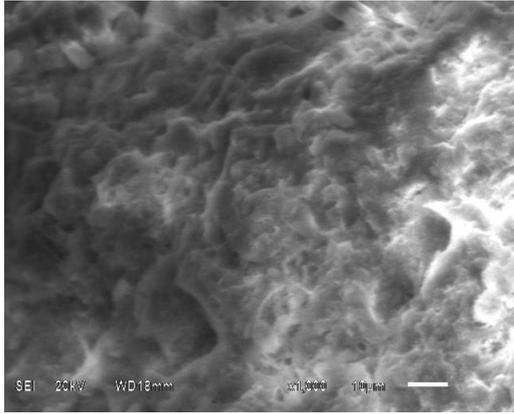
mm depth (Fig. 21) and the microstructure is also found to be relatively less dense. In 21-26 mm depth, portlandite is found (Fig. 22). No major sized voids are found in this depth and the microstructure is found to be relatively denser. In SEM micrographs of samples taken from one of the fifth ceiling beams, the microstructure is found to be less densified up to a depth of 30-40 mm from the surface with presence of micro cracks and clustered micro pores with irregular shape. Hexagonal morphology is also found to be absent up to this depth in the SEM micrographs. At 40-50 mm depth from the surface, the microstructure is found to be relatively denser as compared to the other samples and number of micro cracks at this depth is also found to be fewer in number as compared to the other samples. The depth up to which concrete was found to be affected as indicated by the DTA results was generally in agreement with the appearance of microstructure at various depths as indicated by the SEM micrographs.

Fig.21 – SEM images of samples from 2nd floor column, from depth range of 14-19 mm depth. Presence of hexagonal morphology indicating the probable presence of portlandite

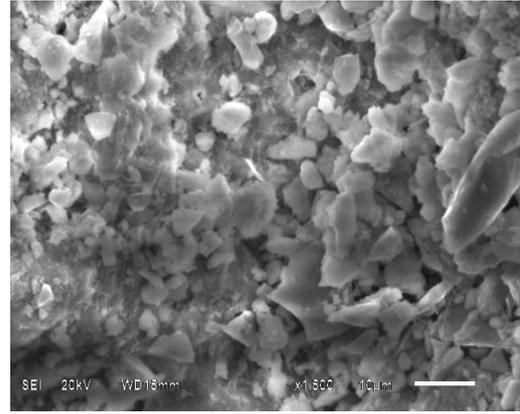
Fig.22 – SEM images of samples from 2nd floor column, from depth range of 21-26 mm depth. Hexagonal morphology is absent. Microstructure found to be less densified with presence of micro pores and micro cracks

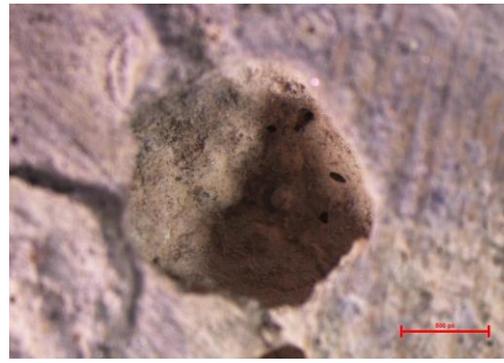
The OM micrographs of the undamaged concrete sample due to fire taken from 3rd floor column (Fig. 29) have indicated the presence of closed voids with deposited hydrated products with relatively smooth margins and compactness of mortar and aggregate. The OM micrographs of the samples taken from fire damaged floors on the other hand have indicated presence of greater number microcracks (Fig. 30) and formation of micro cracks in cement mortar

Fig. 28 – Development of micro cracks at the base of void from fire damaged concrete (15X)

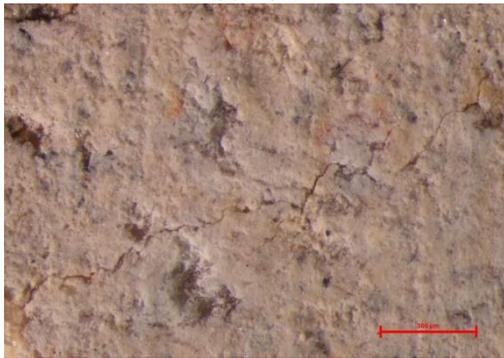
and at the interface of aggregate and cement mortar (Fig. 31 and Fig. 32) which may be due to effect of heating. The microscopic investigation of the fire damaged cores indicated that the distribution pattern of the grains and pores spaces changed drastically. Even the morphology of the grains of the fine aggregate component was also changed. Large variation was noticed in air void distribution pattern from the front to inside portion. Bottom portion was directly exposed to fire, which had caused sealed walled air voids bigger in size. Size of pores after fire might have increased but have very stable and firm walls, which had presently helped to achieve more strength to the concrete. As the tracking of microscopic analysis gone inside the core, size of air voids reduced drastically. However, partial melting of fine aggregate component was noticed in these areas. The same was seen from SEM Study results also when the samples were compared from fire damaged portion and sample from the concrete portion unaffected by the fire.

Fig. 29 – Formation of micro cracks in cement mortar and at the interface of aggregate and cement mortar (45X)

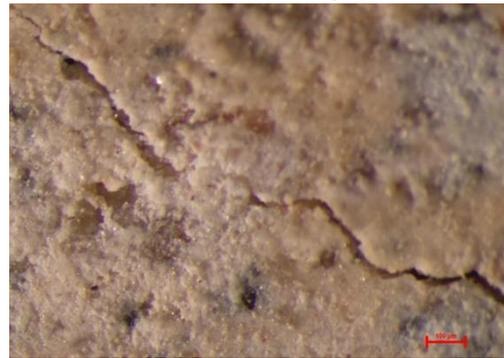
Fig. 30 – Formation of micro cracks in cement mortar and at the interface of aggregate and cement mortar (90X)
