Damage evaluations of oven-dried mortar subjected to one-directional fire

Onnicha Rongviriyapanich*, Yasuhiko Sato and Withit Pansuk

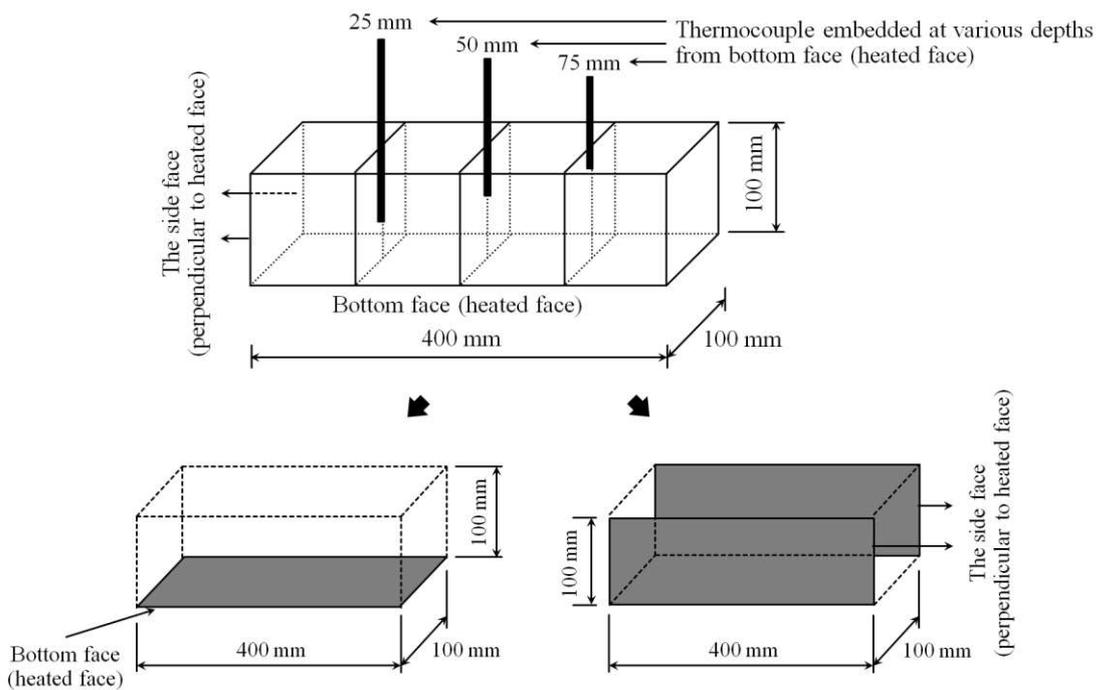
Fig. 1 – Details of specimens and surface types

The 100×100×400 mm prismatic specimens were cast for the one-directional fire test. First, cement and fine aggregate were dry mixed to ensure a uniform distribution before being hydrated by water in the mix proportion. After being mixed well, the fresh mortar was poured and compacted in a 100×100×400 mm prismatic mold. It was then kept in the mold for 24 hours. As shown in Fig. 1, thermocouples were embedded during casting at various depths, e.g., 25 mm, 50 mm and 75 mm from the bottom surface. Two types of surfaces for the specimen, called the heated face and the side face, are considered. The heated face is the bottom face of the specimen, where the fire is loaded, while the side face is perpendicular to the heated face.

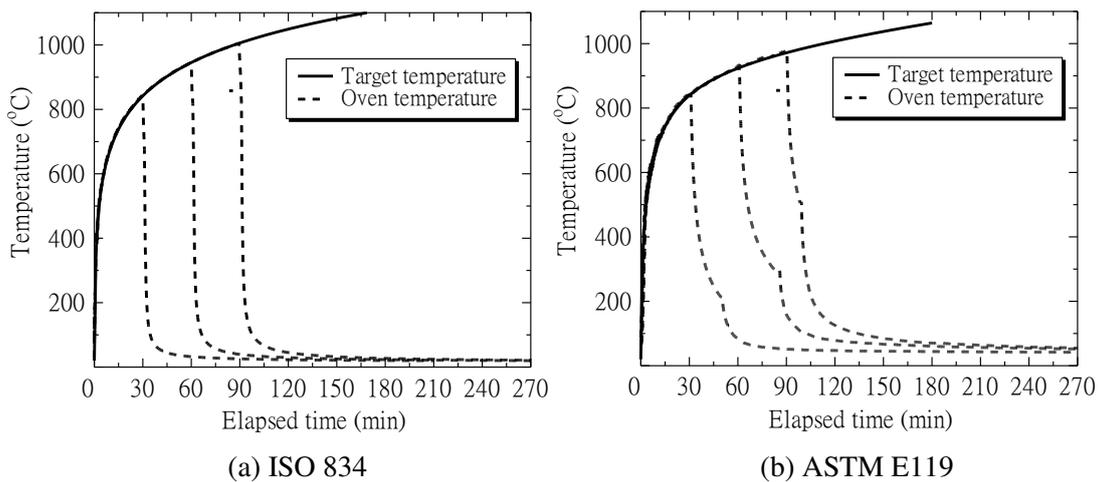
Fig. 2 – Target and oven temperature

The specimens were one-directionally heated using a furnace programmed with the standard fire curves of ISO 834 and ASTM E119, as shown in Eqs. (1) and (2), respectively, and then cooled to ambient temperature. Fire tests were simulated for three durations (30, 60 and 90 minutes). When the targeted duration was reached, the furnace was automatically switched off, the doors opened immediately, and the specimens were left to cool in the air over many hours to room temperature, as shown in Fig. 2.

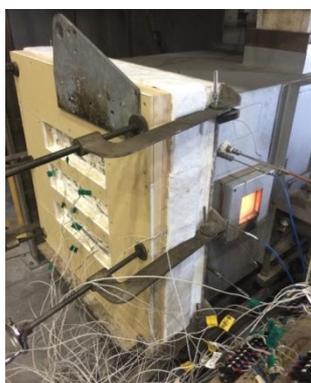
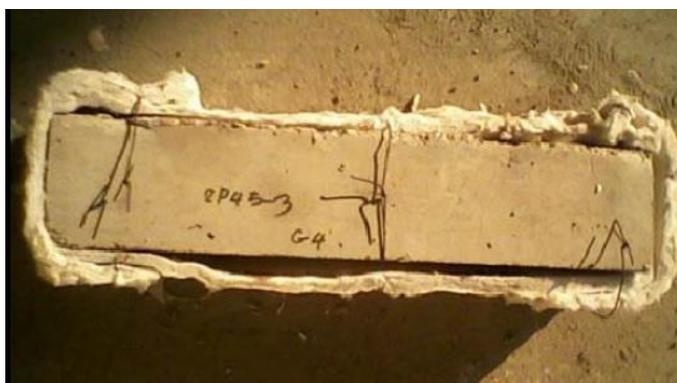
(a) ISO 834

(b) ASTM E119

Fig. 3 – Experimental conditions of fire test

However, the experimental conditions of fire tests under ISO 834 and ASTM E119 were slightly different owing to the configurations of the furnace. Fireproof material was used to protect all faces of the specimens except the heated face before being left inside the furnace programmed with ASTM E119. On the other hand, the fireproof material was not necessary for specimen which was burnt with fire curve of ISO 834 because they were placed at the lid of the furnace. The details of raw materials made of mortar, as well as the standard fire curves and experimental conditions, are summarized in Fig. 3 and Table 2.

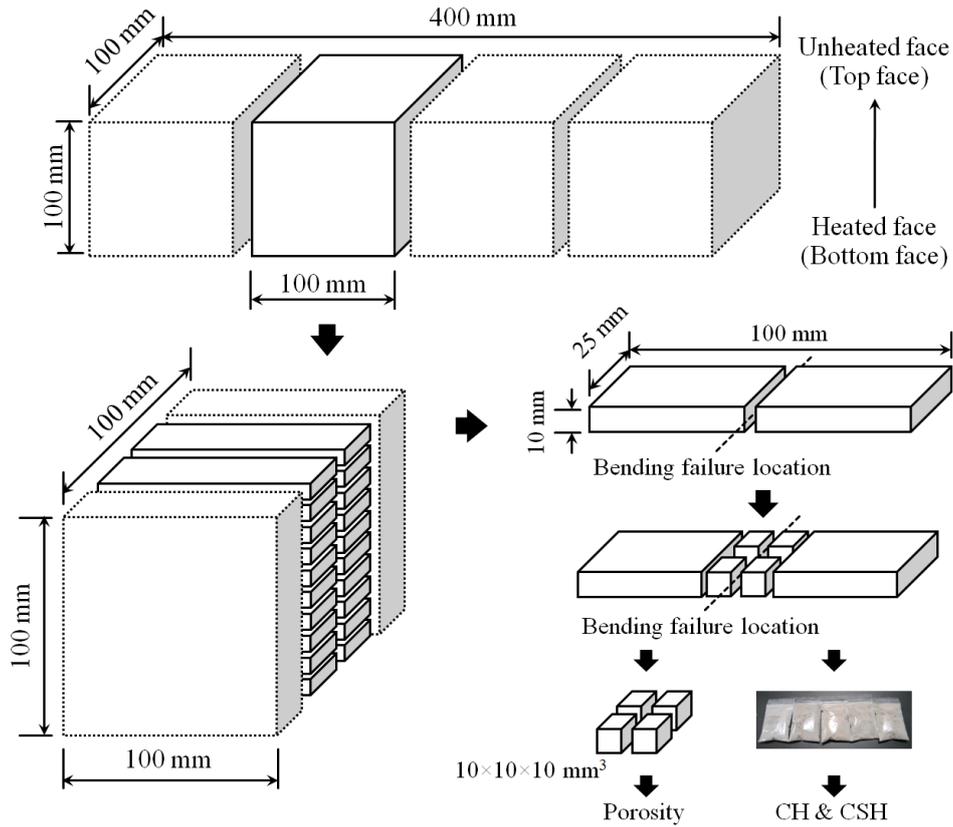
Fig. 4 – Use of specimen for damage assessments along the beam depth

As mentioned before, quantitative damage assessment of flexural strength, porosity, and residual chemical compounds has previously been conducted using only the JP ISO series. Figure 4 shows the use of a specimen hewed from the original prism for quantitative damage assessment. The thin specimen was first used for the bending test. Approximately 10×10×10 mm cubes were extracted from both sides of the bending failure location for the porosity test, while the remaining part was ground into a powder with a diameter of approximately 150 μm for chemical testing. In the 3-point bending test, a single point load, with a constant displacement rate of 1 μm/s, was applied to the top fiber at mid-span, and three LVDTs were installed at the middle and both ends during the entire period. A schematic bending process is shown in Fig. 5.

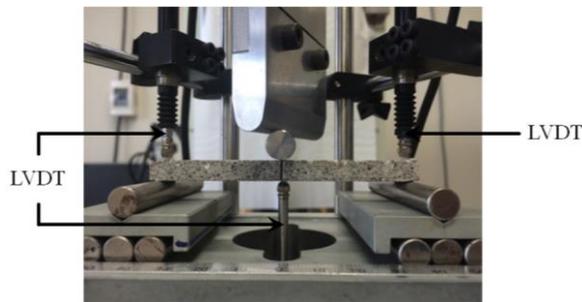
Fig. 5 – Schematic 3-point bending test

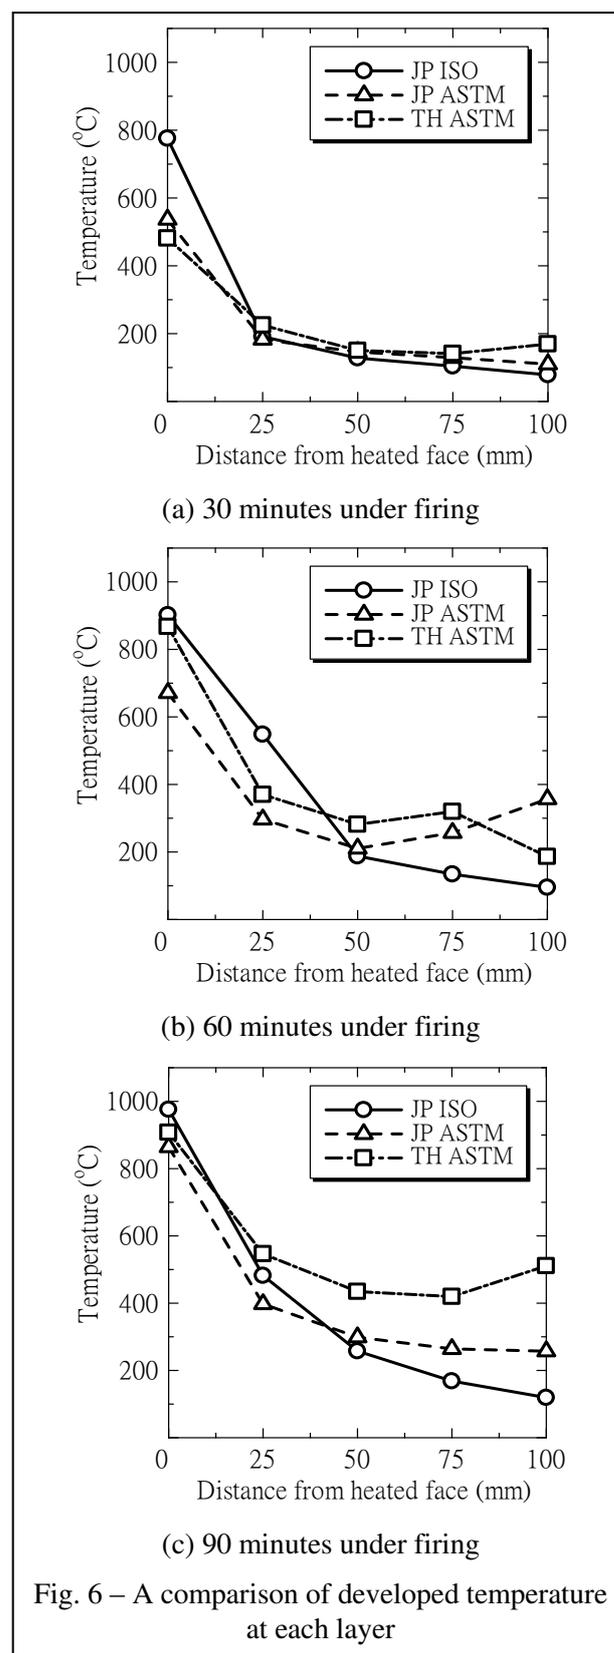
Fig. 6 – A comparison of developed temperature at each layer

When mortars were subjected to one-directional fire exposure, the internal temperature gradients started to gradually increase with elapsed exposure time. At a given distance from the heated face, the temperature tends to be higher when subjected to a longer duration. Along the cross section, the developed temperature gradually decreases at a greater distance from the heated face. Figure 6 shows the maximum internal temperature measured at each depth for all series. In the case of calcareous mortars, the developed temperature gradients were approximately similar despite being exposed to different temperature histories. For 30 and 60 minutes under firing, the developed temperatures had approximately the same tendencies in all mortar series. However, there were prominent differences between series when the exposure time was 90 minutes.

As seen from the developed temperature gradients, the types of raw material used in mix proportions, rather than the external thermal loading, might play a dominant role in the development of internal temperature, especially for long-term exposure. For cementitious materials exposed to fire, the initiation and propagation of a crack and its intensity probably cause a non-uniform temperature gradient along the cross section [14,25]. Therefore, the significant difference in temperatures between calcareous and siliceous mortar under the same fire

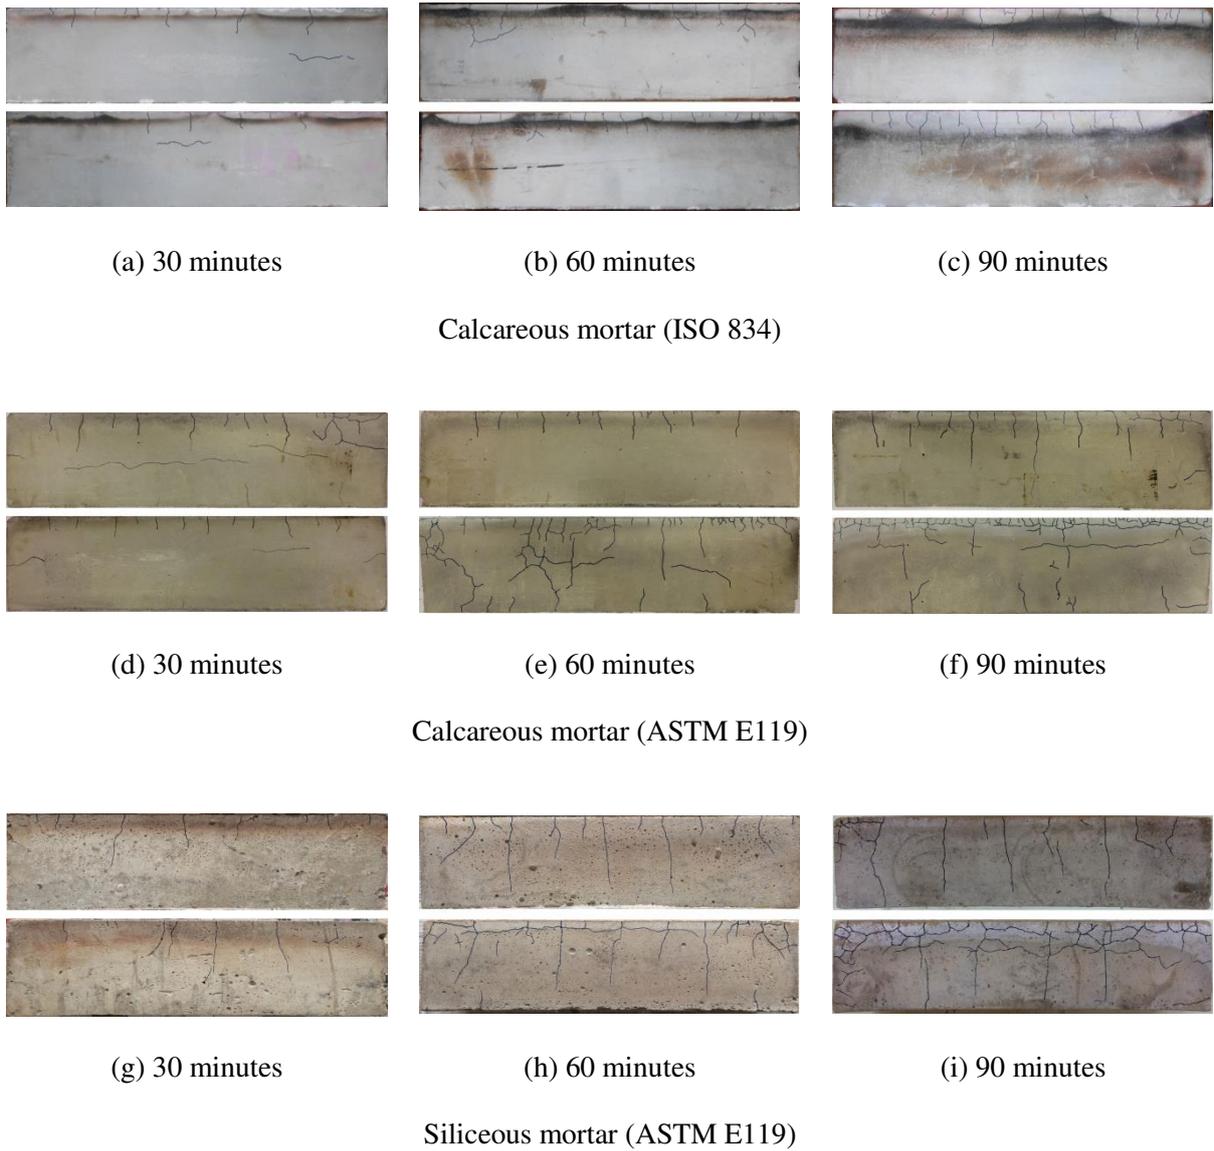
Fig. 7 – Crack patterns on both sides of specimens

The physical condition of the fire damaged specimens is shown in Fig. 7. One-directional fire exposure was applied to the heated face, which experienced a drastically increased temperature. Meanwhile, the temperature of the internal layer of mortar might have been comparatively low. This means that there was a large difference in temperature between the heated and unheated faces at the beginning of the burning process. This could cause an expansion at the heated face, without corresponding expansion of the other sides. In this study, all specimens were instantaneously cooled in air after reaching the target duration. As a result of this, the temperature to which mortars were exposed, especially at the heated face, changed suddenly. An expanded surface in the heating process might suddenly shrink. Therefore, relatively straight cracks were introduced perpendicular to the heated face owing to the decrease in tensile strength under high temperature, as well as the rapidly developed tensile stress [26].

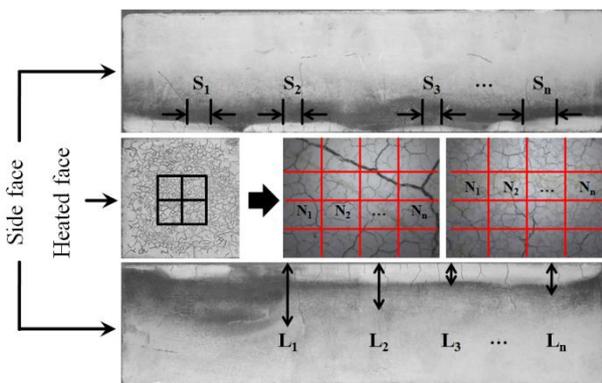
Fig. 8 – Crack observations of specimen's face

From the overview of the physical damage conditions in all specimens, it is seen that the number of cracks increases with increasing time exposure. Moreover, the average length of these cracks tends to be higher for longer durations. To obtain a better understanding of this phenomenon, quantitative cracking assessments of the JP ISO series were conducted. Figure 8 shows the techniques of crack observations. The surface crack density at the heated face was determined by the number of interceptions of craze cracking on the virtual grid. Meanwhile, the crack depth and crack spacing were determined on both side faces. The crack density on the heated face, as illustrated in Fig. 9, tended to be higher for specimens that were exposed to higher temperatures.

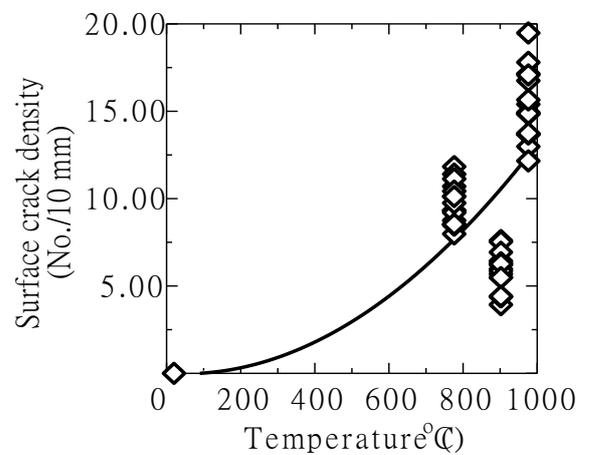
Fig. 9 – Surface crack density-temperature relation

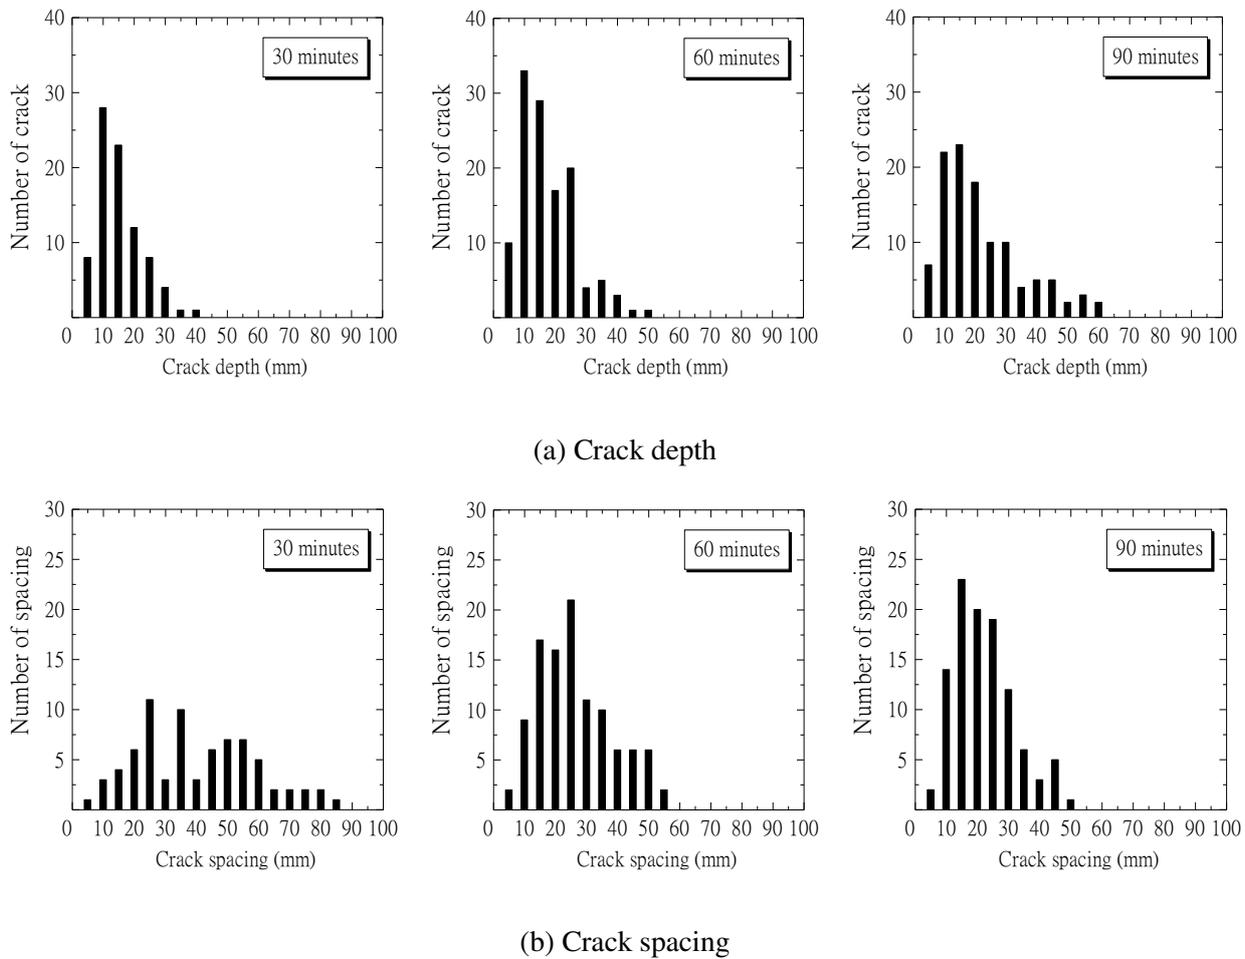
Fig. 10 – Crack observations on side face

seen on the side faces. The crack depth, which was measured from the edge of the side face to the tips of cracks, was not significantly different when comparing different cases and the distribution of spacing between single cracks became less scattered as the time exposure increased. The results of the crack depth and spacing are shown in Fig. 10(a) and 10(b), respectively. Although longer cracks could be observed when specimens were subjected to longer exposures, there is no clear relationship between average crack depth and exposure time. As seen from Fig. 10(b), the crack spacing could explain the progress of cracks more clearly. Because the mortar was allowed to cool down immediately in air, the external thermal loading at the heated face changed suddenly from high to ambient temperature. The increase in exposure time and temperature might cause more expansion in the mortar and decrease the resistance to crack initiation. Therefore, the number of cracks on the side faces is increased with increased exposure time. The high variance in the crack spacing is observed in mortar exposed to short-term firing, whereas scattering decreases with longer exposure.

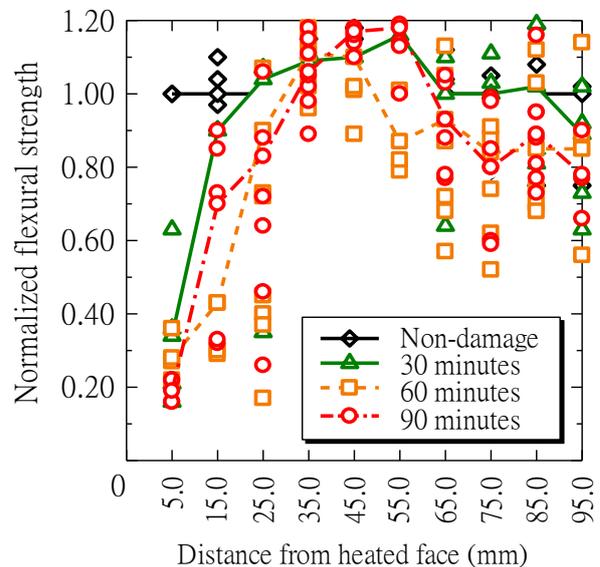
Fig. 11 – Meso scale flexural strength

The flexural strength along the beam depth for all fire cases, including reference specimens, is illustrated in Fig. 11. The average flexural strength of non-damaged mortar was 7.20 N/mm², and this tended to be reduced in all fire-exposed specimens, especially for the layer that was directly exposed to fire at the bottom. The flexural strength of those layers was reduced by 66%, 72%, and 81% of non-damaged strength for 30, 60, and 90 minutes under firing, respectively. The loss of flexural strength of

those layers was not significantly different when compared between cases because the existing crack caused a weak point and a bending failure location. At a greater distance from the heated surface, the visible damage disappeared. Therefore, the flexural strength gradually became similar to the flexural strength of the non-damaged material. Based on the

measurements of flexural strength, the loss in strength was up to approximately 30 mm from the heated face, the same as the existence of damage evidence on the surface of the thin specimens. Therefore, the influence of cracking on post-fire material strength should be taken into account. We also observed a slight increase in strength in some layers next to the severely damaged zone. This is probably because of the rehydration of the unhydrated cement particles within the appropriate range of temperature.

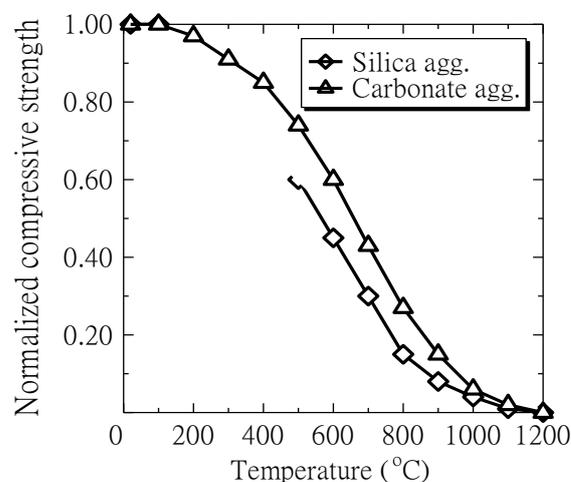
Fig. 13 – Variation of compressive strength at elevated temperature by Eurocode [29]

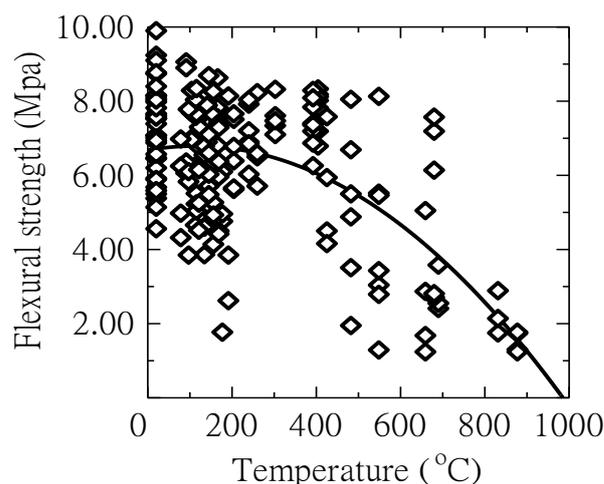
Fig. 14 – Flexural strength-temperature relation

Figure 14 shows the relation between flexural strength and temperature. In the early stage of burning, the flexural strength is slightly increased compared with the strength without any damage. After that, a rapidly decreasing gradient is observed. With respect to an increase in temperature, the flexural strength would be more scattered because of the existence of cracks induced by fire. The flexural strength-temperature relation is slightly different from that of the Eurocode because the existence of a fire crack has been taken into account and the meso-scale damage assessment could obtain the post-fire properties more precisely than conventional methods of evaluation.

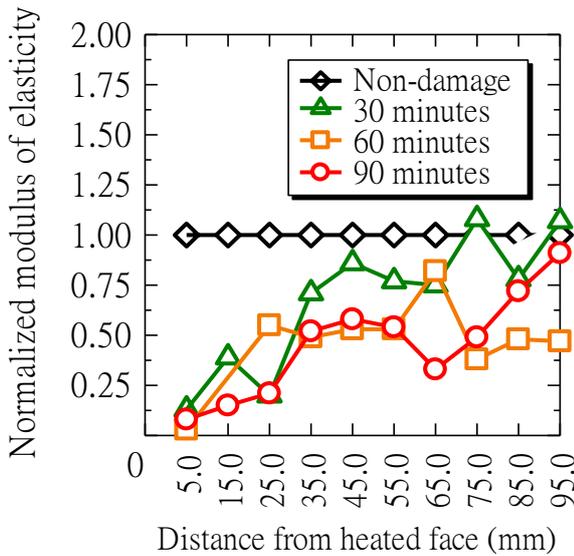
Fig. 15 – Modulus of elasticity

mental data of the 3-point bending test, as shown in Eqs. (4), (5), and (6), respectively. Figure 15 shows the average modulus of elasticity along the beam depth. The result shows that the severely damaged zone could be observed as being the same as the flexural strength. When the distance from the heat-

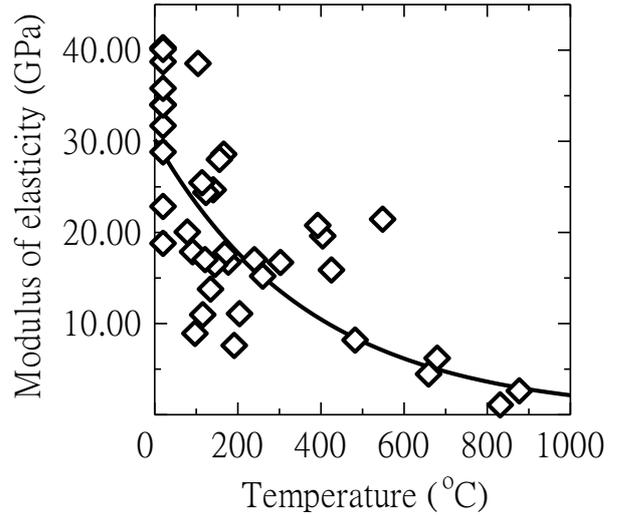
Fig. 16 – Modulus of elasticity-temperature relation

As for the flexural strength, the relationship between the modulus of elasticity and temperature can be discussed as shown in Fig. 16. It can be seen that, as for flexural strength, the modulus of elasticity is strongly related to temperature experiences. Therefore, both are supposed to have a mutual relation. Figure 17 shows the relationship between the modulus of elasticity and flexural strength. An obvious decrease in the modulus of elasticity can be seen when the flexural strength was also comparatively low, i.e., the flexural strength of specimens with an existing fire crack. However, the modulus

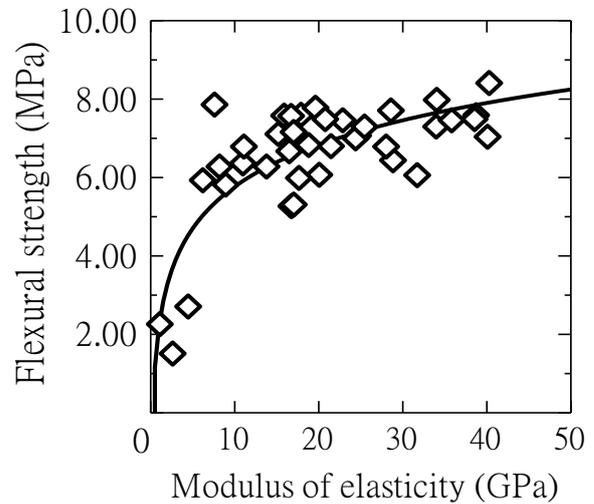
Fig. 17 – Flexural strength-modulus of elasticity

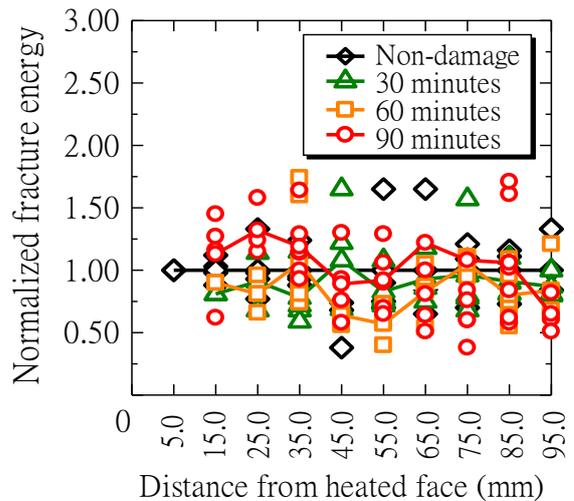
Fig. 18 – Theoretical fracture energy

The result of fracture energy, G_f , calculated based on the concept of the RILEM recommendation, is illustrated in Fig. 18. The average G_f of the non-damaged series is 24.78 N/mm. According to the results, the fracture energy of all fire-damaged series was not significantly different compared with that of the reference specimens.

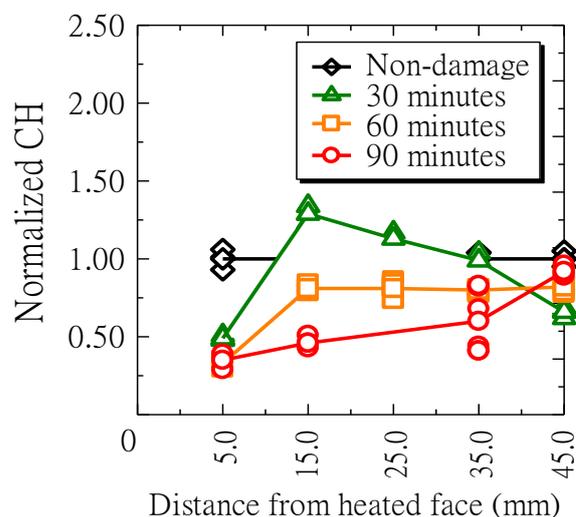
Fig. 19 – Residual amount of CH

The results of the remaining amount of CH in Fig. 19 could describe the reduction tendency along the beam depth, especially in the directly heated layer. The amount of CH was reduced by 51%, 67%, and 65% compared with the non-damaged specimen after 30, 60, and 90 minutes under firing, respectively. The average temperatures of 659 °C, 831 °C, and 877 °C for each case are sufficiently high for the decomposition of those layers. At a greater distance from heated face, the residual amount of CH tends to be higher.

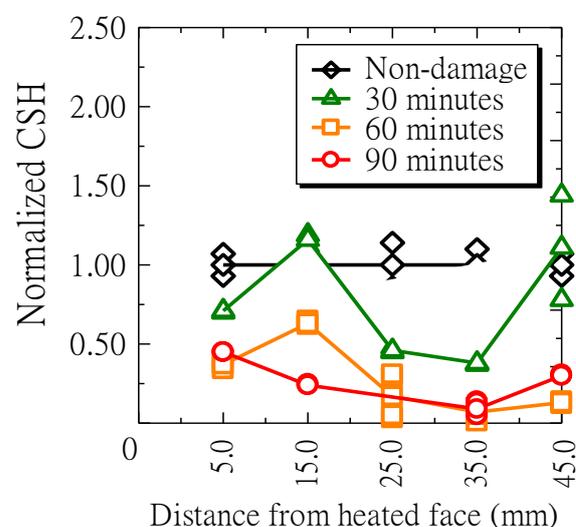
Fig. 20 – Residual amount of CSH

The result shown in Fig. 20 clearly indicates that CSH decomposition occurred in all fire-exposed specimens. In the layer that was directly heated at the bottom fiber, CSH was decomposed by 29%, 63%, and 55%, compared with the non-damaged specimen after 30, 60, and 90 minutes under firing, respectively. A substantial decrease in CSH could also be observed even at greater distances from the heated side.

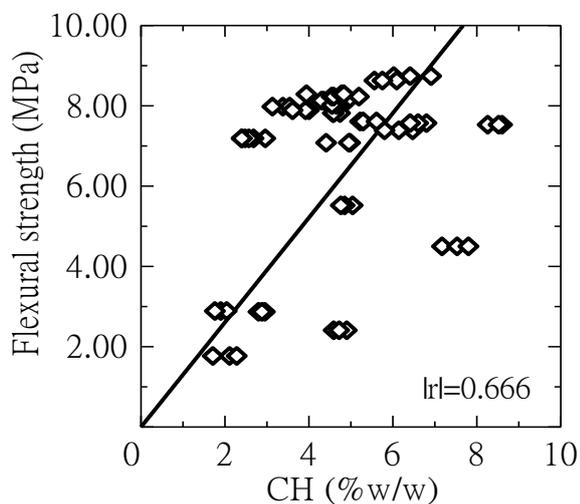
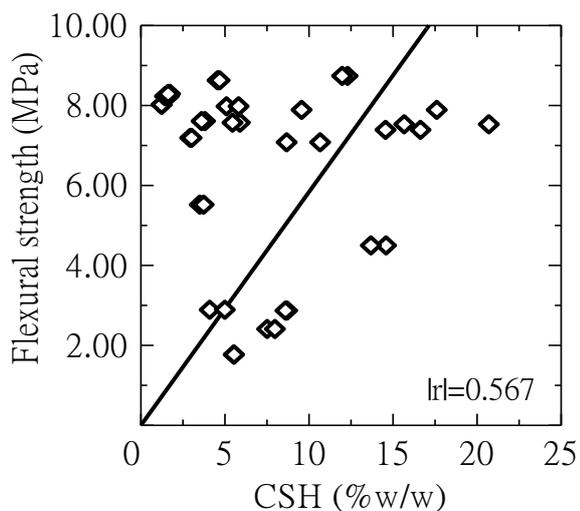
(a) Flexural strength-CH relation

(b) Flexural strength-CSH relation

Fig. 21 – Flexural strength-chemical compounds relations

To understand the effect of cement hydrates on the mechanical strength of fire-deteriorated cementitious material, the relationships between chemical compounds and flexural strength are shown in Fig. 21(a) and Fig. 21(b) for CH and CSH, respectively. The individual relation of each chemical compound to flexural strength does not show a clear tendency. However, the integration of the decomposed amount of chemical compounds also does not clearly describe the loss in flexural strength. Moreover, the change in porosity caused by the chemical decomposition is mainly affected by the calcium leaching, not by the evaporation of chemically bound water from the molecular structure. Consequently, the individual influence of porosity and the physico-chemical characteristics might not have a strong relation with the mechanical characteristics of cementitious material in the fire problem.

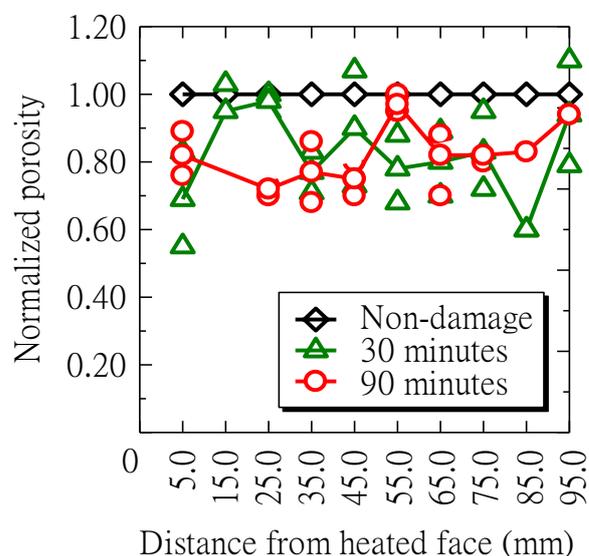
Fig. 22 – Porosity by water absorption

Approximately $10 \times 10 \times 10$ mm cubes were picked from both sides of the thin specimens beyond the bending crack after testing. To obtain an overview of the changes in porosity, the authors would like to describe the porosity trends induced by short and long durations of firing. Figure 22 shows that the porosity along the beam depth of fire-damaged specimens is not significantly different compared with reference series. Because the porosity test was conducted on the post-cooling specimens, additional cement hydrates [10,26,31], as well as existing fire cracks, could affect the porosity value. Therefore, porosity might not be an appropriate index for understanding the material strength of fire-damaged mortar. Although the fire did not introduce a change in porosity value, it might introduce a change in pore structure in other ways, such as pore structure coarsening.

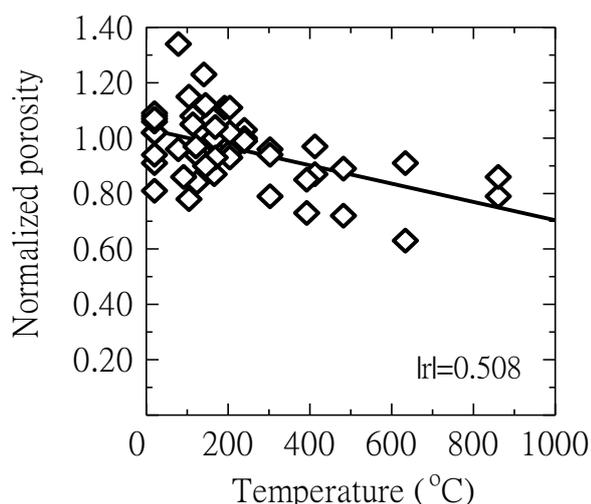
Fig. 23 – Porosity-temperature relation

Instead of the expected increasing trend in the relationship between porosity and temperature due to chemical decomposition, the porosity did not show a strong relation with temperature, as demonstrated in Fig. 23, as for the mechanical properties, i.e., flexural strength and modulus of elasticity. Therefore, porosity is not a good index for understanding the strength of cementitious material in the fire problem.
