# Load carrying capacity of RC beams with locally corroded shear reinforcement

Rahmat Ullah\*, Hiroshi Yokota, Katsufumi Hashimoto and Shunichiro Goto

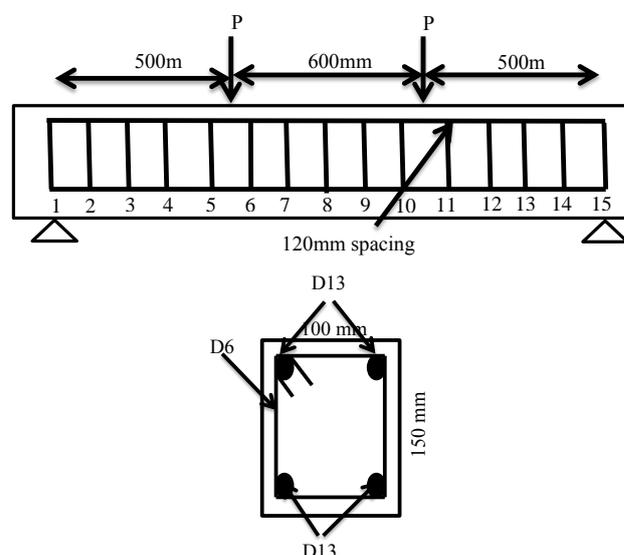
Fig. 1 – Beam layout and cross sectional view

A wire was connected at the top of the stirrups using soldering to facilitate current for corrosion. All the stirrups were weighed after attaching wire with soldering. Steel cage was prepared with 120 mm spacing of stirrups and 30 mm concrete cover. A sponge was placed at the bottom of beam and then wrapped with three towels all around after curing for the purpose of keeping the target area of the beam wet. Figure 1 shows the beam layout and cross sectional view.

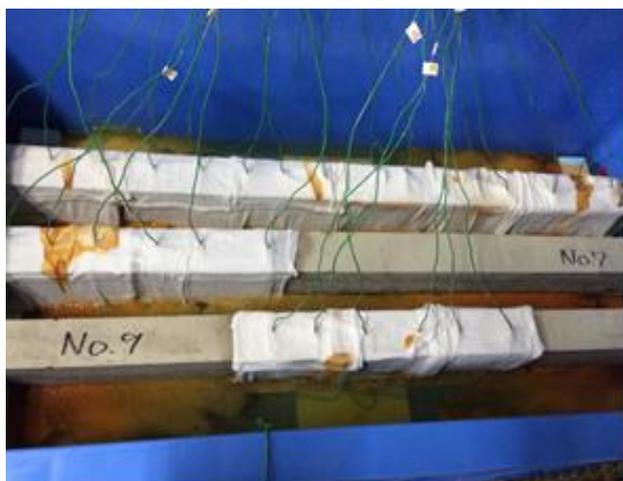
Fig. 2 – Corrosion process for beams

After 14 days of curing, the beams were subjected to direct current to induce corrosion. After preparing the beams, they were placed in a pool with 3% NaCl solution. The height of solution was up to the sponge level. Accelerated current technique was applied for corrosion. A current of  $2.6 \text{ mA/cm}^2$  was passed for 7 days and 14 days for mild and severe corrosion, respectively [7].

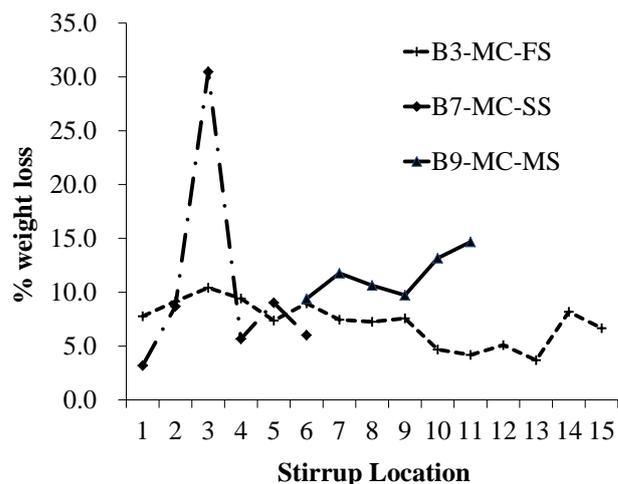
Fig. 3 – Weight loss of stirrups for mild corrosion

Figure 3 shows the weight loss of mild corrosion case for B3-MC-FS, B7-MC-SS, and B9-MC-MS with respect to the location of the corroded stirrups. For the mild corrosion, the maximum weight loss was 30.5% and observed in B7-MC-SS (stirrups corroded in the shear span only). The minimum weight loss of 3.2% was also observed in this beam, and the average weight loss for all the stirrups of B7-MC-SS was 10.5%. B9-MC-MS (stirrups corroded in the middle span) had a slightly higher weight loss, with an average of 11.6% for all the stirrups. The maximum and minimum weight losses for B9-MC-MS were 14.7% and 9.4%, respectively. The average weight loss for the 15 stirrups of B3-MC-FS was 7.2%, with the maximum and minimum values as 10.4% and 3.7%, respectively with little variation in weight loss among the stirrups.

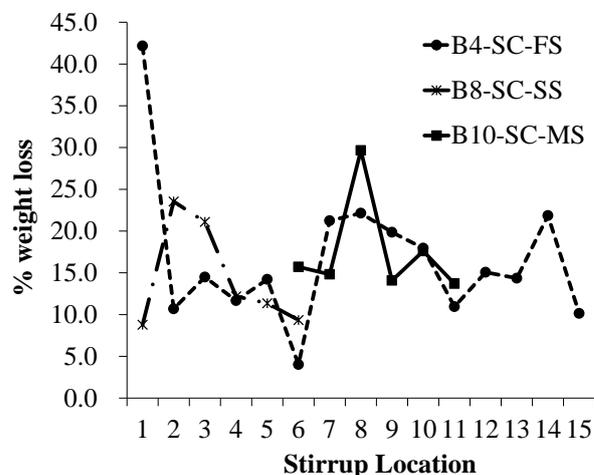
Fig. 4 – Weight loss of stirrups for severe corrosion

Figure 4 shows the weight loss of stirrups and location for B4-SC-FS, B8-SC-SS, and B10-SC-MS. For the severely corroded beams, the expected weight loss was 20%, but actually slightly less corrosion was observed for most of the stirrups. The maximum and minimum weight losses measured in B4-SC-FS (stirrups corroded in the full span) were 42.2% and 4%, respectively, with the average weight loss of 16.7%. This wide range of the differences shows the change in resistance of concrete. As in the case of the mild corrosion, the stirrups corroded in the middle span had the maximum average weight loss for the severe corrosion. B10-SC-MS (stirrups corroded in the middle span) had average weight loss of 17.6%, with extreme values of 29.7% and 13.7%. For B8-SC-SS (stirrups corroded

in the shear span), the average percentage of weight loss was 14.4%, with extremes of 23.5% and 8.8%.

In case of severely corroded beams, B8-SC-SS had the maximum deflection ductility factor of 5.59. This is because the stirrups were corroded in the shear span, but the failure was flexure after corrosion of stirrups. However, unlike the mild corrosion beam B7-SC-SS, the deflection ductility factor of B8-SC-SS was higher. For an identical load, both the strain of corroded tension bars and the deformation of cracked compression concrete of corroded beams become greater than that of the non-corroded and non-cracked control beam. As a result, the deflection ductility was improved for the B8-SC-SS [10]. B10-SC-MS had almost the same deflection ductility factor as the control beam, with a value of 4.66. B4-SC-FS had the least deflection ductility factor, 3.79, because the stirrups were more corroded than other beams, as reflected in Fig. 4 showing weight loss of corroded stirrups.

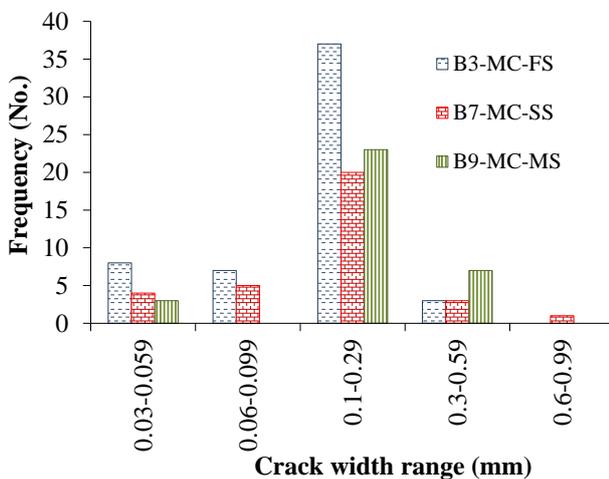
Fig. 5 – Corrosion crack width frequencies for mild corrosion

Figure 5 shows the frequency of corrosion cracks for the mild corrosion. For 10% weight loss (mild corrosion), the maximum number of cracks remained was in the range of 0.1-0.29 mm width. B3-MC-FS had the maximum number of cracks (37) in the range of 0.1-0.29 mm. This is because the stirrups were corroded in the full span, so the length across which corrosion cracks appeared was greater. For B7-MC-SS (shear span corrosion) and B9-MC-MS (middle span corrosion), the number of cracks was the same (33) with a slight change in the frequency of crack widths. Only B7-MC-SS had one crack in the range of 0.6-0.99 mm width, and there were no cracks smaller than 0.03 mm.

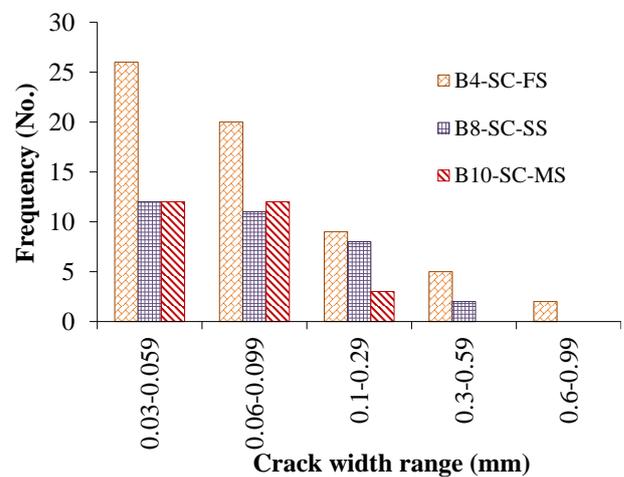
Fig. 6 – Corrosion crack width frequencies for severe corrosion

sion (10% weight loss). In all the beams with severe corrosion, the maximum cracks were in the range of 0.03-0.059 mm width. For the crack range of 0.06-0.099 mm, B8-SC-SS (shear span corrosion) and B10-SC-MS (middle span corrosion) had almost the same number of cracks, 11 and 12, respectively, but for B4-SC-FS, the corrosion cracks decreased for the wider crack width ranges starting from 0.06-0.99 mm. The cracks were spread across all the crack width ranges, but as the crack width increased, the number of cracks decreased. Cracks were found on all four sides of beams where the stirrups are corroded. Figure 7 shows the corrosion crack widths and distributions on the front and back side surfaces of the corroded beams.

Figure 6 shows the frequency of corrosion cracks for severe corrosion. For the severe corrosion (20% weight loss) micro cracking formation was observed. The number of cracks was more for smaller crack widths, unlike the case of mild corro

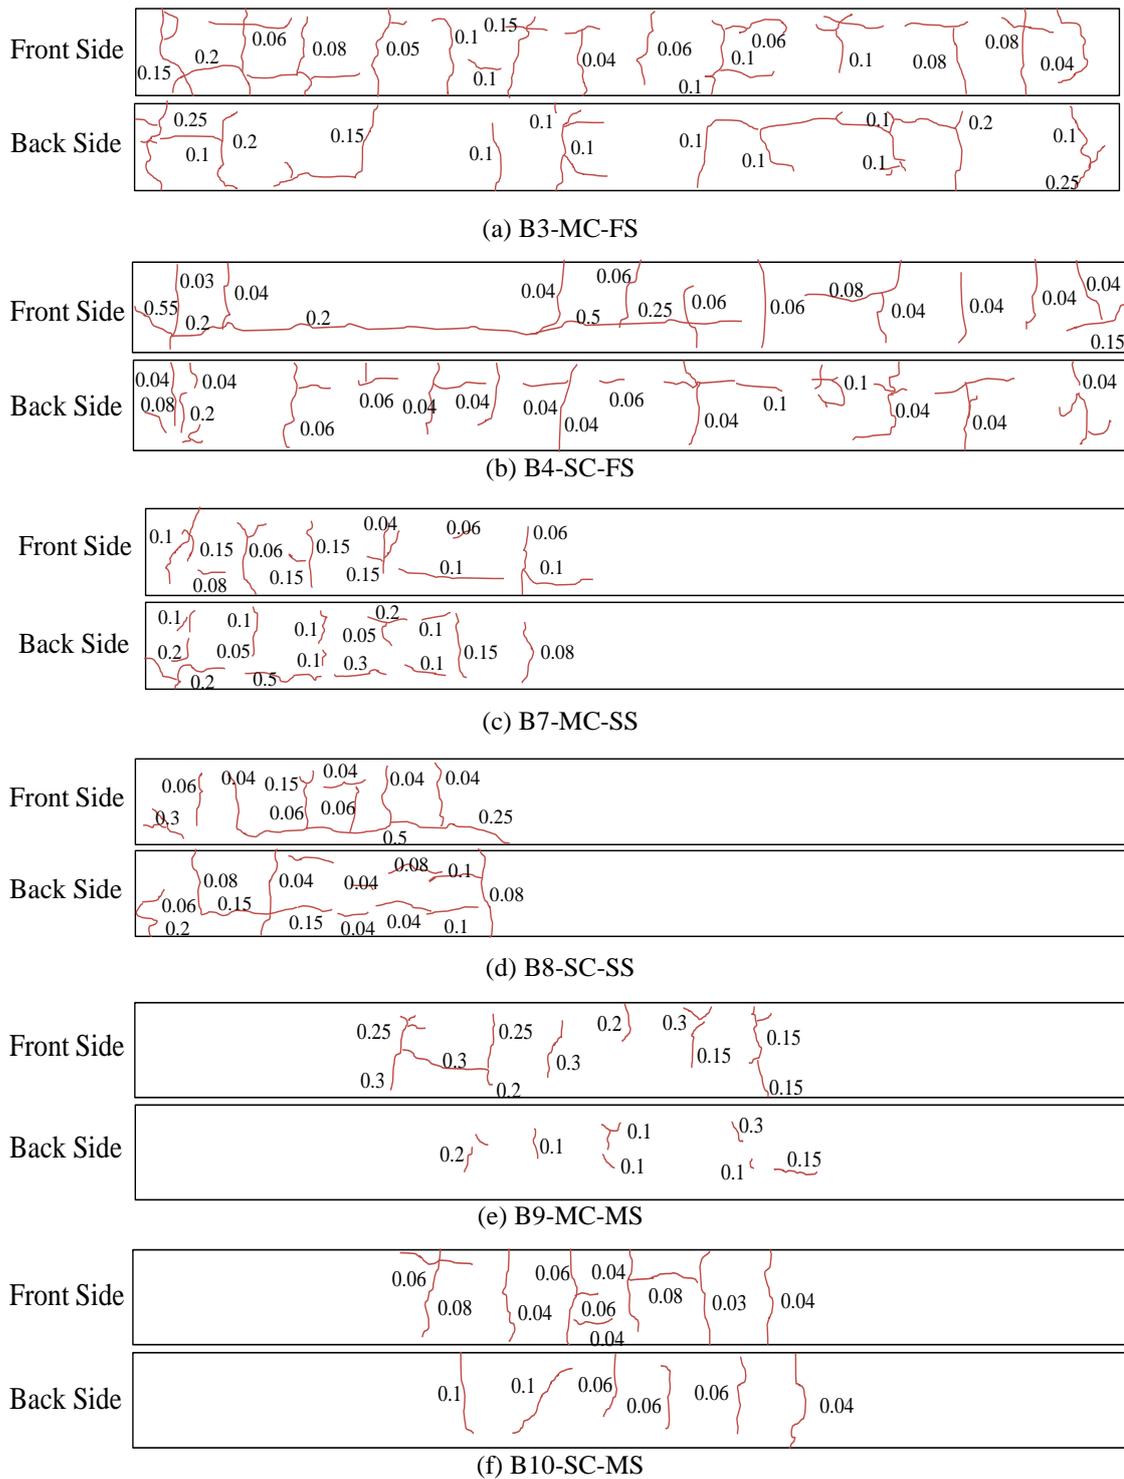
Fig. 7 – Corrosion crack widths and distributions of corroded beams

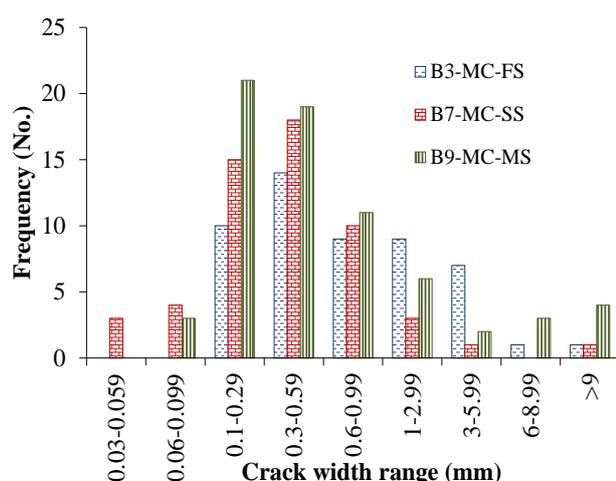
Fig. 8 – Flexural crack width frequencies for mild corrosion

For the middle span mild corrosion B9-MC-MS, the maximum number of cracks was in the range of 0.1-0.29 mm width with 21 cracks. The beams were designed to fail in flexure before corrosion. After corrosion, the beams also failed in flexure because the degree of corrosion in the stirrups was not too high, and the concrete shear capacity was not reduced much. In case of B9-MC-MS, corrosion occurred in the middle span, and the failure mode was also flexure. The corrosion cracks started to widen up in the four-point loading test. After the application of further load, new cracks also started to occur and, because of this cracking, the maximum cracks fell in the range of 0.1-0.29 mm width. The maximum number of cracks (69) was also found in B9-MC-MS. Figure 8 explains the frequency of flexural cracks for mild corrosion.

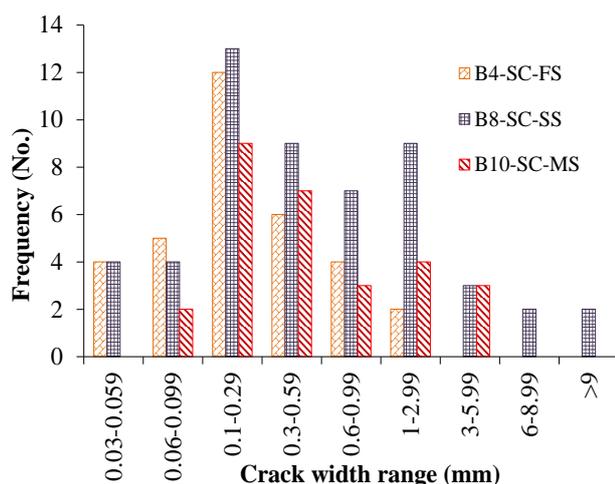
Fig. 9 – Flexural crack width frequencies for severe corrosion

The maximum number of cracks for B4-SC-FS and B10-SC-MS were 33 and 28, respectively. When compared with the number of cracks for B3-MC-FS (51) and B9-MC-MS (69), it was observed that, with a greater degree of degradation, the number of flexural cracks became less. In case of corrosion cracks, the crack width for the maximum number of cracks was less than for the higher degree of degradation. The maximum number of cracks for the severe corrosion was in the range of 0.1-0.29 mm width for all three cases. The maximum number of cracks in the range of 0.1-0.29 mm width for B4-SC-FS was 12, as compared to 13 for B8-SC-SS and 9 for B10-SC-MS. In B10-SC-MS, the cracks already existed because of corrosion, which could be the cause for smaller number of cracks. For B4-SC-FS, there was no crack wider than 3 mm, and, for B10-SC-MS, no crack wider than 6 mm, as compared with beams with mild corrosion B3-MC-FS and B9-MC-MS. However, B8-SC-SS (shear span severe corrosion) did not follow the pattern of B4-SC-FS and B10-SC-MS, which was also severely corroded. This was because the cracks, or degradation, were in the shear span, but the loading cracks were in the middle span. The loading cracks had no relation with the corrosion cracks in this case. Figure 9 shows the frequency of flexural cracks for mild corrosion, while Fig. 10 shows the flexural cracks width and distribution on both side surfaces of the corroded beams.

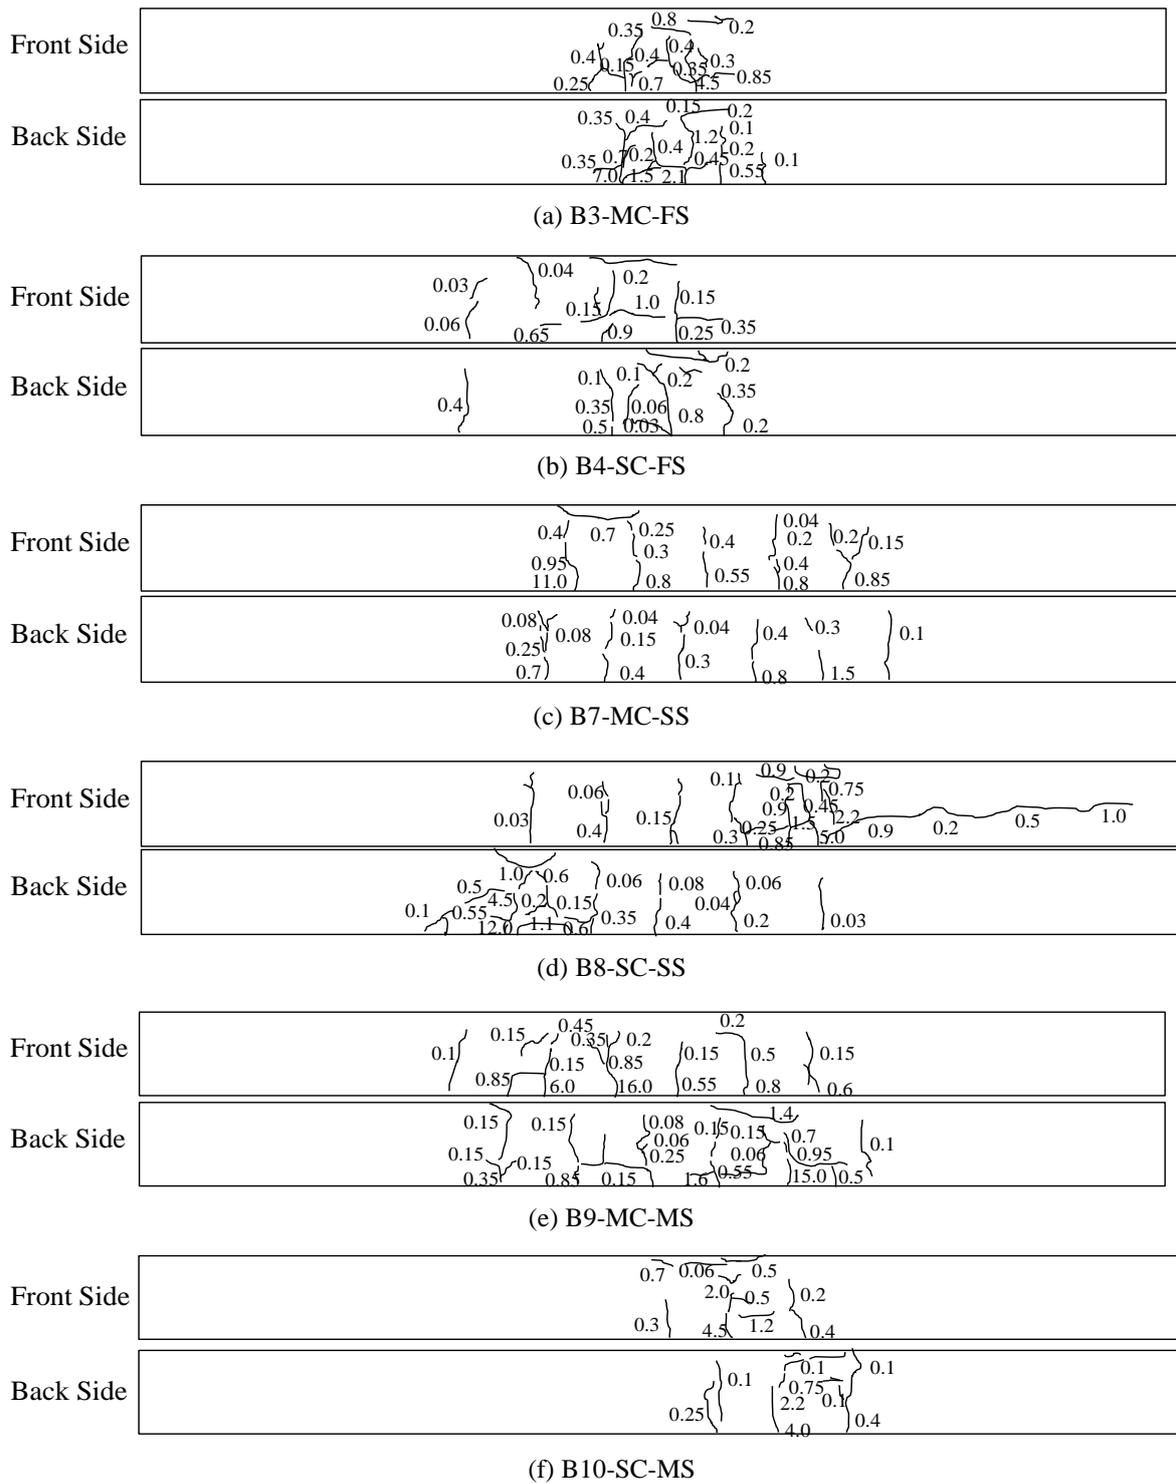
Fig. 10 – Flexural crack widths and distributions of corroded beams

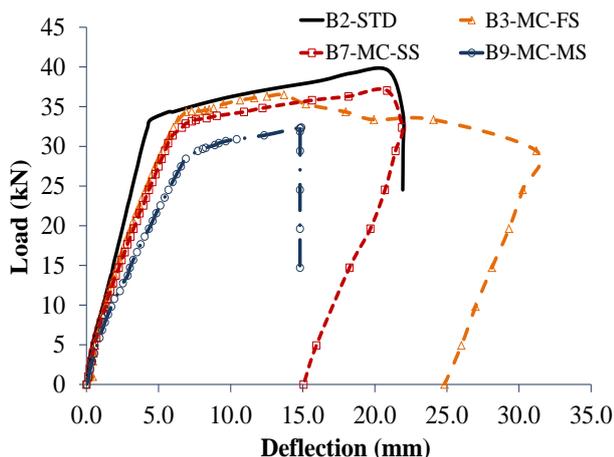
Fig. 11 – Load-deflection curves for mild corrosion

Figures 11 and 12 show the results of the loading test and deflections for the mild and severe corrosion, respectively. B2-STD had no corrosion as it was the control beam. It followed typical behavior of the reinforced concrete beam with an ultimate load of 39.53 kN and maximum deflection of 21.96 mm. All the other beams with corrosion had less flexural capacity, and the maximum deflections of all beams were different. The design failure mode of all the beams was flexure, and after corrosion, they still had flexural failure. The expected corrosion did not affect the failure type, although it was likely to be shear failure as the stirrups were corroded.

For mild corrosion (10% weight loss) the least flexural capacity was observed in B9-MC-MS, in which corrosion of stirrups were done in the middle span. The flexural capacity was 32.37 kN, with a 18.11% reduction from the control beam, and the maximum deflection was 14.90 mm, with a 32.14% reduction. The corrosion cracks and failure cracks occurred in the middle span of the beam. B7-MC-SS (stirrups corroded in the shear span) somewhat followed the same behavior as the control beam B2-STD, with the least reduction in load carrying capacity. The ultimate load capacity was 37.03 kN, with just a 6.32% reduction, and the maximum deflection of 21.89 mm was almost the same as that of the control beam B2-STD. B3-MC-FS also followed the same behavior in the beginning but, after the peak load of 36.49 kN, the behavior changed. The reduction in flexural capacity was 7.69%; however, instead of decreased maximum deflection, it increased. The maximum deflection was 31.21 mm, with an increase of 42.12% compared to the control beam B2-STD. This increase in maximum deflection was not expected, and the maximum deflection

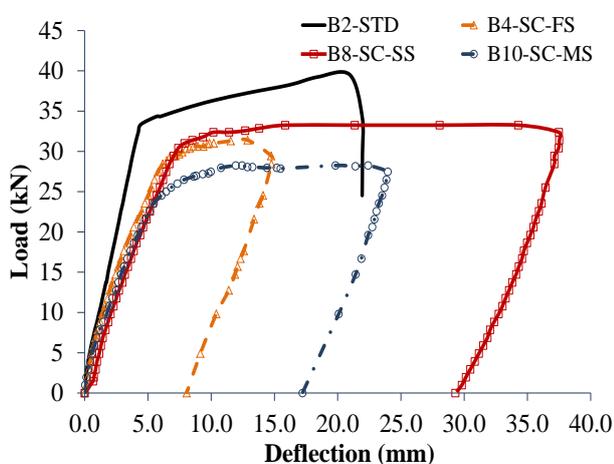
Fig. 12 – Load-deflection curves for severe corrosion

In case of severe corrosion (20% weight loss), the least flexural capacity was again observed in the beam in which stirrups were corroded in the middle span. B10-SC-MS, whose stirrups were corroded in the middle span, had a flexural capacity of 28.25 kN, with a 28.54% reduction in strength, as compared with control beam B2-STD. However, the maximum deflection was 23.96 mm, which is 9.11% more than the control beam B2-STD. For corrosion of stirrups in the full span, the flexural capacity and maximum deflection decreased considerably. The ultimate load for this beam B4-SC-FS was 31.39 kN, with a 20.59% reduction, and the maximum deflection was 14.76 mm, with a 32.79% reduction compared to the control beam B2-STD. The smallest reduction in load carrying capacity for severe corrosion was observed in B8-SC-SS, where shear stirrups were corroded in only one shear span, but the flexural cracks were in the middle span. The flexural capacity of B8-SC-SS was 33.26 kN, with a reduction of 15.86%, and the maximum deflection was 37.51 mm. There was a decrease in flexural capacity, but a considerable increase of 70.81% in maximum deflection was observed as compared to the control beam B2-STD.

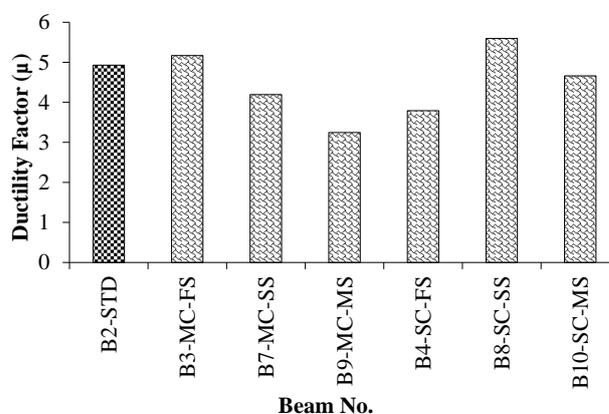
Fig. 13 – Deflection ductility factor of the corroded beams

For the purpose of this paper, the ductility is determined by Eq. (1), deflection ductility. Figure 13 illustrates the deflection ductility factor of the corroded beams and the control beam. The deflection ductility factor is believed to depend on the failure mode and, in this study, all the beams failed in flexure after corrosion of stirrups only. However, the deflection ductility factor varied for all the corroded beams, as the location of the corrosion was not the same. The deflection ductility factor of the control beam B2-STD was calculated as 4.93. Mild corrosion beam B3-MC-FS had a slightly higher deflection ductility factor of 5.17 than the control beam B2-STD. B7-MC-SS had a deflection ductility factor of 4.19, which is almost the same as the control beam B2-STD, as the stirrups were corroded in the shear span but flexural failure was observed after corrosion. The corrosion cracks did not affect the deflection ductility significantly. B9-MC-MS had the least deflection ductility factor, with a value of 3.25.
