The durability and rehabilitation technologies of concrete sewerage pipes: A state-of-the-art review

Abstract: This paper reviews the literature available on the subject of the durability of concrete sewer pipes and the corresponding rehabilitation technologies. An introduction related to the importance of the sewer system in urban life and its durability issues was first discussed as most people did not recognise the scale and complexity of the underground sewer system. Then the recent development of alternative binder materials or filler materials to improve the acid resistance of concrete was specified. For instance, the effects of alternative binders on the hydration products and the mechanism of biogenic corrosion were discussed in detail. The paper ends with the current rehabilitation technologies and the structural performance of rehabilitated sewer pipes. Also, some suggestions associated with future research were made.

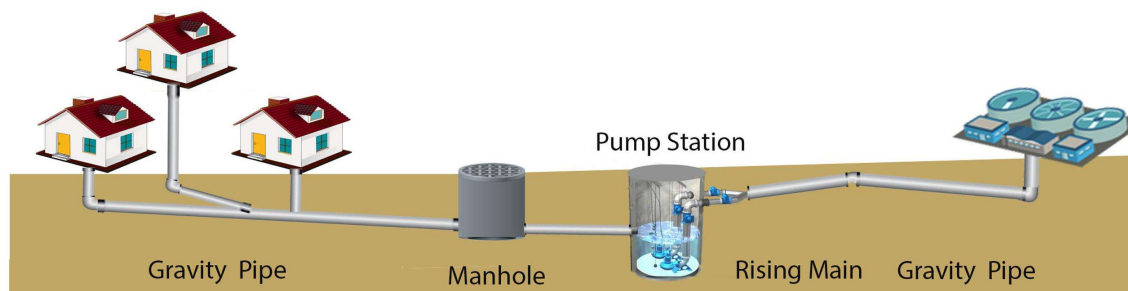
Fig. 1 – Schematic view of sewerage network infrastructure [4]

The sewer system is a critical urban infrastructure, which comprises a collection system and treatment system to transfer wastewater from households to the wastewater treatment plant [1,2]. A simplified schematic view of the underground sewerage piping system is shown in Fig.1. In some countries, the total length of the sewer system can

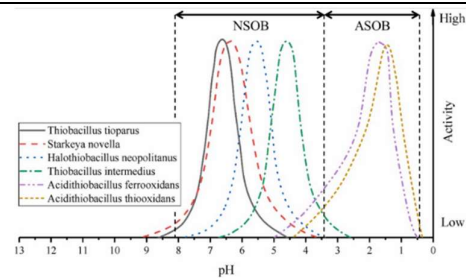
Fig. 5 – The SOB activity of different bacterial communities related to the pH value (modified from [30]); NSOB: Neutrophilic SOB; ASOB: Acidophilic SOB

Fig. 5 shows the relationship between SOB activity and pH values. The neutrophilic SOB (NSOB) first colonizes at the surface when the pH is between 4 and 9. Then, the surface pH can be further reduced below 4 with the continuing growth of bacteria communities. The acidophilic SOB (ASOB) will start to grow within this pH range and reach its highest activity at pH values between 1 and 2 [17,30].

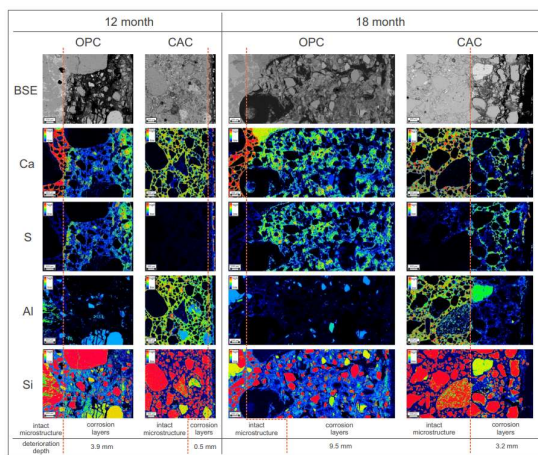
Fig. 9 – Acid corrosion depth characterized by chemical mapping and back-scattered electron image in OPC and CAC mortar after 12 months and 18 months of testing [53]

durable rehabilitation and a low cost. The reasons for the improvement can be attributed to (i) without drying the substrate and by-pass the effluent in most cases, (ii) exceptional acid resistance. Berndt [51] also confirmed that CAC-based mortar exhibited excellent resistance to acid attack. Furthermore, the biodeterioration of mortar made with CAC and Portlandite cement was investigated in bioleaching tests, which provided a new insight to explain the acid resistance improvement of CAC-based mortar [52]. For instance, the different reactive phases of CAC lead to a weaker acid-neutralizing capacity, resulting in a quicker drop of pH from 6.5 to 3, decreasing the amount of bio-generated sulfuric acid. Recently, Grengg et al. [53] investigated the long-term MIC resistance of mortar samples using CAC, OPC, and geopolymer. Compared with the other two binders, CAC-based mortar exhibited a stable low corrosion rate, and the corrosion depth of OPC and CAC samples was characterized by back-scattered electron image combined with element mapping (Fig. 9). Such an explanation was also supported by the study of Herisson et al. [54,55], which demonstrated the excellent long-term acid resistance of CAC-based mortar. In addition to lab-scaled sulfuric acid tests, Khan et al. [56] and Kiliswa et al. [57] conducted a study on MIC resistance of CAC mortar and OPC mortar under actual sewer. After tests, the obtained results further evidenced the superior acid resistance of CAC-based mortar, and crystallization of gypsum was the main factor for the deterioration.

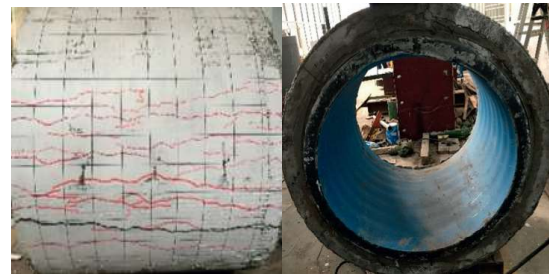
Fig. 16 – Crack distribution and RCP repaired with HDPE liner [91]

Slip lining rehabilitation for sewer pipes has been developed for decades, which is the oldest pipeline renew technology that uses a corrosion-resistance liner material to cover the deteriorated concrete pipe. The liner material includes high-density polyethylene (HDPE) line and corrugated steel pipe liner depending on different applications. Simpson et al. [90] used slip lining to rehabilitate an RCP under surface loading. Before and after slip lining, two damaged RCP samples were buried and tested under surface load. Reported rehabilitation results showed that the stiffness of the pipes was significantly increased by 87%, and the vertical diameter deformation was decreased by 93%. Li et al. [91] investigated the load-sharing theory of slip-lined RCP with HDPE liner; the obtained results showed that the load-carrying capacity was 1.51 times higher than the original RCP. The cracking distribution and pipe after HDPE lining is shown in Fig.16.

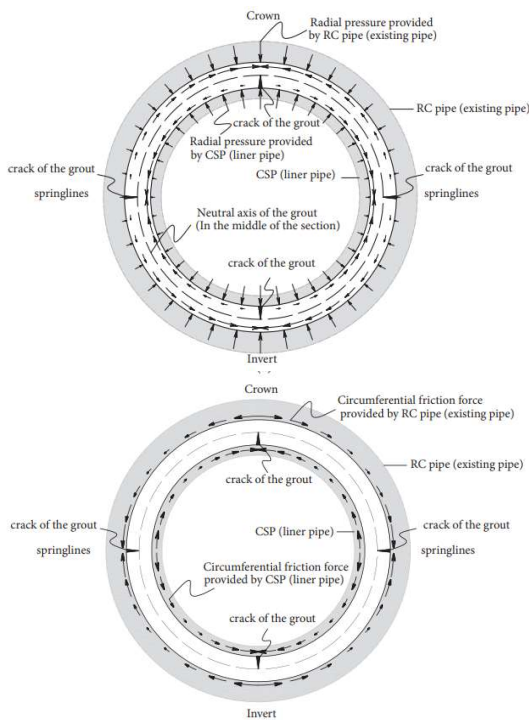
Fig.17 – Stress distribution of CSP-lined RCP [92]

promise solution for deteriorated concrete sewer rehabilitation. Also, the structural performance of CSP-lined RCP was investigated by the study of Hu et al. [93]. The results showed that the RCP could undergo a large residual deformation after rehabilitating with a CSP liner. A calculation method was proposed, and the estimated value of the test loading capacity of post-rehab RCPs is provided within 30%.
