## The durability and rehabilitation technologies of concrete sewerage pipes: A state-of-the-art review

Yan Zhuge\*, Wei Fan, Weiwei Duan, Yue Liu

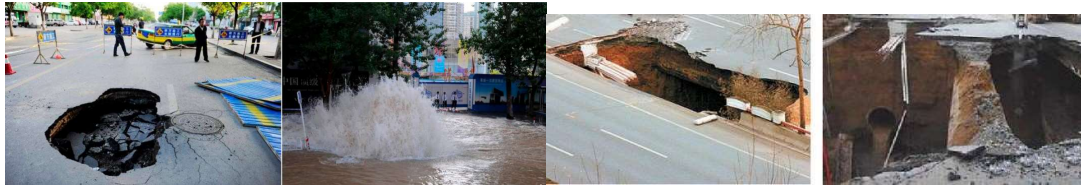
Fig. 2 – Pavement collapse and pipe burst caused by concrete pipes failure [7,8]

Concrete is the most used material for manufacturing sewer pipelines [5,6]. However, the concrete sewer pipes are susceptible to failure prematurely far before reaching their asset life due to microbially-induced acid corrosion (MIC). Specifically, MIC is the process in which the acid generated by microbial activities keeps dissolving the cement-matrix. Leaking or even collapse of the concrete sewage pipes can be caused by MIC; therefore, regular maintenance is required. Fig. 2 shows the health and safety concerns derived from damage to roads and pavements during and after a catastrophic pipe failure.

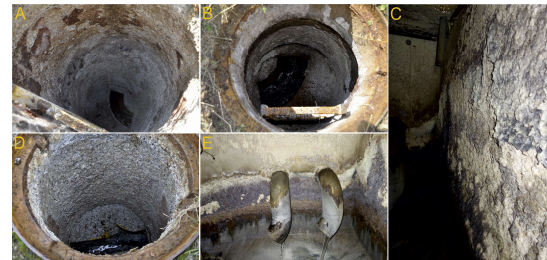
Fig. 3 – Photos of MIC in sewage facilities [17], Photos (A), (B), (D) are taken from the manhole of sewage pipes; Photos (C) and (E) are taken from wastewater catchment basins.

facilities that suffered from MIC (Fig. 3). To repair such deteriorations, a cost of around £85 million in the UK and \$390 billion in the USA is needed in the next 20 years [17].

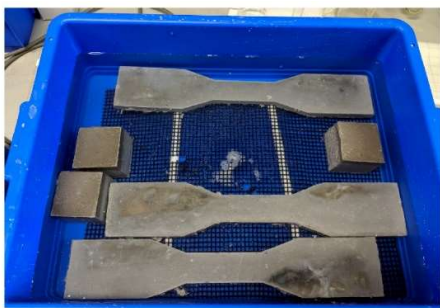
Fig. 7 – Sulfuric acid corrosion test for mortar samples (modified from [39])

In addition to placing samples in the actual sewer system, many lab-scale evaluation methods have been developed to determine the cementitious materials' performance under MIC attack [37,38]. They can be divided into two categories: mineral acid corrosion test and microbiological simulation corrosion test. The mineral acid corrosion test utilizes chemical sulfuric acid directly as the corrosion media to simulate the final stage of MIC. An example of a mineral acid corrosion test is shown in Fig. 7. In the test, samples are immersed in the sulfuric acid solution. The acid concentration is maintained by regularly replacing the sulfuric acid solution [39,40] or using automated titration [41,42]. Mineral acid corrosion test provides a simple method to evaluate MIC resistance. It can accelerate the reaction rate and, therefore, shorten the experimental time. However, the limitation of this method is that it neglects the material's effect on microorganism activities. For instance, if the materials could prevent the growth of the corrosion-induced bacteria at an earlier stage, the material is not necessary to have strong resistance to sulfuric acid corrosion.

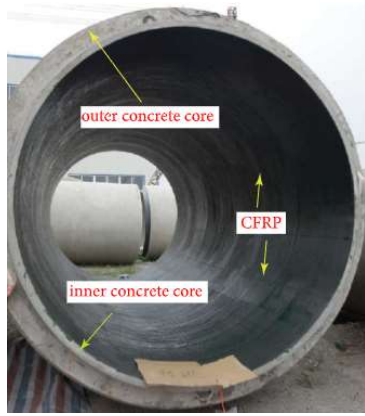
Fig. 13 – The image of CFRP-lined PCCP [85]

CFRP is the most used rehabilitation material for deteriorated concrete pipes [84]. It has favourable long-term durability as well as high strength. CFRP can be easily bonded to the surface of the damaged area with epoxy adhesive to enhance the load-carrying capacity. Moreover, CFRP can also hinder sulfuric acid ingress, therefore effectively protecting the integrity of concrete pipes. Hu et al. [85] used CFRP as an inner liner to repair a prestressed concrete cylinder pipe (PCCP) under combined loads (Fig.13). The rehabilitation effect of CFRP-lined PCCP was evaluated by 3D finite element analysis (FEA) models. The results showed that CFRP-lined PCCP had an excellent rehabilitation effect on the inner concrete core, and CFRP worked even more effective with the increasing number of broken wires. Another case of using CFRP-lined PCCP under internal pressure was also reported in the study of Ozbay et al. [86]. To prevent a catastrophic failure of PCCP by broken prestressing wires, CFRP adhered at the inner concrete core as an internal repairing method. A full-scale experimental, as well as FEA model (see Fig. 14), was conducted to evaluate the structural performance of the CFRP-lined PCCP. Results showed that the watertightness could be improved by using CFRP laminate under internal pressure. Simulation results also showed that, for each additional CFRP layer, the design pressure threshold value increased by seven broken wires under the damage limit state and by 20 broken wires for the working pressure. Similar results were also reported in Zhai et.al. [87]. Prestressed concrete cylinder pipe operation was improved after repairing with CFRP; strains and stresses both decreased at the spring line. The strengthening effect of CFRP-lined PCCP was enhanced as the number of repair layers increased [88].

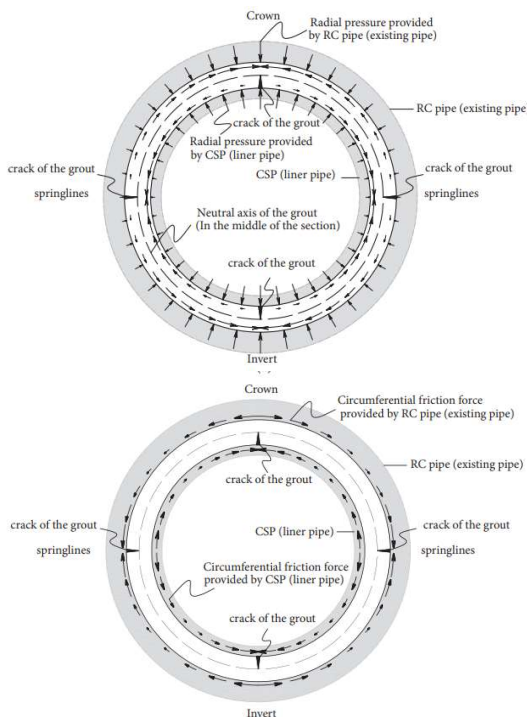
Fig.17 – Stress distribution of CSP-lined RCP [92]

promise solution for deteriorated concrete sewer rehabilitation. Also, the structural performance of CSP-lined RCP was investigated by the study of Hu et al. [93]. The results showed that the RCP could undergo a large residual deformation after rehabilitating with a CSP liner. A calculation method was proposed, and the estimated value of the test loading capacity of post-rehab RCPs is provided within 30%.
