Technical Paper

Investigation on possible causes of expansion damages in concrete – a case study of sleepers in Indian Railways

Anupam AWASTHI*; Koji MATSUMOTO; Kohei NAGAI; Shingo ASAMOTO; and Seishi GOTO

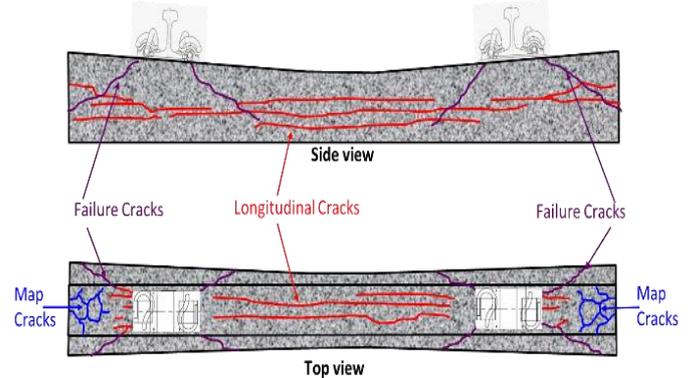
Fig. 1 – Schematic diagram of typical cracking pattern observed in concrete sleepers in Indian Railways

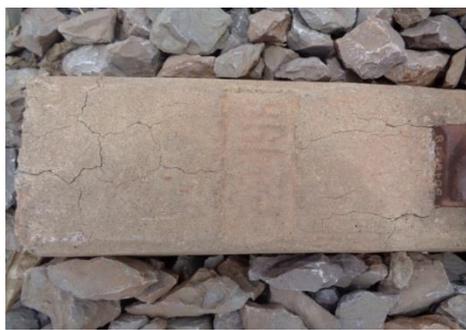
(a) Map cracks observed at the end of the concrete sleepers

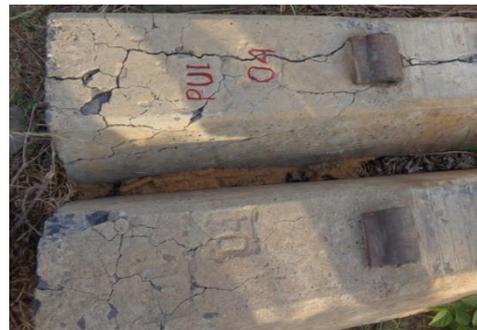
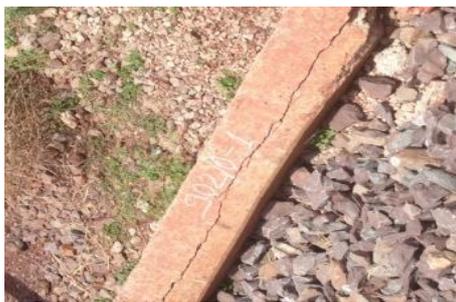
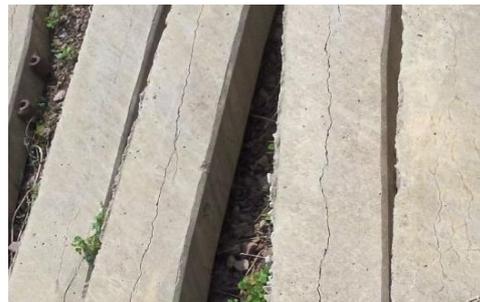
(b) Longitudinal cracks observed at the middle of the concrete sleepers

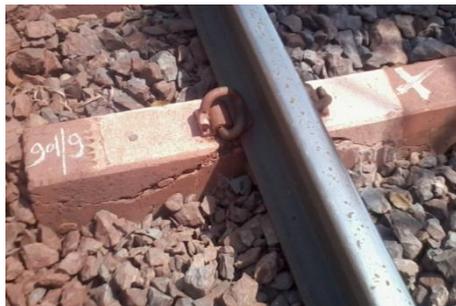
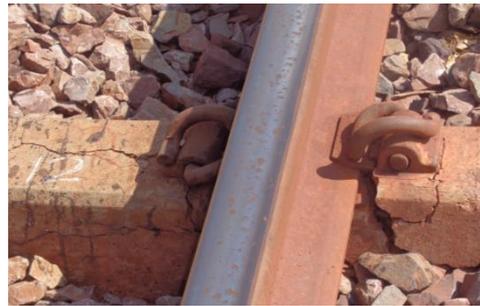
rail loads. Figure 2(c) shows the photographs of such cracking patterns. The crack width ranges from just visible from naked eye i.e. around 0.3 mm to wide enough to cause failure cracks i.e. 10 mm. Maximum crack width generally occur in failure crack observed near insert location due to combined effect of external load due to trains and internal damage in concrete due to expansive reactions (Fig. 1 and Fig. 2(c)). In the present study cracks are only visually examined to categorize sleepers according to different levels of damage. The area, where cracks in sleepers are reported, has no proximity to sea; therefore chances of chloride attack can be eliminated. There is no corrosion related problem; hence there cannot be carbonation related problem. Also, freeze-thaw deterioration can be eliminated, since the region is not cold and snow never occurs. There is no overload or strength problem since the sleepers which were never loaded also get cracked. The environment is also not aggressive for chemical attack. Therefore, it is predicted that there is some

(c) Failure cracks observed at the location of the insert in the concrete sleepers
Fig. 2 – Cracking patterns observed in the concrete sleepers of Indian Railways

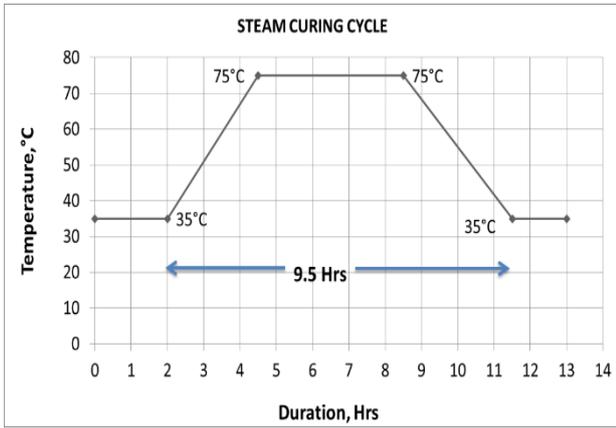
Fig. 4 – Steam curing cycle adopted

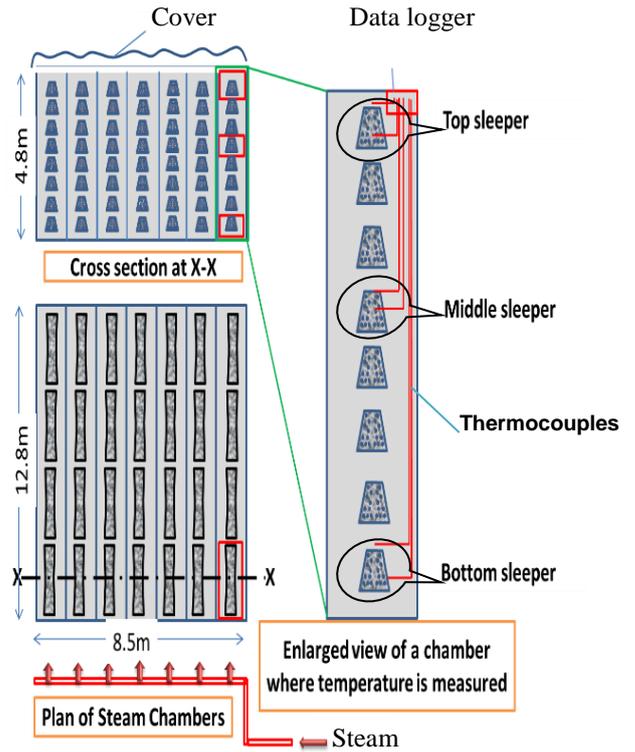
imately 12.8 m x 8.5 m x 4.8 m that are used for steam curing. The steam is supplied from the bottom and there are 7-8 chambers in a tank where the bench holding the sleepers is inserted for curing. In a chamber sleepers are stacked in 8 layers one over the other. Figure 5 shows the typical arrangement of curing chamber and position of the sleeper for which temperature measurement was done. Three sleepers namely bottom most, middle (5th from the bottom), and top most were chosen for temperature measurement to study the effect of deep curing chamber used in stress bench method. For a sleeper, temperature was measured at two points, one inside the sleeper where maximum temperature was ex-

Fig. 5 – Schematic diagram of curing chambers adopted in stress bench method

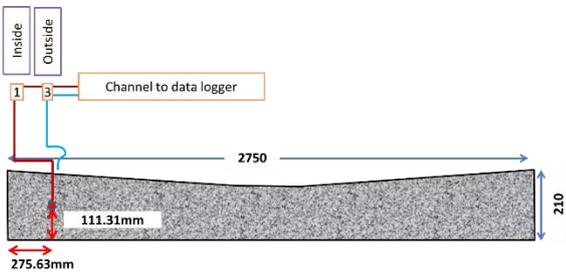
Fig. 6 – Typical arrangement of thermocouple in field measurement-1

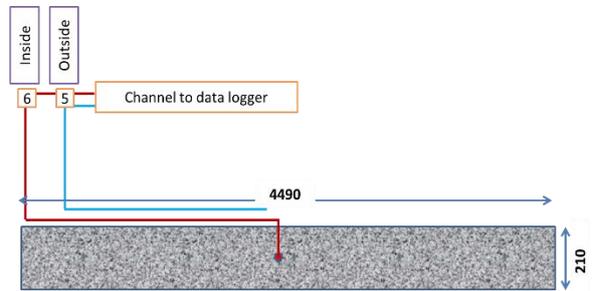
Fig. 7 – Typical arrangement of thermocouple in field measurement-2

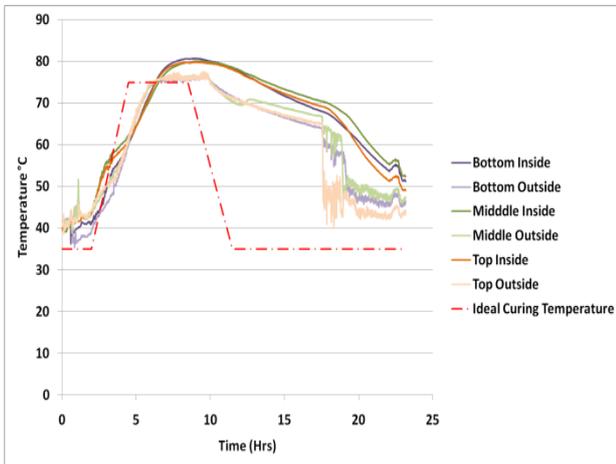
Fig. 8 – Results of temperature measurement-1 in sleeper plants in India

Field measurement of temperature reveals that the maximum temperature reached inside concrete is 80.7°C and 84.9°C for the bottom-most sleeper in field measurement-1 and field measurement-2, respectively (Figs. 8 and 9). Therefore, it is very well established that concrete temperature is beyond the critical temperature for the occurrence of DEF problem (as mentioned by Ghorab et al. [7], Heinz and Ludwig [8], Hanehara and Oyamada [9]). The temperature inside concrete generally follows the trend of temperature outside concrete but becomes more than the outside temperature after approximately 6 and 1/2 hours of casting. This depicts the effect of heat of hydration in addition to the outside curing temperature. In the two cases of field measurement the bottom most sleepers reached the maximum temperature. This shows that heating is not uniform in a deep steaming chamber when steam is supplied only from bottom.

Rise of temperature inside the concrete is very close to the ideal curing curve but the fall of temperature greatly deviates from the ideal curve (Figs. 8 and 9). This may be due to the layout of curing chambers adopted in stress bench method. In contrast to long line method, where only one line of sleeper is casted and cured at a time, in stress bench method there are series of 7 to 8 chambers inside one big tank. Depth of chambers is such that around 8 benches of sleepers can be kept one over the other (Fig. 5). The chambers are separated by thin brick wall through which heating of a chamber can rise the temperature in adjacent chamber. Therefore, if the adjacent chambers are not synchronized for the curing cycle, the heating effect of one chamber does not allow dropping the temperature of other. Figure 10 shows the schematic diagram depicting differences between long line method and stress bench method. Therefore, stress bench method of pre-stressing poses some structural deficiency which adversely affects the curing cycle. It is also observed that sleeper plant works in two shifts of 12 hours and if laborers of one shift do not turn up, the benches are removed when the next shift of laborers come. This also adversely affects the cooling cycle. Although absolute maximum temperature is most important factor for DEF problem, as mentioned in section 2, Lawrence et al. [10] concluded that the start of expansion occurs early in case of a specimen heated for longer duration. Therefore, Indian concrete sleepers are exposed to high early age temperature more than 80°C and availability of moisture is ensured from heavy rainfall during monsoon period, which can lead to DEF induced damages in the sleepers as observed in the field. Hence, there is a need to revise curing cycle for the

production of concrete sleepers in India so that temperature inside concrete should always below critical temperature for DEF which is around 70°C. To achieve this, maximum curing temperature can be kept between 55°C to 60°C after taking due care of heat of hydration. Trials can be done to arrive at optimum curing cycle which also suits to the production set up in factories. More care should be taken for the sleepers produced by “stress bench method” since it adversely affects the curing cycle. Local issues like non removal of sleepers from curing chambers should be avoided as it adversely affects the curing cycle. For the new sleeper plant “long line method” should be adopted instead of stress bench method. Another area which can be dealt with as a preventive measure is that of “pre-curing time and rate of rise and fall of temperature”. In case of Indian sleeper production, pre-steaming period is 2 hours, rate of rise of temperature is 16°C and rate of fall of temperature is 13.3°C.

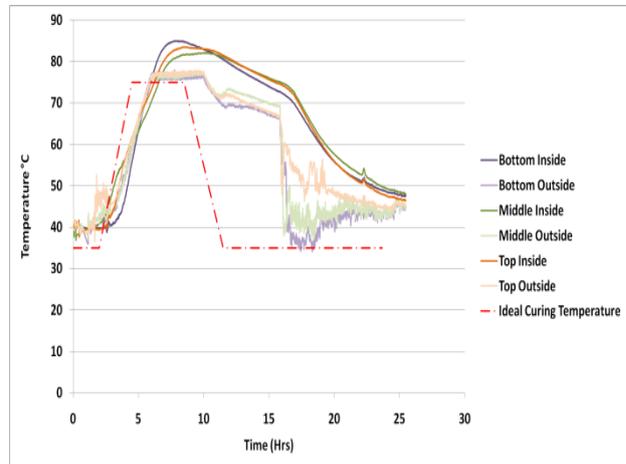
Fig. 9 – Results of temperature measurement-2 in sleeper plants in India

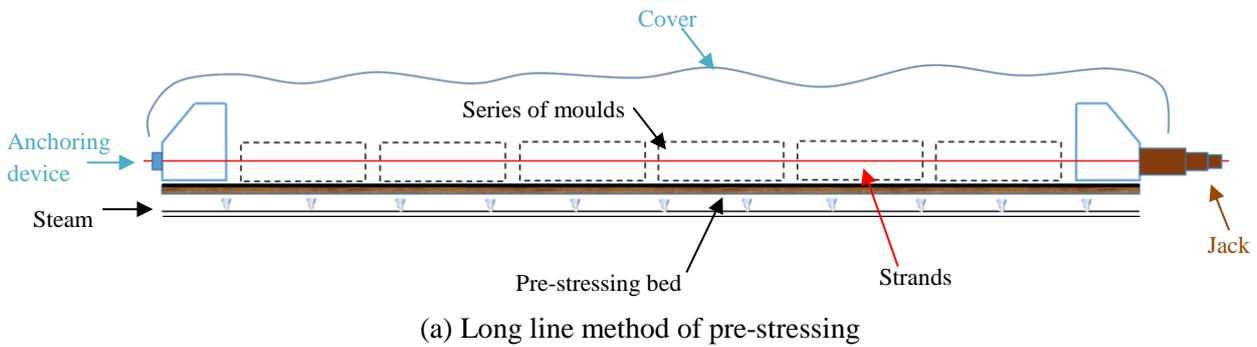
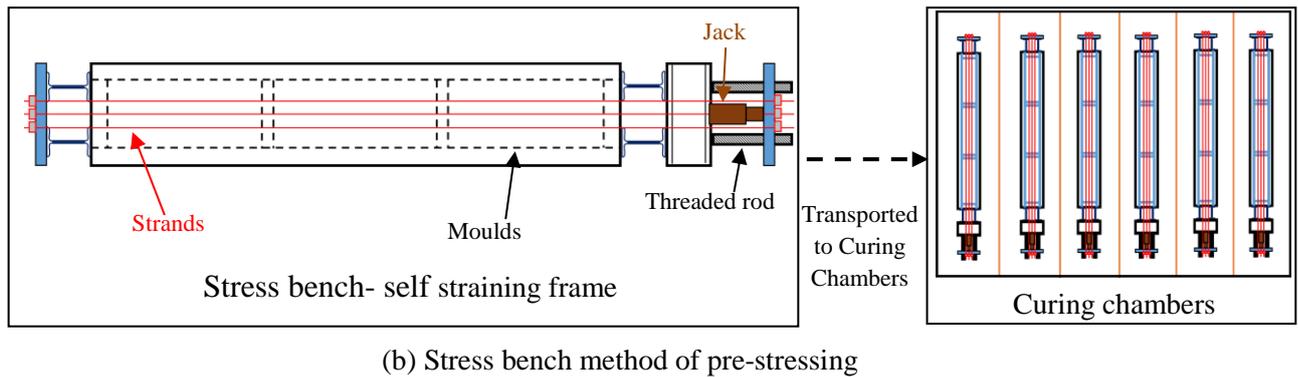
Fig. 10 – Schematic diagram showing “long line method” and “stress bench method” of pre-stressing

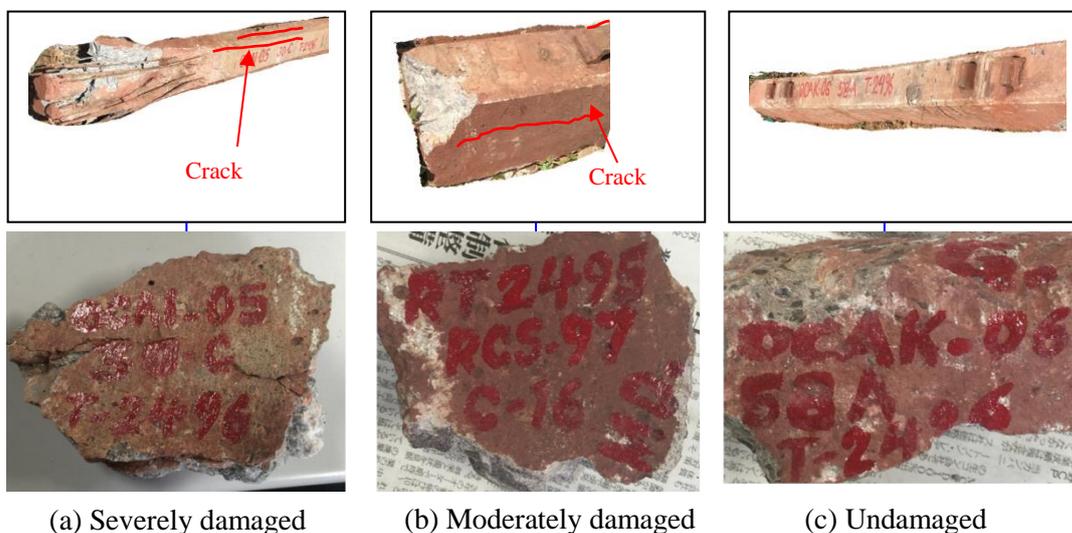
Fig. 11 – Typical concrete sample

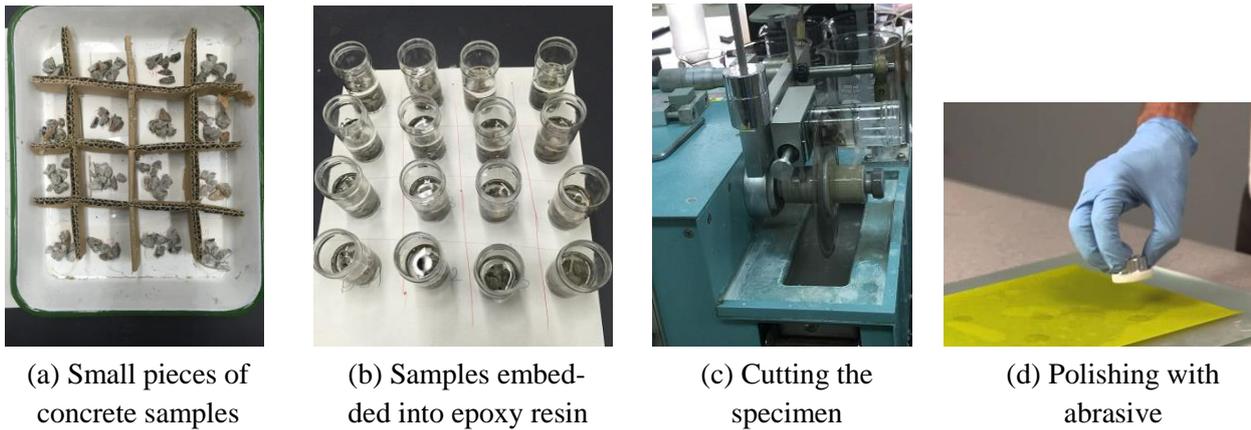
Fig. 12 – Sequence of operation for preparation of polished specimens

Both polished and unpolished specimens were observed under SEM. The polished specimens were prepared by embedding small pieces of samples (approximately 10 mm x 10 mm x 10 mm) from each of the three categories into epoxy resin. Epoxy resin facilitates mounting of small pieces of concrete samples, which are polished to view the microstructure of concrete under SEM. Figure 12 shows these sequences of operation. After hardening of the epoxy resin, these specimens were cut and the exposed surface was grinded by using polishing abrasives (Abrasive number 400, 800, 1200, 2000 and 4000 in sequence).

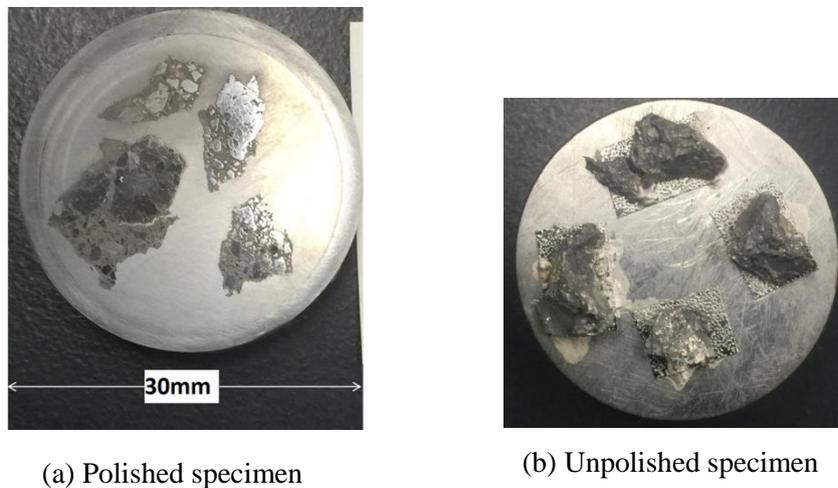
Fig. 13 – Typical Specimens used for SEM analysis

Figure 13 shows such typical polished and unpolished specimens of the sleeper sample. Then the polished surface was coated with platinum, which was needed to prevent the charging of specimen with the electron beam. Along with the polished specimen, unpolished specimens were also observed. Unpolished specimens are also important because it can give 3-D information about microstructure of concrete. Unpolished specimens

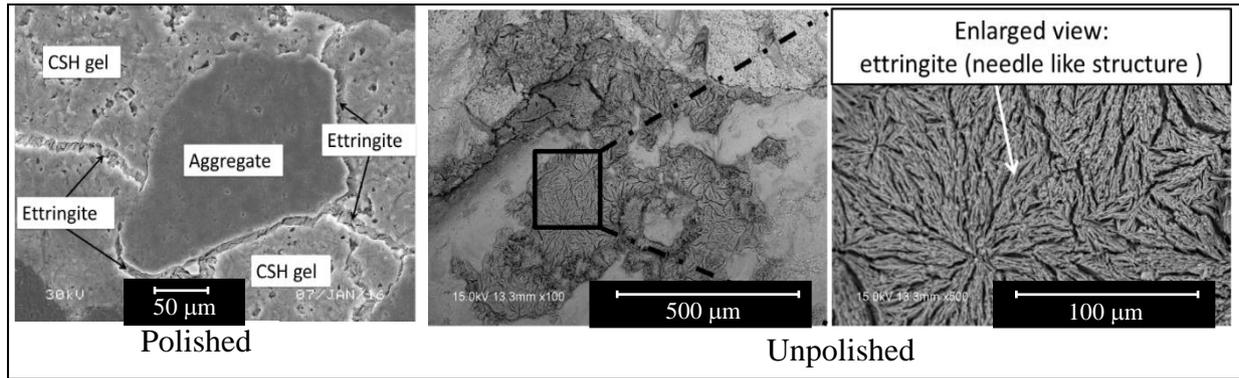
Figure 14 shows the typical SEM images for the polished and unpolished specimen of “Severely damaged” sleeper sample ‘D’. Large ettringite deposition, i.e. ettringite patches of around 1 cm² area which can also be seen with naked eyes as white patches, are commonly noticed at the interface of aggregate and paste. Apart from this, ettringite is also present in the cracks within the paste (C-S-H gel). Unpolished samples also show

large deposition of ettringite around the aggregates. Enlarged view shows typical needle like structure of ettringite. Unpolished specimen also reveals that there is layer of ettringite at the interface of aggregate and paste. There is similarity in pattern of the ettringite deposition in the samples from different locations of India i.e. a rim of ettringite forms around the aggregates and is joined by cracks in the paste filled by ettringite.

Fig. 14 – Polished and un-polished specimen: Sample D

The frequent occurrence of ettringite deposition at the cracks found in the paste and at the interfaces of aggregates and paste, in case of “Severely damaged” (Figs. 14-16) and “Moderately damaged” (Fig. 18) sleepers, suggests that delayed ettringite formation might be the cause of premature damage in the concrete sleepers in India. However, occurrences of alkali-silica reaction cannot be denied. The microstructure of the aggregates and paste in “Severely damaged” and “Moderately damaged” samples are in good agreement with those proposed by Taylor H.F.W. et al. [5]. The cracks are found in the paste and also the interfaces are filled by ettringite. This shows that uniform expansion of the paste might have occurred due to delayed ettringite formation and large crystals of ettringite might have deposited in the gaps and cracks formed by such expansion. According to Thomas et al. [20] DEF results in expansion of cement paste and increase in volume of paste in relation to aggregates which results in separation between them or, in other words, this will lead to gaps or opening between paste and aggregates, which become sites for deposition of larger crystals of ettringite. The SEM images observed in “Severely damaged” and “Moderately damaged” samples (Figs. 14 and 18) show ettringite filled gaps around aggregates which matches very well with the SEM images observed by Thomas et al. [20] for the case of DEF damaged concrete. Similarly, Scrivener et al. [21] also noted that, in case of DEF, gaps form as a consequence of relatively uniform expansion of paste in all directions.

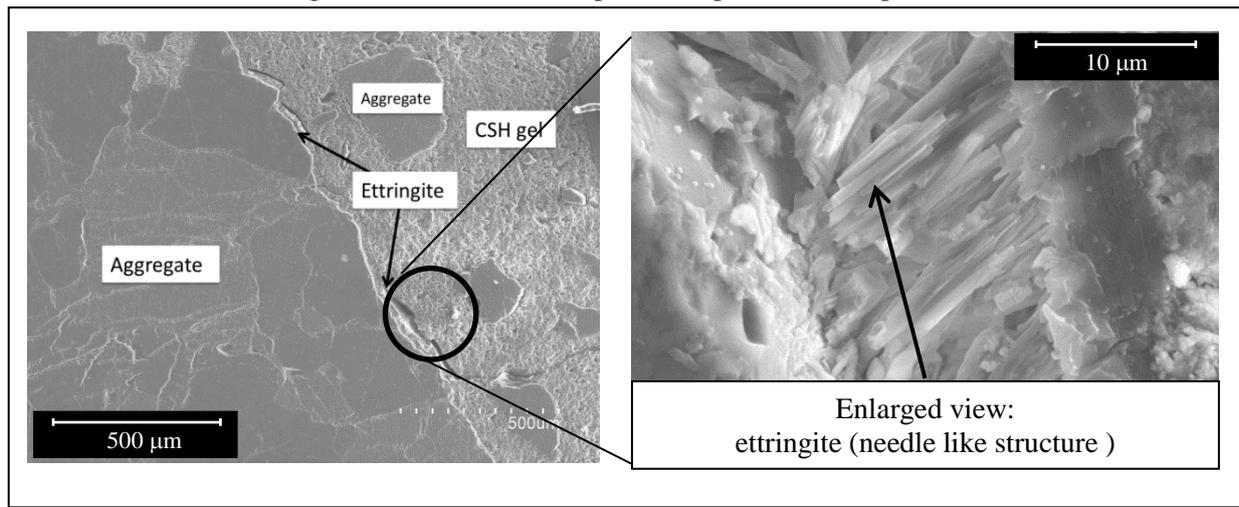
Figure 15 shows polished specimen of sample DU1, where ettringite deposition at the interface of aggregate and paste can be noticed. There is some porosity and hair cracks in coarse aggregate but ASR gel like substances are not noticed. Figure 16 shows SEM image of Sample DS1. Ettringite deposition can also be noticed at the interface of aggregate and paste in this sample.

Fig. 15 – Polished specimen: Sample DU1

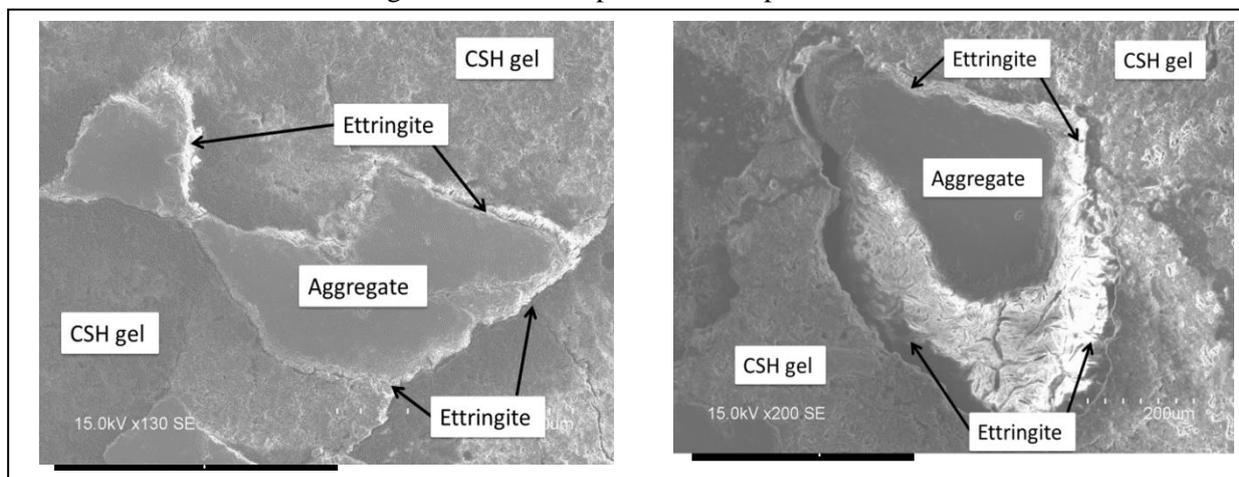
Fig. 16 – Polished specimen: Sample DS1

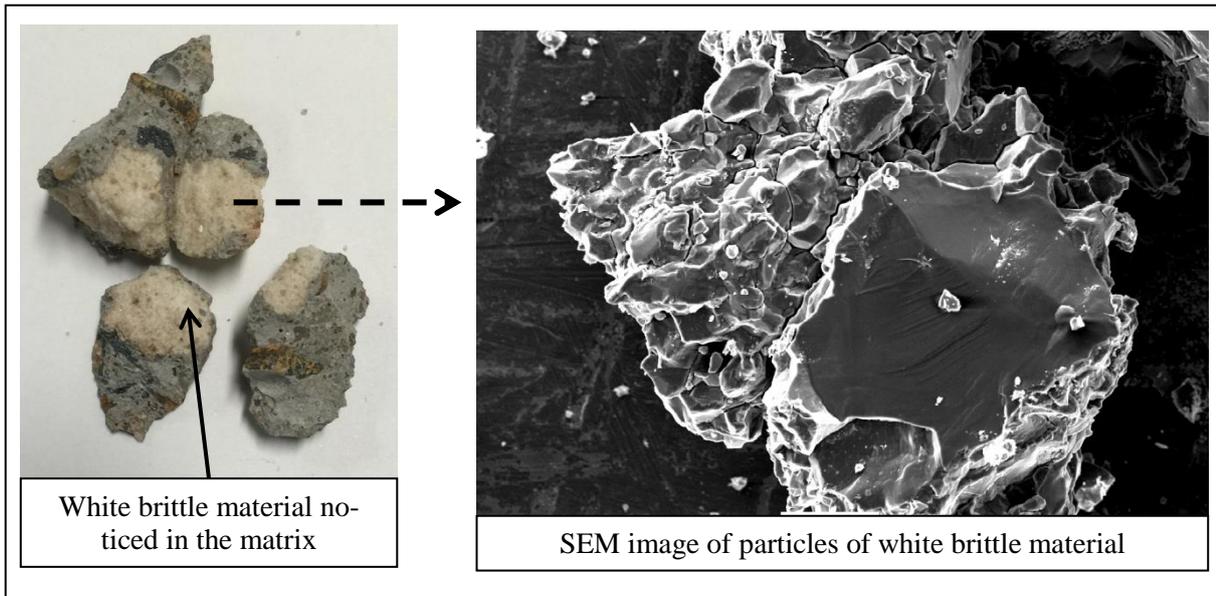
Contrary to above, in the matrix of sample DS1, white brittle material is also noticed (Fig. 17). The SEM image of the sample shows alkali-silica gel like substance. Typical glassy surface of gel can be observed in the SEM images. The sample was also analyzed for EDS (details are explained in the next section), which shows only substance in the material is silica. Therefore, ASR or combined effect of ASR and DEF cannot be denied in some of the sleepers and further investigation is required in this regard.

Fig. 17 – Unpolished specimen: Sample DS1

On the other hand, ASR gel like product, in one of the “Severely damaged” sleeper sample (DS1, Fig. 17), suggests that ASR might have taken place. Coexistence of alkali-silica reaction gel and ettringite, similar to that observed in one of the “Severely damaged” case, was explained by Brown and Bothe [20]. According to them cracks resulting from expansive reaction of ASR may provide space where ettringite crystallizes. The formation of alkali-silica gel decreases the alkali concentration of the pore solution. Development of ettringite is favored in low alkali solutions and ettringite may form in areas close to alkali-silica gel. Also, there are evidences that high early age temperature in concrete triggers both ASR and DEF [20, 23].

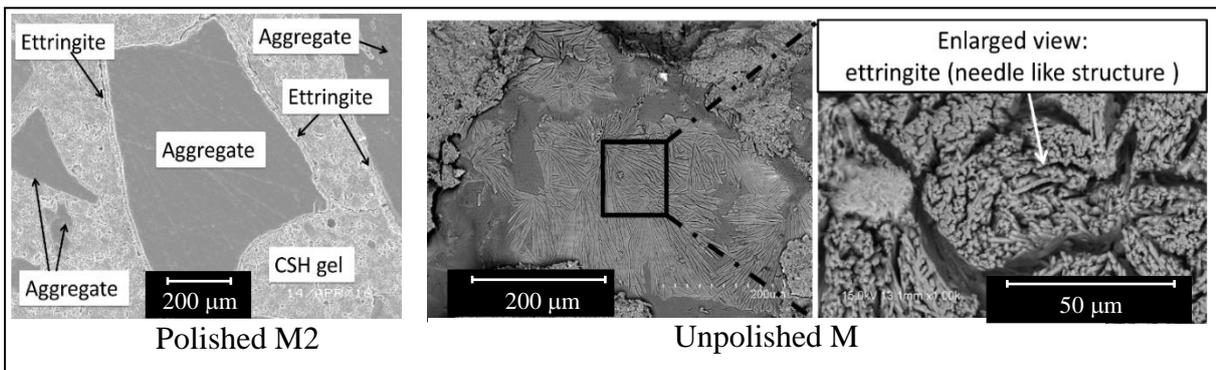
Figure 18 shows the typical SEM images of polished and unpolished specimen of “Moderately damaged” sleepers. As in the case of “Severely damaged” sleeper samples, SEM images of “Moderately damaged” sleeper also reveal that there is ettringite deposition around the interface of aggregate and paste. Ettringite could be noticed inside the paste as well. Few coarse aggregates also show some porosity and cracks inside them but ASR gel like substance is not noticed. It is observed that the locations with ettringite deposition are fewer in this case as compared to “Severely damaged” case. Unpolished specimen also confirms ettringite deposition and a typical needle like structure of ettringite could be noticed in an enlarged view.

Fig. 18 – Polished and unpolished specimen: Sample M2 and M

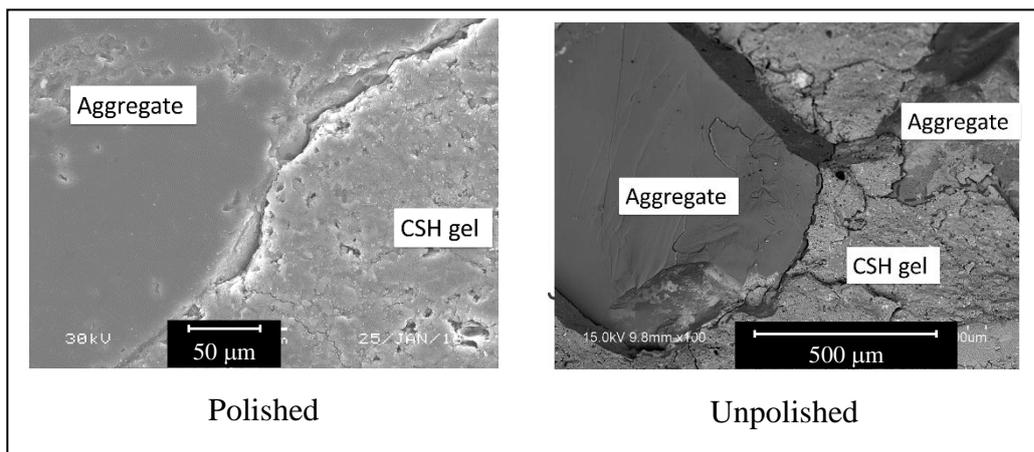
Figure 19 shows the SEM image of “Undamaged” sleeper sample ‘G’. In such relatively older sleeper samples, for example sample G (year of manufacturing: 1992), interface of aggregate and paste seems to be intact and no ettringite deposition has been noticed either in the C-S-H gel or at the interface of aggregate and paste. Apart from this, no ASR gel like substance is noticed. Figure 20 shows SEM image of “Undamaged” sleeper sample ‘GB1’. Unlike in “Undamaged” old sleeper sample like ‘G’, in relatively newer sleeper samples like ‘GB1’ (year of manufacturing: 2012), ettringite deposition similar to the case of “Severely damaged” and

“Moderately damaged” case is noticed, however the sleeper does not show macroscopic cracks or damage. This indicates that the expansive reaction in these sleepers is in progress, but till now it is not large enough to cause macroscopic cracks. However there are high chances that in future these sleepers may become “Severely” or “Moderately” damaged.

Fig. 19 – Polished and Unpolished specimen: Sample G (Year of manufacture: 1992)

On the other hand, in case of relatively old “Undamaged” sleeper samples (Sample G, Fig. 19), the absence of ettringite indicates that expansive reaction has not taken place. However, some of the relatively newer sleeper samples (GB1, Fig. 20) have the similar microstructure as in the case of “Severely damaged” and “Moderately damaged” case, where ettringite deposition is commonly noticed. This indicates that an expansive reaction in these relatively newer

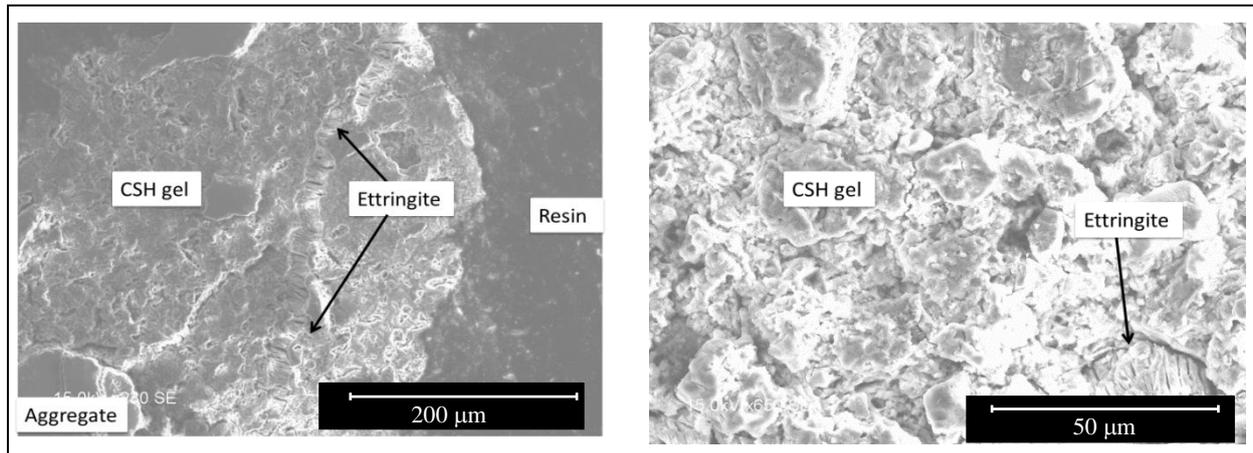
Fig. 20 – Polished specimen: Sample GB1 (Year of manufacture: 2012)

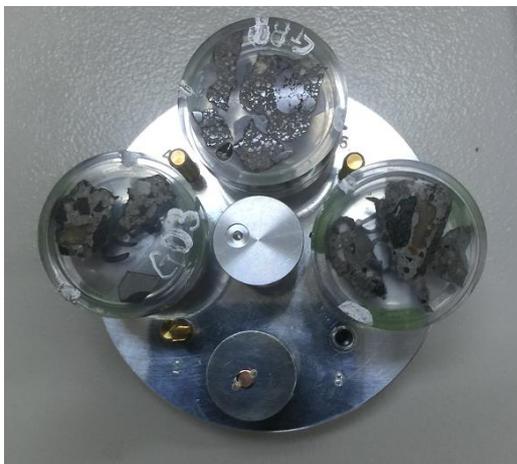
Fig. 21 – Typical specimen for EDS analysis

Samples for EDS analysis were prepared in similar fashion as in the case of SEM analysis. The preparation of samples for SEM has been discussed in section 3.3. Both polished and unpolished samples were tested for EDS. Figure 21 shows picture of typical polished sample used for EDS analysis.

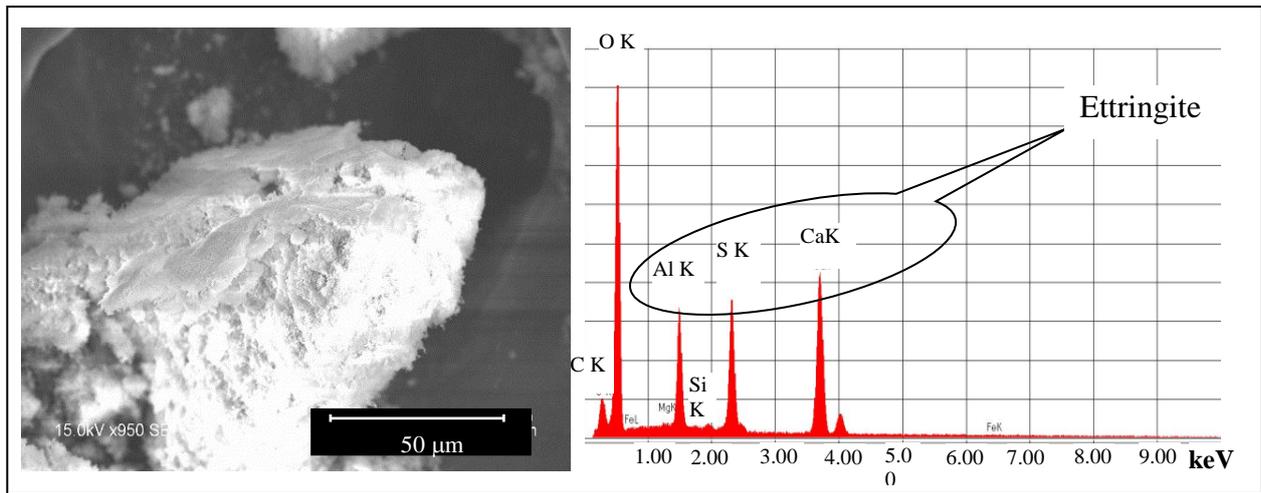
identify ettringite, first EDS pattern of synthesized ettringite was obtained and compared with EDS response of the spots in the sample. Figure 22 shows the standard synthesized ettringite and its EDS pattern.

Fig. 22 – Standard synthesised specimen of ettringite

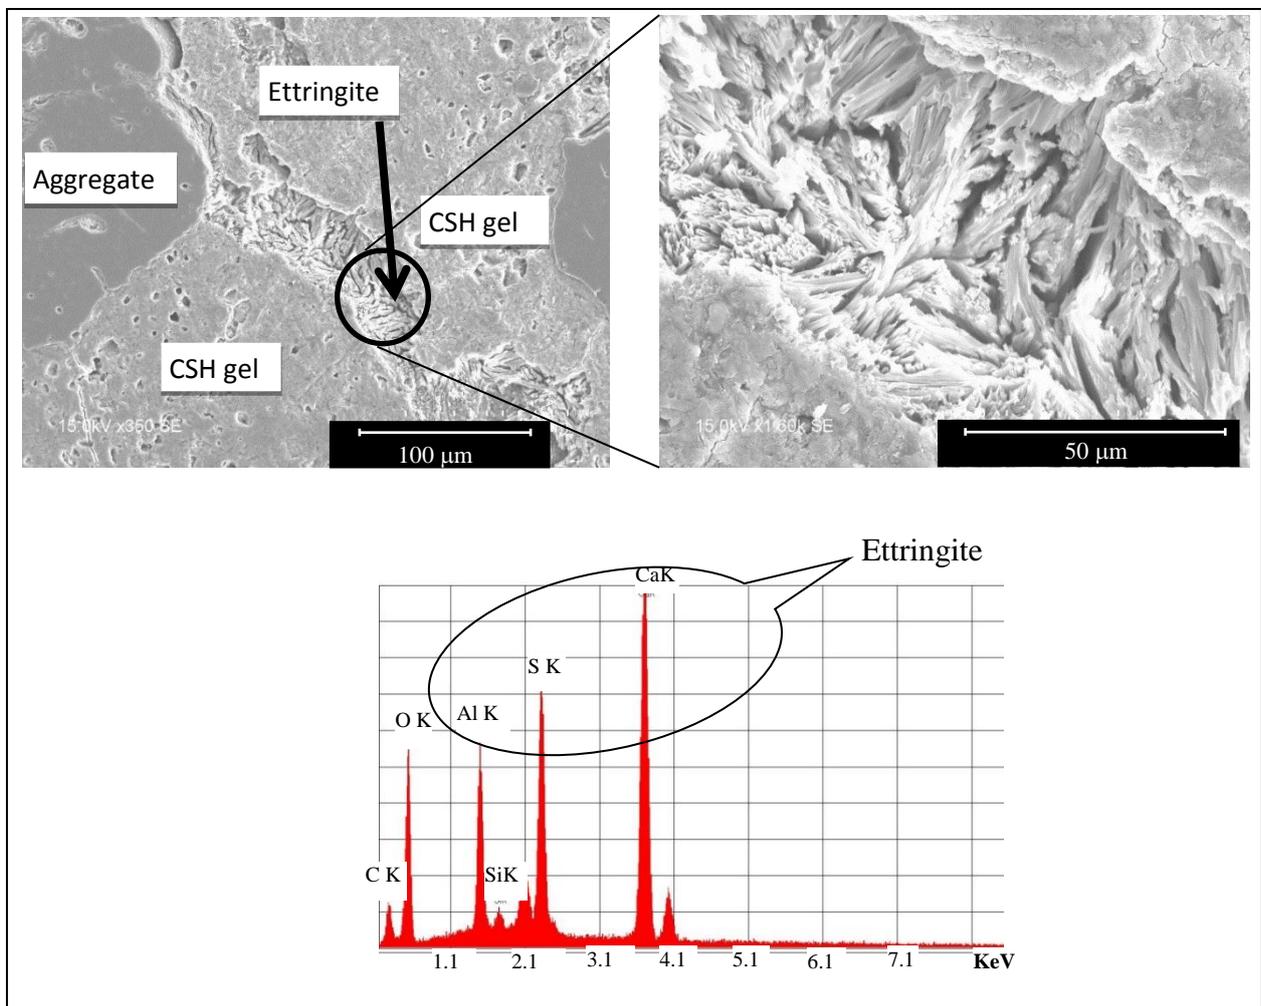
EDS patterns of ettringite obtained from different specimens of concrete sleepers (EDS pattern of one such typical specimen of sample 'D' is shown in Fig. 23) show that its intensity pattern matches with the standard synthesized specimen of ettringite (Fig. 22), which confirms that substance deposited in the cracks and in the interface between aggregate and paste is ettringite.

Fig. 23 – Polished specimen: Sample D

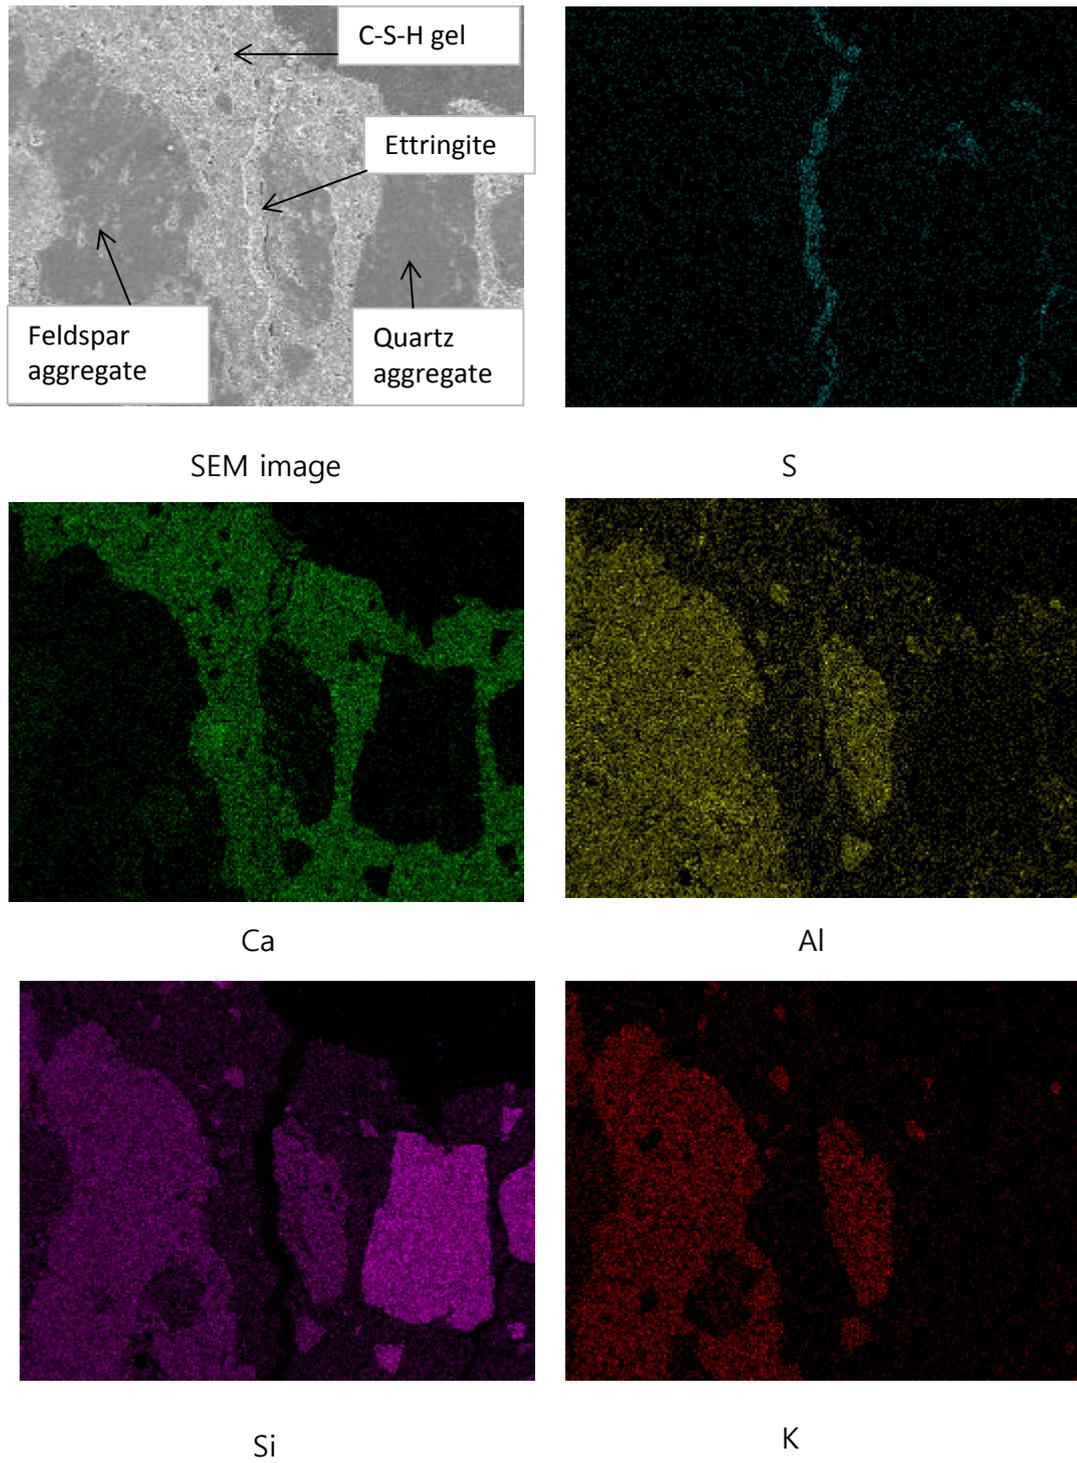
Fig. 24 – Characteristic X-ray map of sample D1

Characteristic X-ray maps of damaged sleeper sample D1 in Fig. 24 reveal that ettringite is deposited in the crack and around aggregate (peaks of Ca, Al, and S together can be seen at the location of cracks and around aggregates). Feldspar aggregate (containing peaks of K and Si) and quartz aggregate (No peak of K and only peaks of Si) are distinctly identified. Also, C-S-H gel containing peaks of Ca and Si is identified.

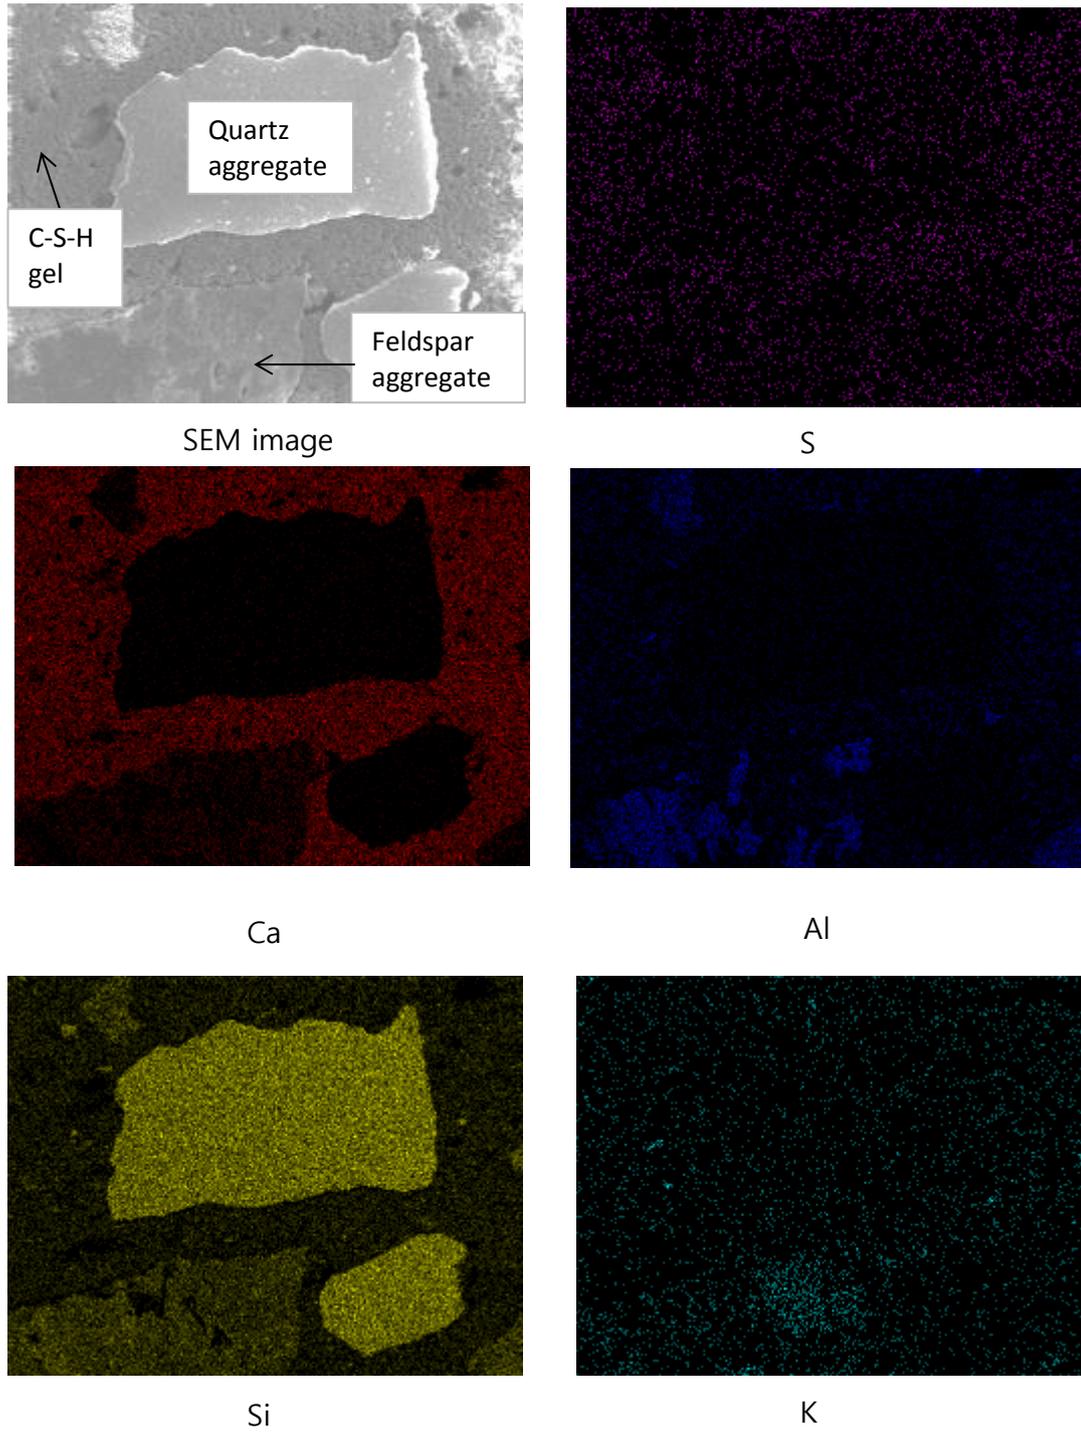
Fig. 25 – Characteristic X-ray map of sample GD3

Characteristic X-ray maps of undamaged sleeper sample GD3 in Fig. 25 reveal that no ettringite deposition is present in the matrix. Quartz aggregate, feldspar aggregate and C-S-H gel can be identified.
