## Technical Paper

# Visual investigation method and structural performance evaluation for DEF induced damaged Indian Railway PC sleepers

Rajamurugan Sundaram\*, Koji Matsumoto, Kohei Nagai and Anupam Awasthi

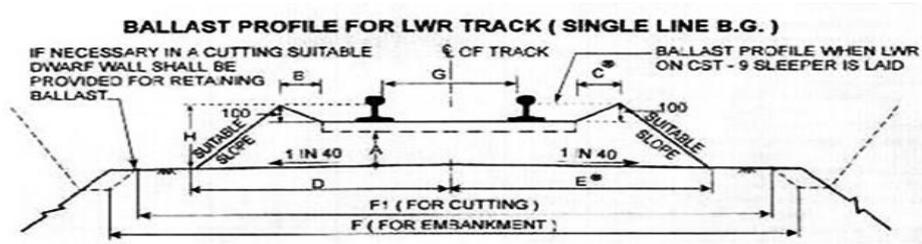
Fig. 2 – Ballast profile track slab

Sleepers are placed on ballasted track bed as shown in Fig. 2. This ballast track bed acts as an elastic bed and transfer the load coming from sleeper to wider area of formwork. This formation is earthen embankment and its not bonded to concrete structure.

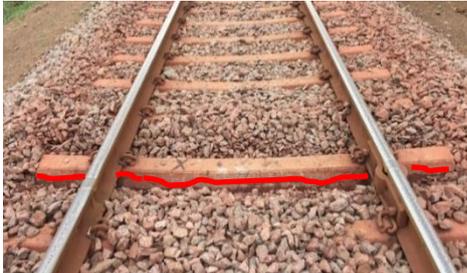
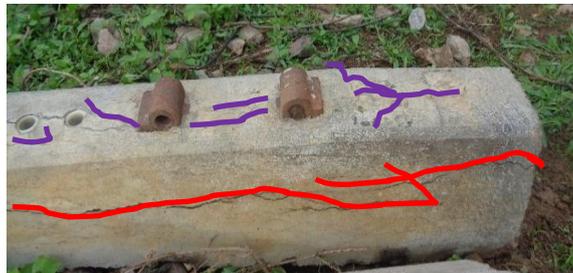
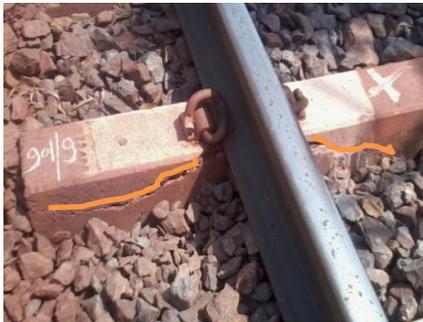
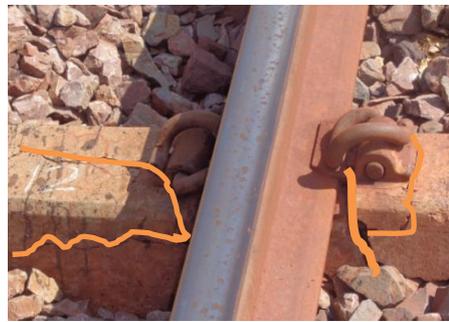
Fig. 3 – Crack sequences

(a) First Step (Cracks at side face) (b) Second Step (Cracks visible on top surface)

(c) Third Step (Cracks near insert location)

Description of these cracks with crack widths is shown in Table 1. Typical view of these crack patterns is shown in Fig. 11. Cracks typically occur around 6 to 9 years after their manufacture. The ballast profile and crack sequence are shown in Figs. 2 and 3, respectively. When sleepers are in service, i.e. installed condition on track, first cracks are usually seen on the side face of the sleeper. The side face is covered with ballast and cracks are visible only after opening the ballast. In later stages cracks are also seen on the top surface of the sleeper. Ultimately failure occurs near the inserts [1].

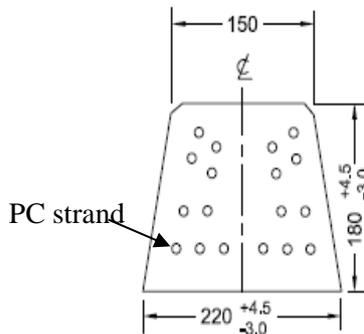
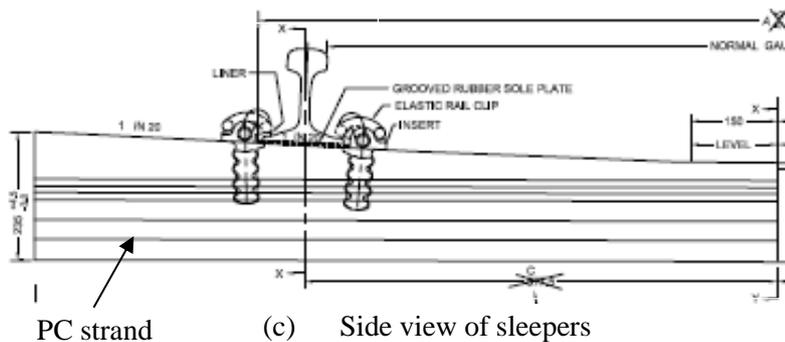
Fig. 4 – PS tendon profile

(a) Cross section of sleepers (unit: mm)

(b) 3 x 3mm wire strands

(c) Side view of sleepers

Indian Railways uses M55 grade sleepers for its tracks (See Table 2). 3 ply of 3 mm high tensile strength strands are used in sleepers (See Fig. 4). According to the specification, each reinforcing strand is to be tensioned with initial force of 27 kN. Typical tendon profile and cross section of sleepers are shown in Fig. 4.

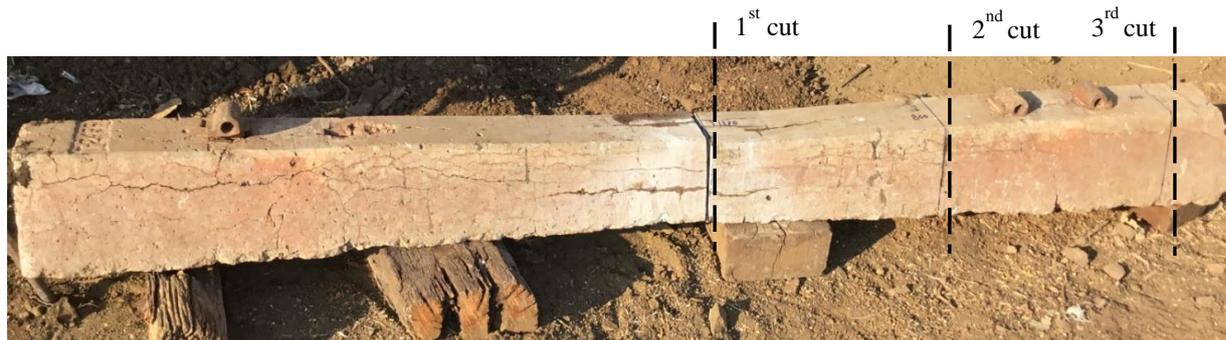
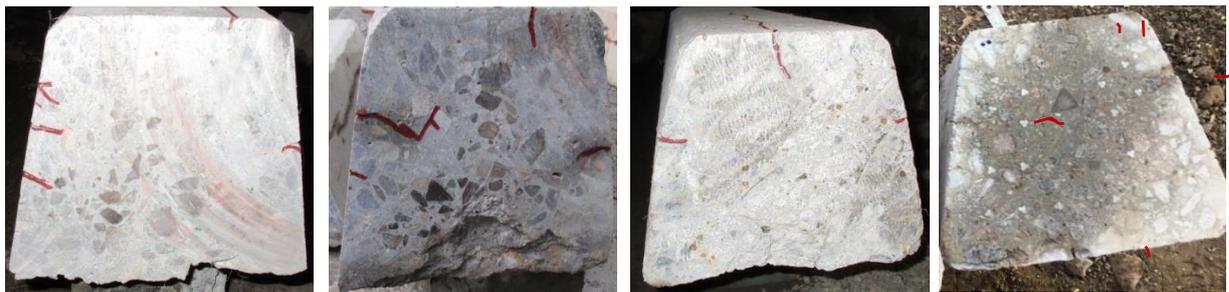
Fig. 6 – Cut cross section in sleepers

(a) Typical side view of Severe damaged sleeper

(b) Mild damage

(c) Moderate damage

(d) Severe damage

Sleepers were cut to find whether cracks have infiltrated inside the sleepers. Sleepers were collected from both damaged and undamaged sleepers (See Fig. 6), where manufacturing year of sleeper is also mentioned (See Table 4).

view of cross section cut is shown in Fig. 6(a), where three cuts were made on each sleeper. Critical cross sections based on the category with more cracks are shown in this Fig. 6. For both undamaged new and undamaged sleepers no cracks were observed inside the sleepers, crack infiltration up to 20 mm was only observed in the sleepers and cracks did not infiltrate fully inside the sleepers. It is observed from the study that DEF expansion occurs nonuniformly and only the inner portion is expanded, outer side is put in tension in the circumferential direction as we observed in the ring tension behavior, resulting in large cracks only in the outer side of the sleepers.

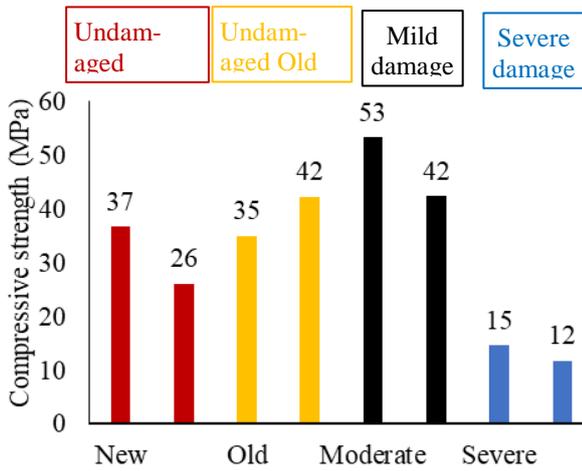
Fig. 8 – Compressive strength of core samples

and compressive strength of core samples were calculated. It was observed that average compressive strength for several damaged specimens was 13.2 MPa and whereas average compressive strength of 53 MPa was observed for Mild damaged core. Figure 8 shows the compressive strength results of the core samples. Static elastic modulus was calculated and the results are compared in Fig. 9. Minimum static elastic modulus of 5 GPa was recorded in the Severe

damaged core, whereas maximum static elastic modulus is recorded in undamaged old core of about 37 GPa (Fig. 8). Even though no visual cracks were observed in the cores, reduction in material strength up to 75% was observed in Severe damaged sleepers when compared to Mild damaged sleepers. It was

found from the study that outer crack is an indication to show the capacity reduction in sleepers, but this is not the main reason for capacity reduction in cores. Main reason is concrete is affected in material level due to expansion in concrete due to DEF and ASR.

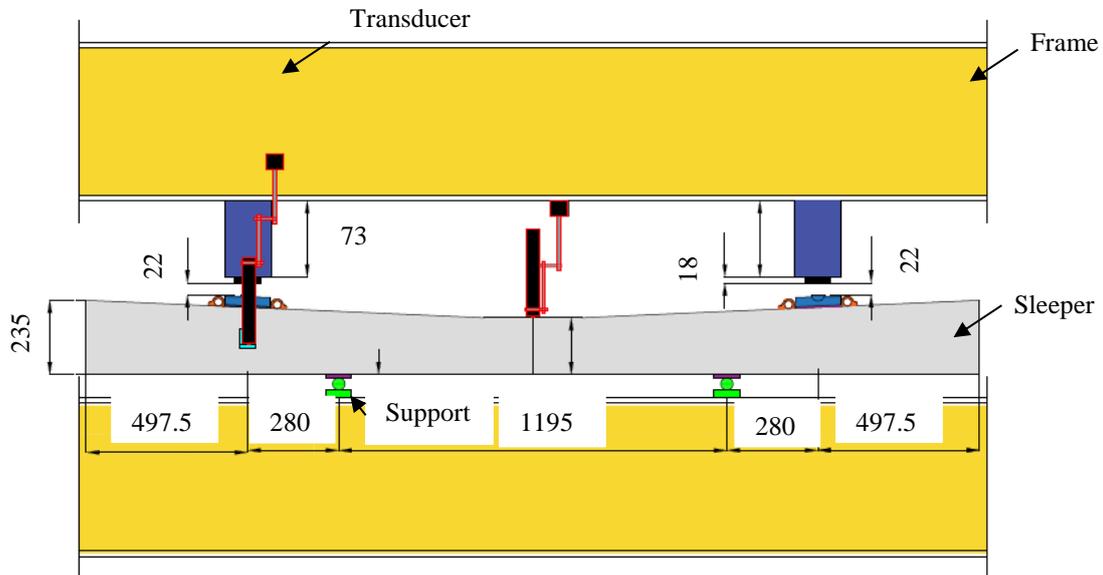
Fig. 10 – Schematic view of flexural test arrangement (Dimensions in mm)

of damage (See Table 7). Flexure test was conducted to find out the flexural capacity of the sleepers (See Fig. 10). Transducers were fixed at the loading points and at the center part of the sleeper to find midspan deflection. Sleepers were loaded in flexure and allowed to be loaded until the failure is observed from the sleeper [1].

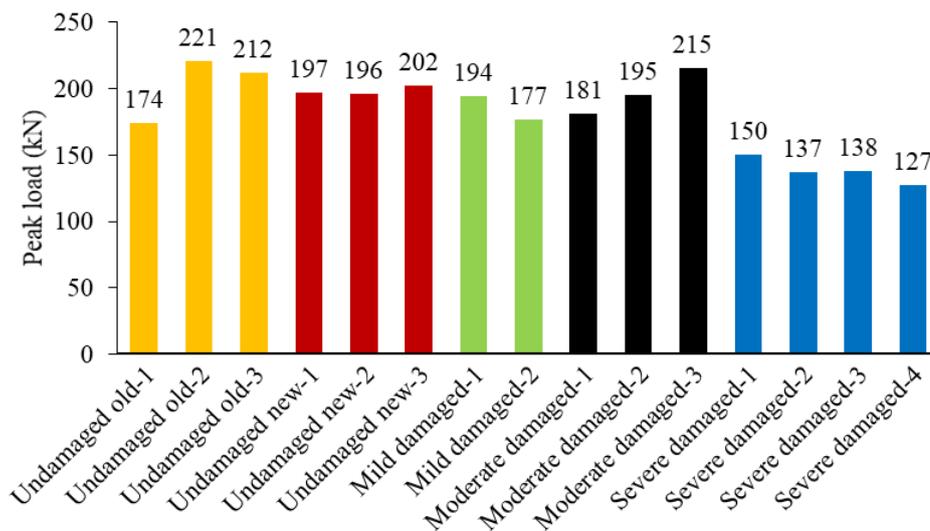
Fig. 12 – Result of flexural test

From the flexure test results, peak loads were obtained for all categories of sleepers (See Fig. 12). It is clearly seen that not only peak load but also stiffness is significantly reduced in the case of severe damaged sleepers. One of the typical views of sleeper after the failure is shown in Fig. 13. Mode of failure is supposed to be flexural compression failure which occurs before yielding of PC strands.

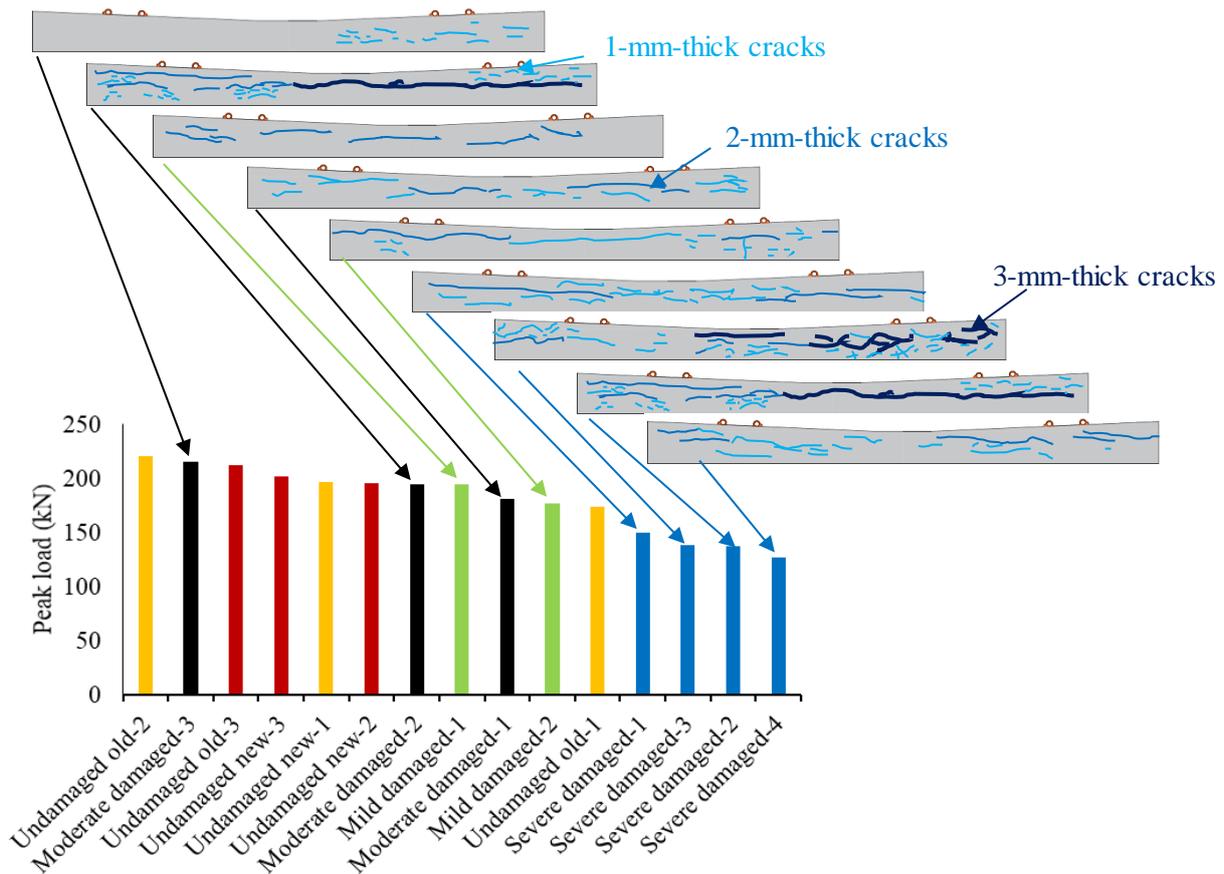
Fig. 14 – Side view – comparison of capacity in damaged sleeper

From the flexural test results, it shows that Severe damaged sleepers show capacity reduction (See Fig. 14). Average peak load of Severe damaged sleeper is 56% capacity reduction. Average peak load of Moderate damaged sleeper is same as Undamaged old sleepers, but in one of the cases Moderate damaged sleeper shows 8% capacity reduction. Average peak load of Mild damaged sleeper is 7% less than Undamaged old sleepers, but in the cases Mild damaged sleeper shows 12% capacity reduction. By comparing the results of both Undamaged old and new sleepers less than 2% difference was observed. If 2 to 3 layers of longitudinal cracks were observed in the central part of sleeper these cracks reduce the capacity of the sleeper.

Minimum peak load as per Indian standards for flexural test is 60 kN. Even though severe damaged sleeper showed reduction in peak load, still the minimum peak load observed in these sleepers was 127 kN. Therefore, sleepers are safe in flexure. The evaluation method in which damage level is classified are appropriate. The evaluation method in which damage level is classified are appropriate, where damage sleepers show lesser capacity compared to undamaged sleepers.

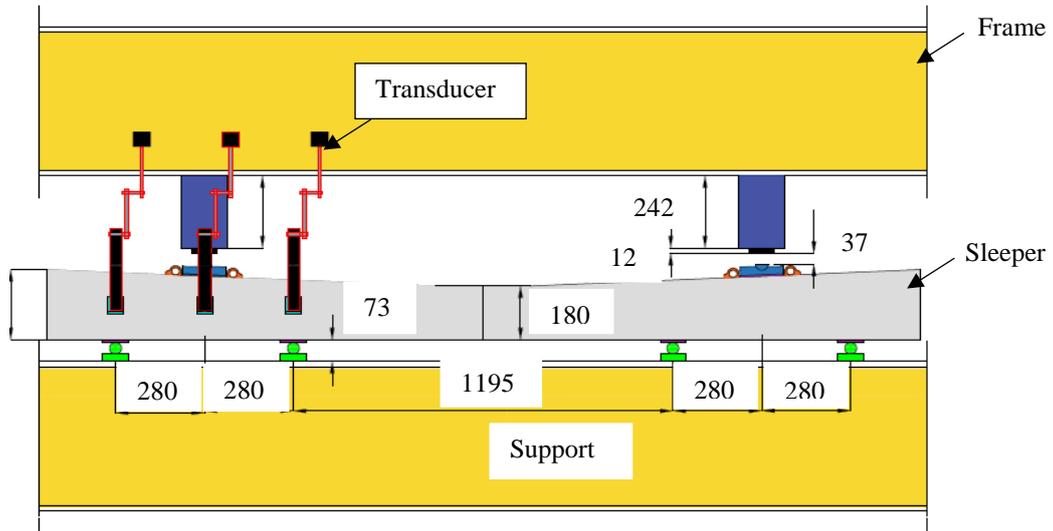
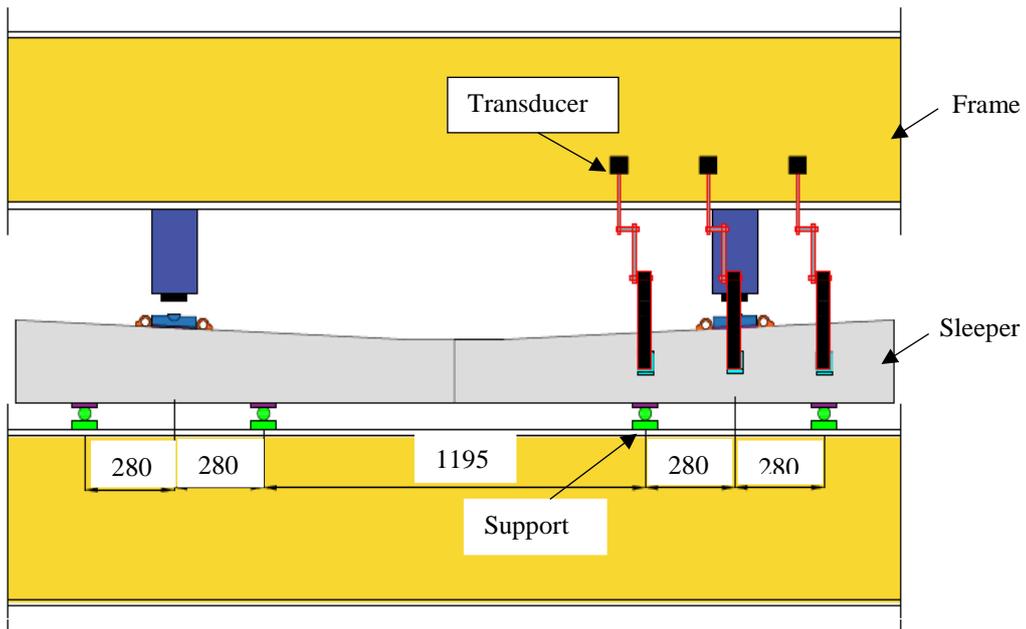
Fig. 15 – Schematic shear test arrangement

a) Typical shear test arrangement on one side

b) Typical shear test arrangement on the other side

Shear test was also conducted for sleepers. Illustrated view of shear test arrangement is shown in Fig. 15. Transducers were fixed near the loading points and at the central part of the sleeper to find midspan deflection. Shear test was conducted on one side first and after completion the test was repeated over the other side on the same sleeper. Sleepers were categorized into “Undamaged new” and “Severe damage” (See Table 8). Typical view of these categories of sleepers is shown in Fig. 16.

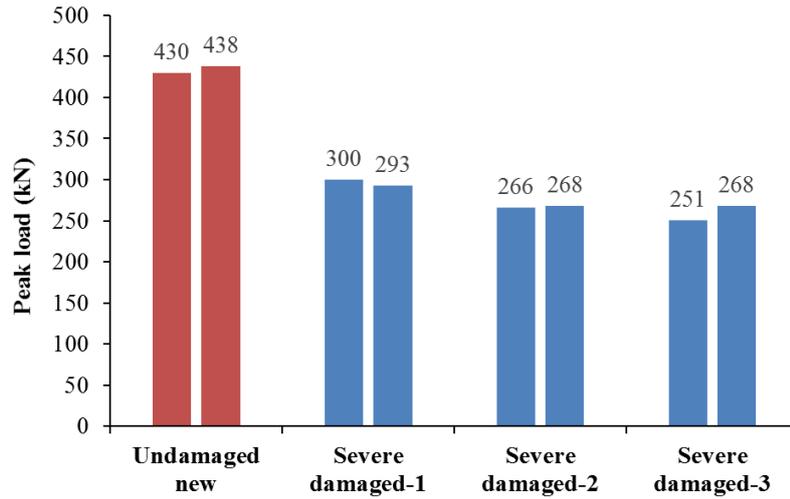
Fig. 17 – Result of shear test

From the shear test results, peak loads were obtained from Undamaged new and Severe damaged sleeper (See Fig. 17). View of the sleeper after failure is shown in Fig. 18. Shear capacity and member stiffness in severe damaged sleepers significantly reduced as observed in the flexure tests.

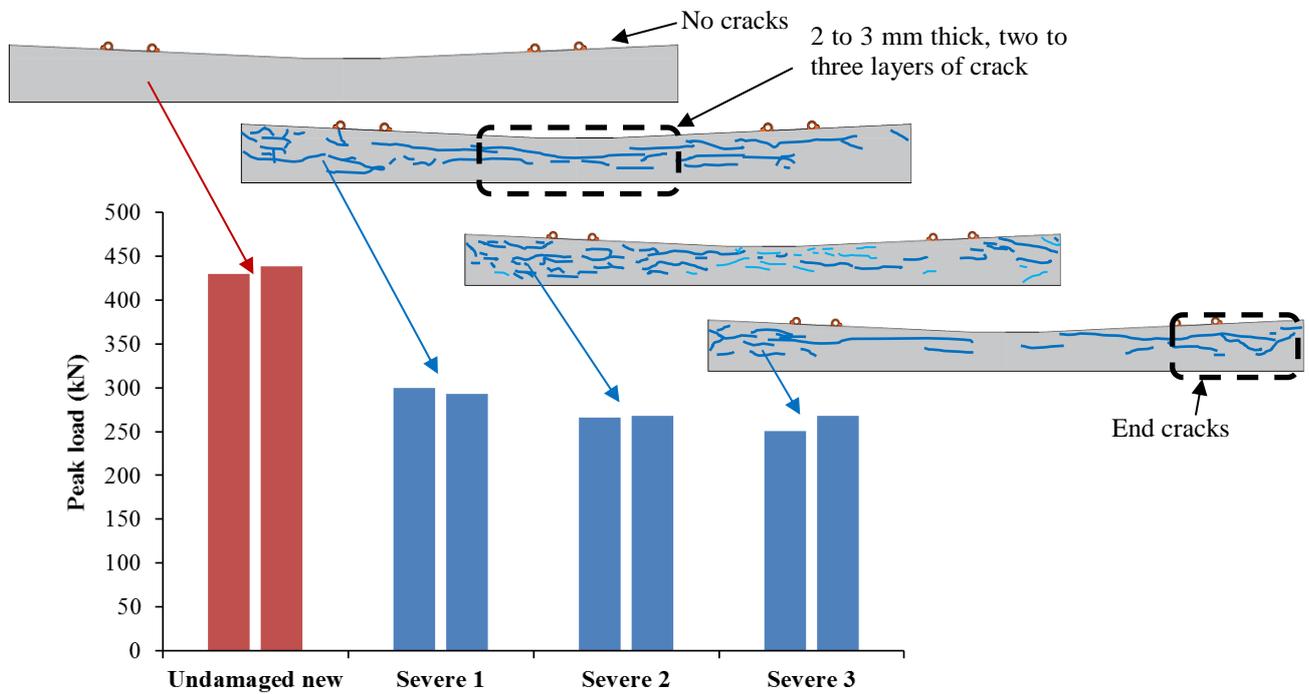
Fig. 19 – Existing crack patterns and shear test results

Figure 19 shows the existing crack patterns available in sleepers. Average peak load of Severe damaged sleeper is 36% less than the Undamaged old sleeper, but in one of the cases Severe damaged sleeper shows 42% capacity reduction. Minimum requirement for the peak load as per Indian standards is 230 kN. In one of the cases peak load is 250 kN and this is close to the minimum requirement for the peak load. Cracks were observed in severe damage sleeper, where more layers of end cracks and more layers of longitudinal cracks were observed in damaged sleepers. It indicates that shear capacities are also correlated.

- (4) Loading tests of PC sleepers were conducted. As a result, both flexural and shear capacities were significantly decreased in the cases of “severe damage”. Especially, shear capacities of the “severe damage” cases closed to the minimum requirement level of Indian Railways, indicating that replacement of those sleepers is an urgent issue. In addition, it was confirmed that there is a good correlation between the structural performances and damage levels, indicating that the evaluation method for damage level proposed in this study is appropriate to determine the priority for the replacement.
