Technical Paper

Diagnosis of alkali aggregate reaction in concrete dams: an Indian case study

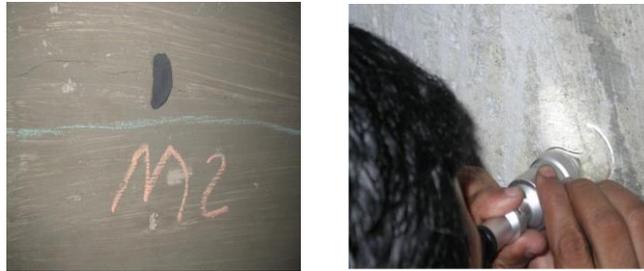
Fig. 1 – Crack measurement on upstream and downstream side of upper gallery-3

Diagnosing AAR in this study included steps starting with the inspection of the structure. Based on the inspection and the available data, coring locations were defined and the samples taken were analyzed with different methods, starting with a visual assessment and finally extending to the residual expansion potential of concrete cores samples. The study on alkali silica reaction (ASR) is presented in this paper, in order to facilitate its identification and diagnosis in dams. Microscopy is emphasized as the major tool, as it makes possible to reliably identify even weakly developed ASR. In case of arch dam under investigation, the cracks were noticed in Gallery-3 on both upstream and downstream faces. These cracks were dispersed mainly in horizontal direction as shown in Figure 1. The width of cracks inside Gallery-3 on downstream face near rock and dam joint i.e. near abutment was more as compared to middle portion of Gallery-3. The crack width near abutment was around 0.45 mm and near central part of Gallery-3 was around 0.25 mm. The width of cracks in case of upstream part inside Gallery-3 was around 0.2 mm and was visible only in few portions.

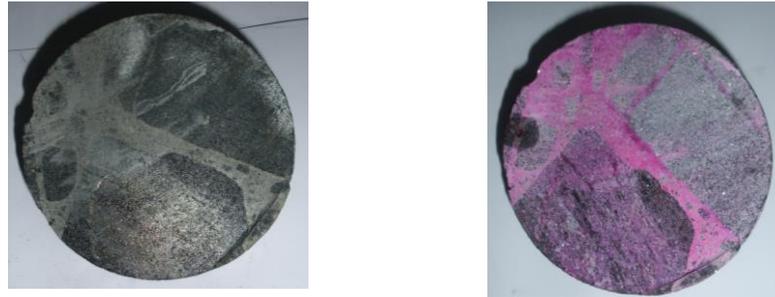
The detection of Alkali Silica Reaction swelling in concrete by staining method (color test) was done based on method proposed by GD Guthrie et.al [13]. The study included the sequential application of solutions of each of two water soluble compounds. Concentrated solutions of sodium cobaltinitrite and rhodamine B in water are prepared. The concrete surface to be examined was treated by pre-rinsing with water and subsequently applying each solution to the surface. After 30-60 seconds, the concrete was rinsed thoroughly with water. The treated surface will show yellow and pink regions where ASR gel is present, yellow regions indicate the presence of K-rich, Na-K-Ca-Si gels. While pink regions indicate alkali-poor gels. The final rinse step was required, since the yellow sodium cobaltinitrite solution will coat the entire concrete surface as will the pink rhodamine B solution, thereby obscuring the stained gel regions. Best results were obtained when the sample is treated first with the sodium cobaltinitrite solution; however, the application of the rhodamine B solution first gave adequate results (Fig. 4).

The slices of core samples were rinsed with water and rinsed surfaces were searched for regions of yellow staining and regions of pink staining whereby K-rich i.e. Na-K-Ca-Si gels generated from ASR were identified by yellow staining and alkali poor, Ca-Si generated from ASR were identified by pink staining. The test results indicated light to dark pinkish color in all cases indicating presence of ASR.

Fig. 4 – Color test method for identifying concrete gels form by ASR
