Assessment of a fire damaged reinforced concrete building

Abstract: A proper condition assessment of reinforced concrete structure after a fire event involves field and laboratory work to determine the extent of fire in order to design an appropriate and cost effective repair scheme. The present paper presents a case study where an attempt has been made to carry out a condition assessment of a fire damaged building in a systematic manner. The approach adopted broadly consisted of questioning of on-site personnel, a detailed visual survey, on-site non-destructive / partially-destructive tests, collection of in-situ samples from site along with some laboratory based investigations on samples collected from site. Differential Thermal Analysis (DTA), X-Ray Diffraction (XRD) Analysis and Scanning Electron Microscopy (SEM) Imaging were conducted for microstructural characterization and analysis of concrete to correlate, corroborate and validate the results obtained through on-site assessment. Since the building was an old structure, carbonation depth in structural members was also evaluated. Finally, based on the visual inspections indicating the condition of surface and structural elem

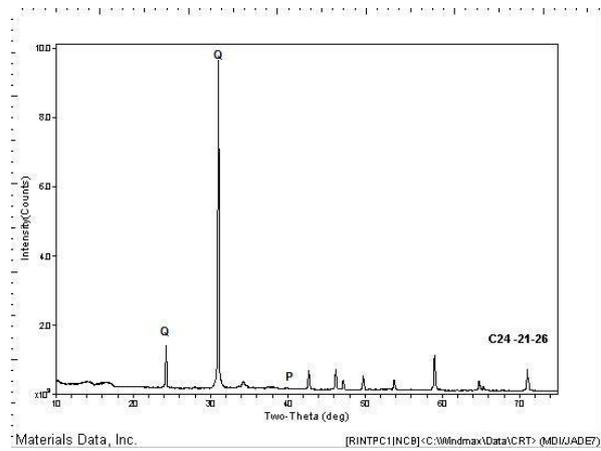
Fig 28 – XRD images of samples from C24 (2nd floor column) from depth range of 21-26 mm depth
