Assessment of a fire damaged reinforced concrete building

Abstract: A proper condition assessment of reinforced concrete structure after a fire event involves field and laboratory work to determine the extent of fire in order to design an appropriate and cost effective repair scheme. The present paper presents a case study where an attempt has been made to carry out a condition assessment of a fire damaged building in a systematic manner. The approach adopted broadly consisted of questioning of on-site personnel, a detailed visual survey, on-site non-destructive / partially-destructive tests, collection of in-situ samples from site along with some laboratory based investigations on samples collected from site. Differential Thermal Analysis (DTA), X-Ray Diffraction (XRD) Analysis and Scanning Electron Microscopy (SEM) Imaging were conducted for microstructural characterization and analysis of concrete to correlate, corroborate and validate the results obtained through on-site assessment. Since the building was an old structure, carbonation depth in structural members was also evaluated. Finally, based on the visual inspections indicating the condition of surface and structural elem

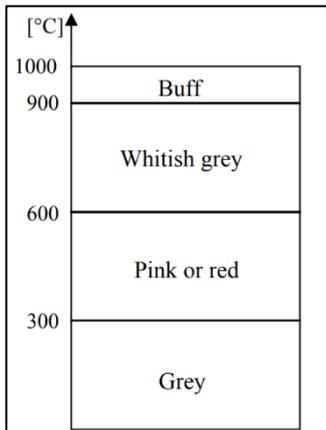
When concrete gets heated to elevated temperatures, a gradual change in colour of the concrete occurs depending on the temperature range it is exposed to. Fib Bulletin 46 (July 2008) [16] gives guidance regarding the probable colour change in concrete depending on the exposure to elevated temperatures (Fig. 10). Change in colour of concrete to pink

Fig.10 – Colour changes in heated concrete (fib 2008)

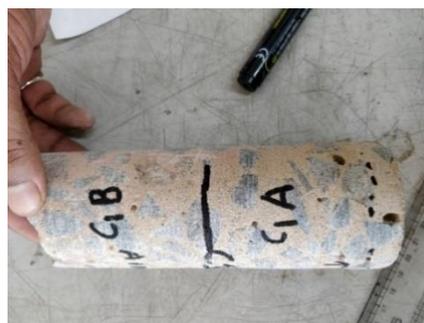
of the core. Higher strength of outer part at some locations may be on account of formation of calcium carbonate due to carbonation of concrete and in some measure due to densification at microscopic level as a result melting of certain components which then subsequently fill the pores. Strength of the cores extracted from the vicinity of the room where fire was first detected is found to be relatively lower compared to other locations. However, it cannot be conclusively said that this reduced strength is due the effect of fire as no significant reduction in strength of outer part of core as compared to the inner part is seen.

Fig.14 – Demarcation of concrete core into two parts (A & B) for separate testing of outer and inner part

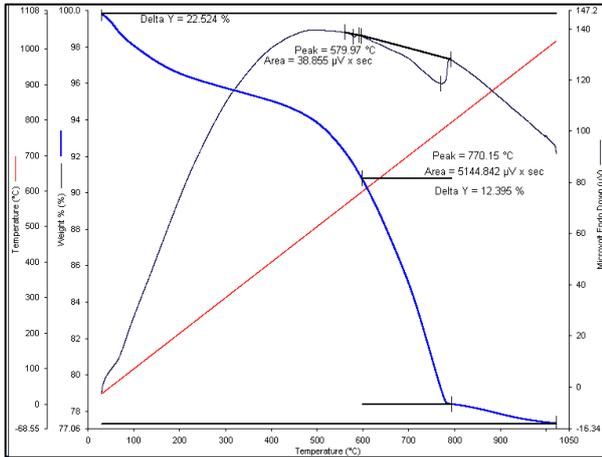
Fig. 15 – DTA curve for 3rd floor corridor column (unaffected by fire) at 0-5 mm depth wherein peak due to decomposition of $\text{Ca}(\text{OH})_2$ is absent – due to carbonation

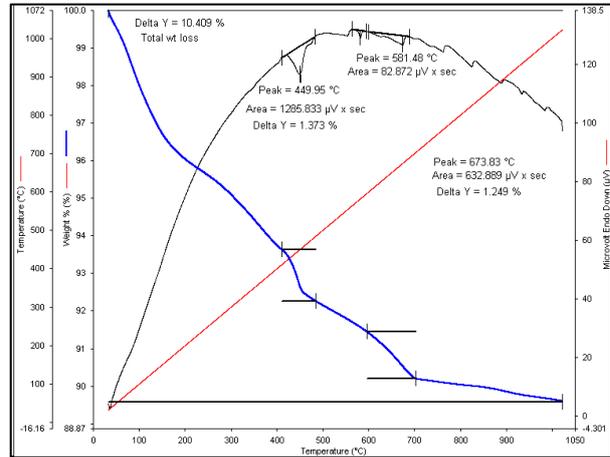
Fig.16 – DTA curve for 3rd floor corridor column (unaffected by fire) at 7-12 mm depth wherein peak due to decomposition of $\text{Ca}(\text{OH})_2$ is present

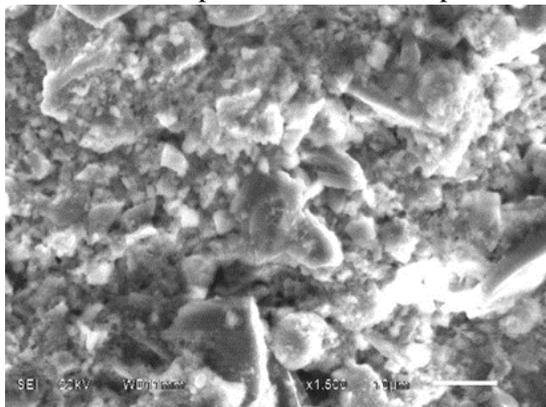
Fig.19 – SEM images of samples from 3rd floor column, from in depth range of 0-5 mm. Hexagonal morphology is absent. Microstructure found to be relatively less densified and porous

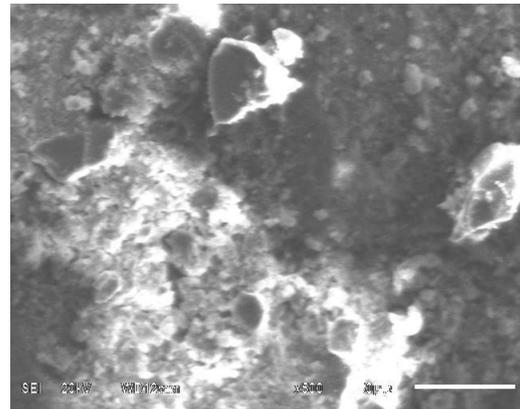
Fig.20 – SEM images of samples from 3rd floor column, from in depth range of 7-12 mm Hexagonal morphology is absent. Microstructure found to be relatively less densified and porous

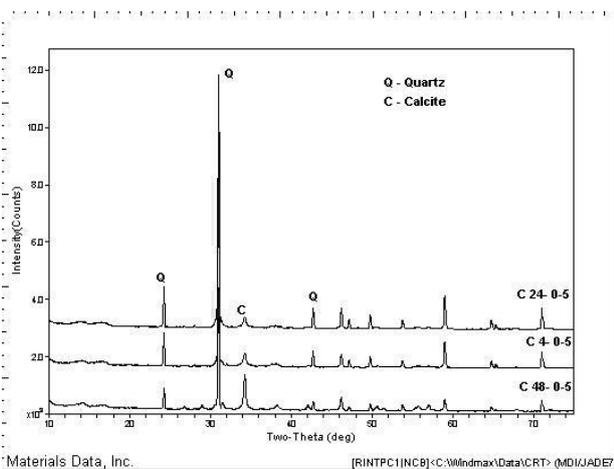
In the present study, slices at varying depths from the extracted concrete cores were obtained by sawing. The mortar/paste portion was then ground to powder form and the evaluation of powdered samples was carried out using XRD technique. In all the samples across various depths, quartz is found to be in predominant abundance. This is due to presence of fine aggregate of the mortar portion which is difficult to separate. In samples of 0-5 mm depth (Fig. 23), portlandite is found to be absent in samples taken from C48 (3rd Floor column), C24 (2nd floor column) and C4 (5th floor column). In samples taken from 7-12 mm depth (Fig. 24), peaks in the XRD pat-

Fig. 23 – XRD images of samples from C48 (3rd floor column), C24 (2nd floor column) and C4 (5th floor column) from in depth range of 0-5 mm

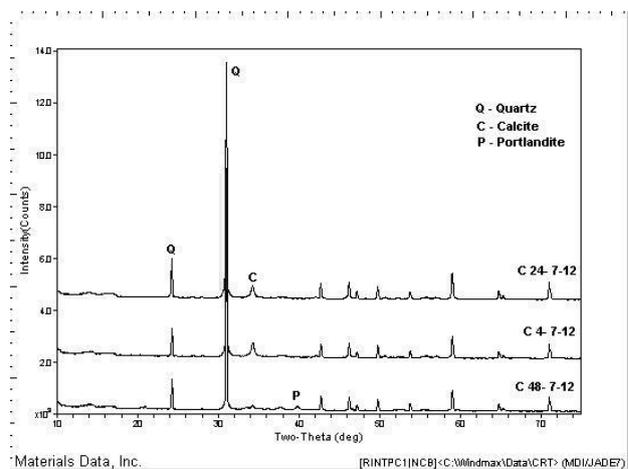
tern corresponding to portlandite in minor abundance are seen in sample of C48 where in samples of C24 and C4, they are absent. In samples taken from 14-19 mm depth (Fig. 25), calcite (CaCO₃) is found to be in relatively major abundance in sample taken from C24 whereas peak corresponding to portlandite is absent. On the other hand, peaks indicating portlandite in minor abundance are seen XRD pattern of C48 & C4 in this depth. In 21-26 mm depth (Fig. 26), peaks indicating portlandite in minor abundance are seen in samples taken from C48, C4 as well as C24. It is seen that the results of XRD analysis are in accordance with the results of DTA and SEM.

Fig.24 – XRD images of samples from C48 (3rd floor column), C24 (2nd floor column) and C4 (5th floor column) from in depth range of 7-12 mm

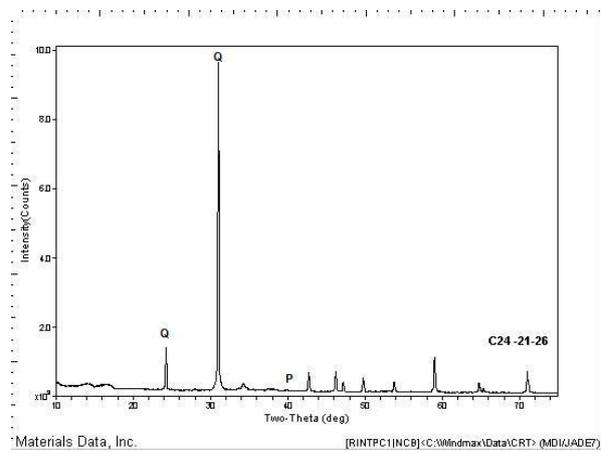
Fig 28 – XRD images of samples from C24 (2nd floor column) from depth range of 21-26 mm depth

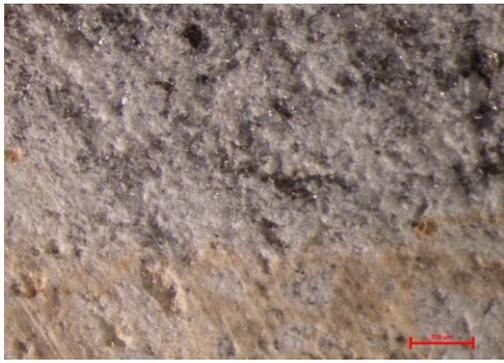
The OM micrographs of the undamaged concrete sample due to fire taken from 3rd floor column (Fig. 29) have indicated the presence of closed voids with deposited hydrated products with relatively smooth margins and compactness of mortar and aggregate. The OM micrographs of the samples taken from fire damaged floors on the other hand have indicated presence of greater number microcracks (Fig. 30) and formation of micro cracks in cement mortar

Fig. 27 – Third floor column with Compactness of mortar with aggregate (30X)
