Technical Paper

Effect of initial curing conditions on air permeability and de-icing salt scaling resistance of surface concrete

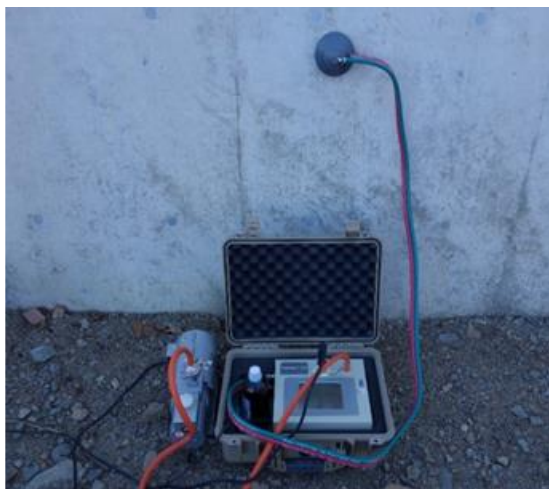
(a) Surface air permeability test

Fig. 2 – Test set-up for the freeze-de-icing salt test and Torrent method

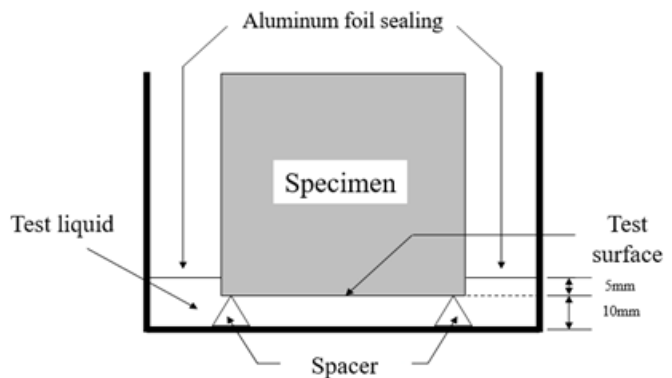
(b) Specimen of de-icing salt scaling test

Specimens with dimensions of 150×150×150 mm were cut from a prism specimen that came from measuring surface air permeability, then the de-icing salt scaling resistance test was conducted in accordance to JSCE-K 572(6.10)(see Fig. 2(b)). The testing surface of a specimen was the side surface perpendicular to the casting direction. The specimens were sealed on their surface except for the testing surface, and after the capillary suction period, they are kept for seven days at a temperature of 20 ± 2°C with 3% Na Cl solution. Then, the specimens were exposed to freezing-thawing conditions (Temperature: 20 ⇔ -20°C, two cycles a day) [14,15]. The scaling amount of a specimen was measured every 6 cycles up to 60 cycles.

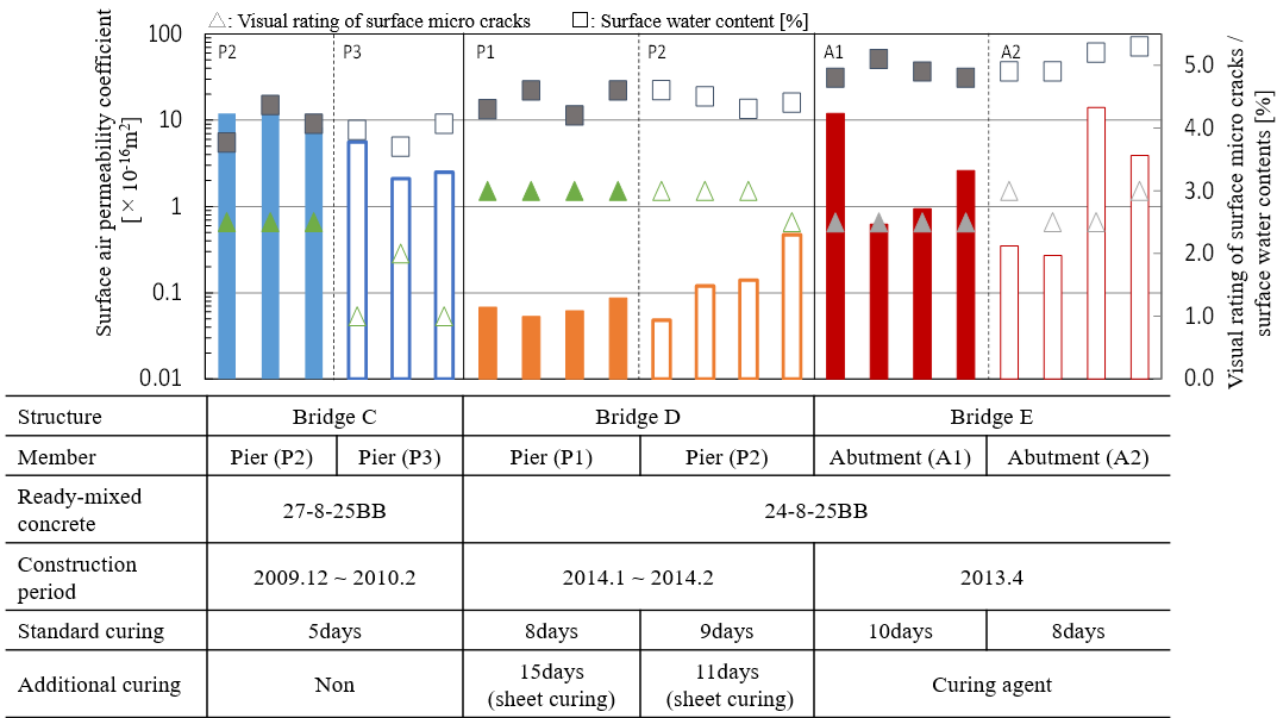
Fig. 3 – Effect of the additional curing on the surface air permeability of existing structure

The results of the surface air permeability coefficient, the surface water contents and the visual rating of surface micro cracks are shown in Fig. 3. Different methods of the additional curing after demolding were utilized. Bridge C is the case of a non-additional curing, Bridge D is the case of a heat-and-moisture retention curing via polyethylene sheet after demolding and Bridge E is the case of using the

curing-agent (low drying shrinkage type) after demolding. Testing the air permeability coefficient requires the water contents of a concrete surface to be at a lower level [12,13]. From this figure, the water contents of all of the measurements are under 5.5%.

From these results, it is observed that the surface air permeability coefficient of Bridge D is lower than Bridge C and Bridge E. The surface air permeability of Bridge C indicated the range from 2.9~14×10⁻¹⁶m² and Bridge E has a range from 0.3~1.2×10⁻¹⁶m². The results are little different between Bridge C and Bridge E, although additional curing has not been conducted on Bridge C. On the other hand, the coefficient of surface air permeability of Bridge D indicated almost 0.1×10⁻¹⁶m². The reason of this is considered that it is due to the effect of heat and moisture-retention by being sealed immediately after demolding with polyethylene sheet, and is due to the result of the improved surface quality of concrete by its positive effect. In addition, compared with the result of the case of another curing method, Bridge E has some fluctuation range of data in the same structural member. It may be due to non-uniform spray of the curing-agent on the surface of concrete.

Moreover, the results of visual rating of surface micro cracks are also shown in Fig. 3. It is showed that the visual rating of Bridge C and Bridge E have larger fluctuations in the same structural member. However, the visual rating and the surface

air permeability coefficient of Bridge D are relatively stable. Thus, the entirety of the concrete structures can obtain better quality via the sheet curing method.

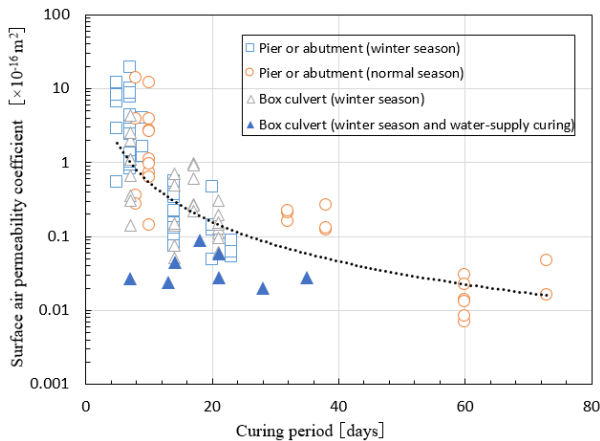
Fig. 4 – The relationship between the surface air permeability coefficient and curing period

Fig. 4 indicates the relationship between the surface air permeability and the entire curing period (including an additional curing period). This figure includes all data from the survey, which includes the results of the survey other than the structures described above, together (see Table 1). The data shown in this figure are (a) Cement type: Blast furnace slag cement (type B), (b) W/C: 50-55%, and (c) Mold types: ordinary mold (wooden type), and the additional curing methods are a case of sealed curing (extension of a demolded period, or using a water-retention sheet).

From this result, it was found that the surface air permeability decreased with the extension of the

curing period which included an additional curing period. Especially, in the case of a curing period less than 10 days, the surface air coefficient change in a range from 0.024×10^{-16} to $19 \times 10^{-16} \text{m}^2$. A trend was recognized that has a large variation. It was considered that the reason was the density of surface concrete was decreased because the cement hydration stopped, and during drying of the concrete surface after demolding, some micro cracks appeared. In the case that the curing period was longer than 14 days, the surface air coefficient change was in the range from 0.007×10^{-16} to $1 \times 10^{-16} \text{m}^2$. A trend was recognized that has less variation, and the coefficient varied within a certain range. Moreover, it was observed that the method of water-supply curing could improve the air permeability of concrete better than others in winter.

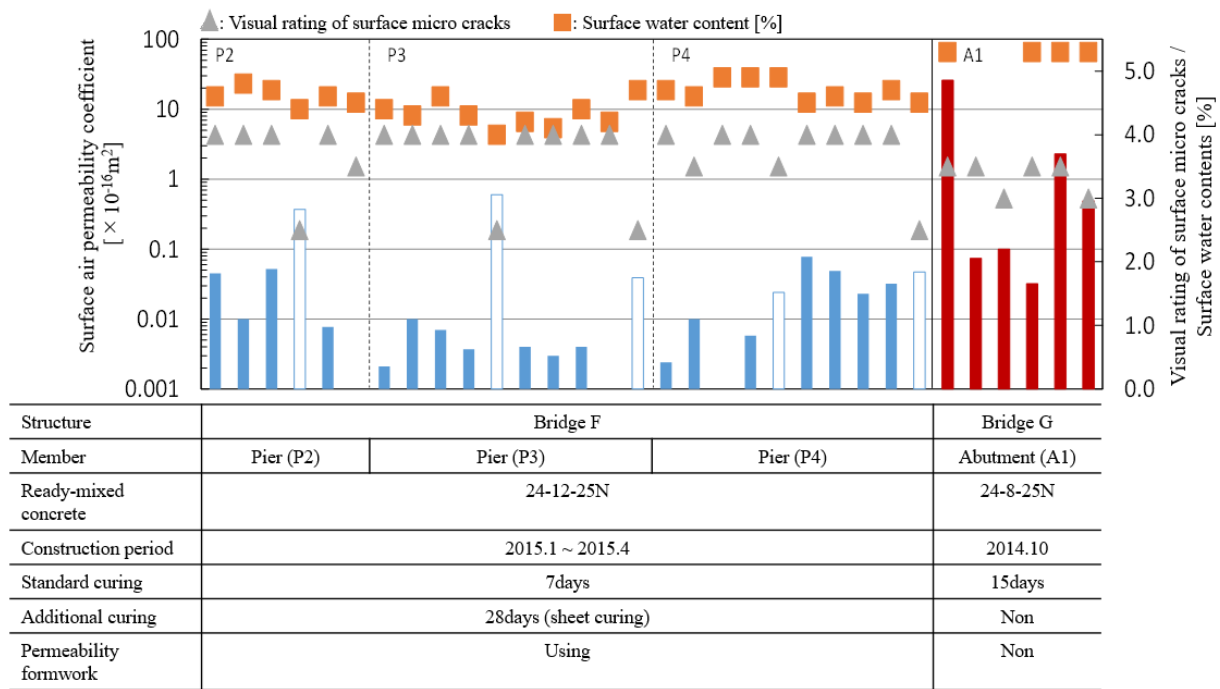
Fig. 5 – Effect of the permeability formwork on the surface air permeability of structure

- Large amount of bleeding water occurred during construction.
- It was not only using a permeability formwork but also conducting a sealed curing with a water-retention sheet for about 1 month.

A comparison of results between Bridge G and Bridge F revealed that the surface air permeability coefficient of Bridge F (about 0.1 to $0.01 \times 10^{-16} \text{m}^2$) was lower than Bridge G (about 0.1 to $10 \times 10^{-16} \text{m}^2$). Therefore, the effectiveness of utilizing permeability formwork was confirmed and indicated. Then, comparing the coefficient of different measuring positions, it can be seen that the surface air permeability

coefficient in the straight position (blue bar less than $0.1 \times 10^{-16} \text{m}^2$) is lower than the curved position (white bar more than $0.1 \times 10^{-16} \text{m}^2$) on Bridge F. In addition, there were also some straight positions that showed a remarkable low coefficient (less than $0.001 \times 10^{-16} \text{m}^2$). This reason may be considered that is the influence of the excessive bleeding amount that was gathered the near surface of concrete in a curved position of the pier and lead to an increase in water to cement ratio.

Moreover, in the case of Bridge F, the results of visual rating of surface micro cracks were indicated that the visual rating increases with the decrease of the surface air permeability coefficient.

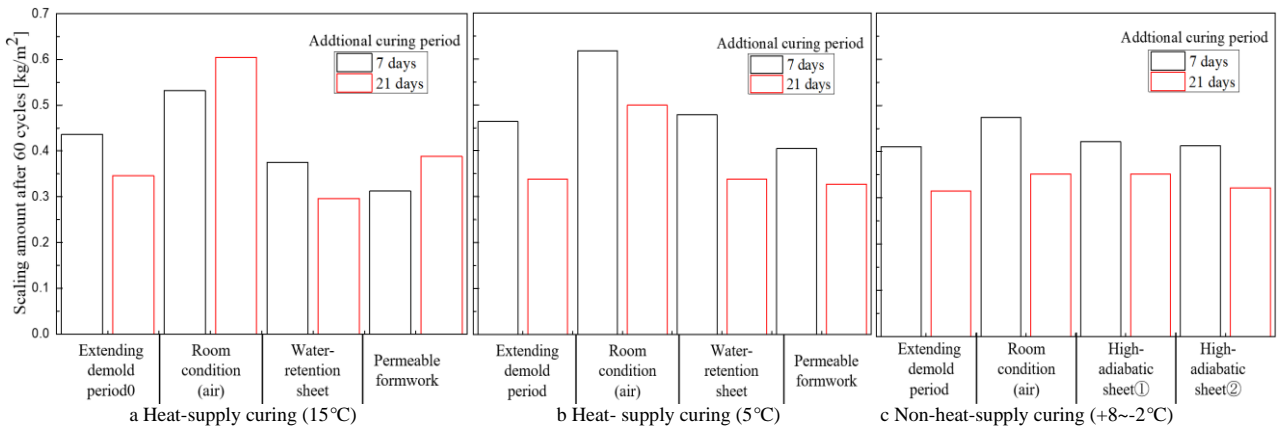
Fig. 6 – The scaling amount after 60 cycles of freezing-thawing action

Fig. 6 presents the scaling amount after 60 cycles of freezing-thawing action. From these figures, for the specimen assuming heat-supply curing (15 °C and 5 °C), it was found that the scaling amount of specimen conducting air curing indicated the trend that large scaling amount occurred compared with that of specimens under other curing conditions. On the other hand, in the case of keeping the mold setting, using a permeability formwork or using a water-retention sheet, it was confirmed that the scaling amount was reduced. The influence of additional curing period revealed that the scaling amount was decreased with the increase of an additional curing period, except in some cases. For the case of no-heat-supply curing (+8~-2°C), the influence of the additional curing method on scaling amount was less, and it was found that the scaling amount was decreased with the increase of the additional curing period regardless of the difference in an additional curing method. Therefore, it was considered that the heat-retaining curing was enough to ensure the surface quality and the de-icing salt scaling resistance of concrete. It was not necessary to conduct heat-supply curing in cold weather concreting when the outside temperature was above -2°C, as the test result showed.

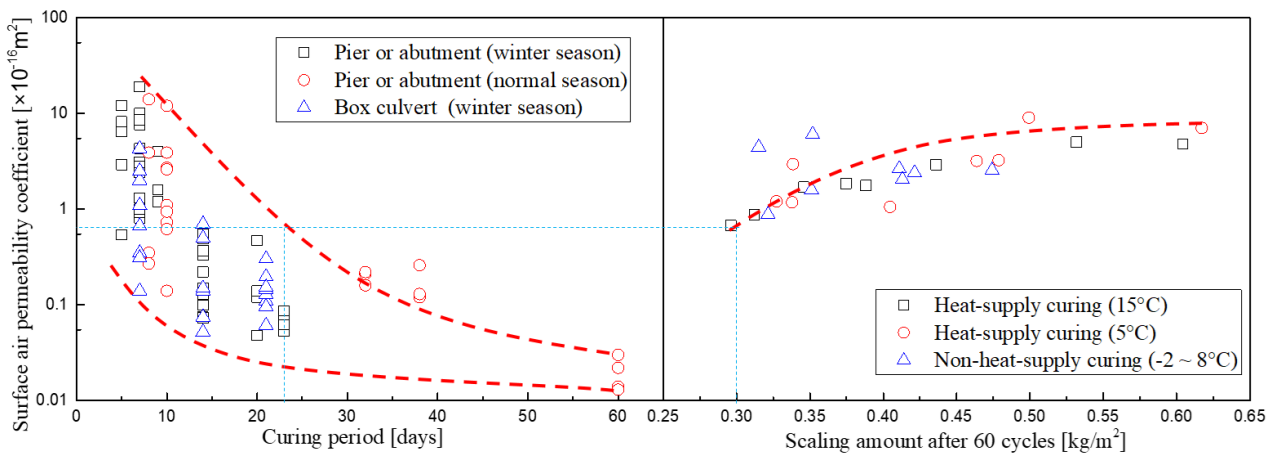
Fig. 7 – The relationship between curing period and the scaling amount after 60 cycles of freezing-thawing action

From this result, it was found that the surface air permeability coefficient decreases with the increase of the curing period, and the scaling amount decreases with the decrease of the surface air permeability coefficient, regardless of curing temperature and curing method. In addition, it can be found that the range of the surface air permeability coefficient changes from large to small. In other words, the surface air permeability coefficient tended towards stability with the increase of the curing period (the surface quality of concrete is improving).

Furthermore, it is possible to consider an appropriate initial curing period according to the low scaling amount and surface air permeability coefficient in Fig. 7. From this figure, when an example of the scaling amount is 0.3kg/m^2 , the safety curing period would need at least three weeks and the surface air permeability coefficient is about $1 \times 10^{-16}\text{m}^2$. It was decided that the concrete has better de-icing salt frost resistance, when the surface air permeability coefficient is less than $1 \times 10^{-16}\text{m}^2$ or the initial curing period is more than three weeks. Therefore, using NDT to test the surface air permeability of concrete is promising as an effective method for confirming the de-icing salt frost resistance of concrete.
